## OFFICE OF THE CITY ADMINISTRATIVE OFFICER

Subject: **SALE OF SURPLUS PROPERTY – LOCATED AT 8131 SOUTH DELGANY AVENUE IN PLAYA DEL REY**

**Advanced Group Property Inspection Co.**

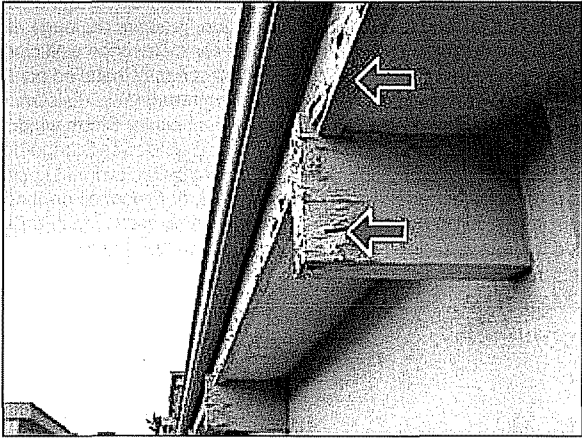
1.0 Picture 1

- Age defects, peeling paint and / or moisture stains/ damage were noted at the eaves and fascia. Recommend further evaluation by a qualified termite inspector and contractor.

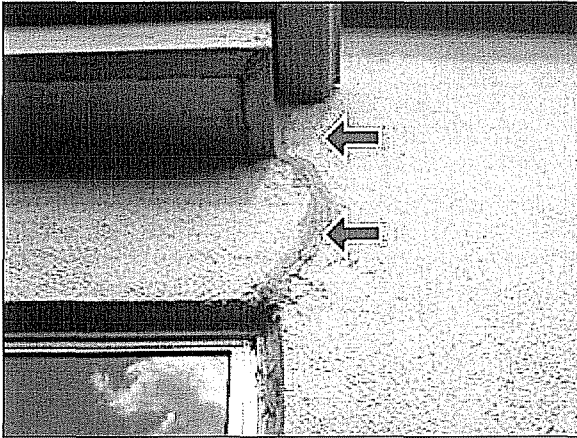
1.1 Picture 1

- Settlement type cracks found at stucco wall(Picture 1) - in need of repair.
- Water damaged wood sidings noted. Have it checked by a qualified termite inspector/ contractor. (Picture 2- 4)

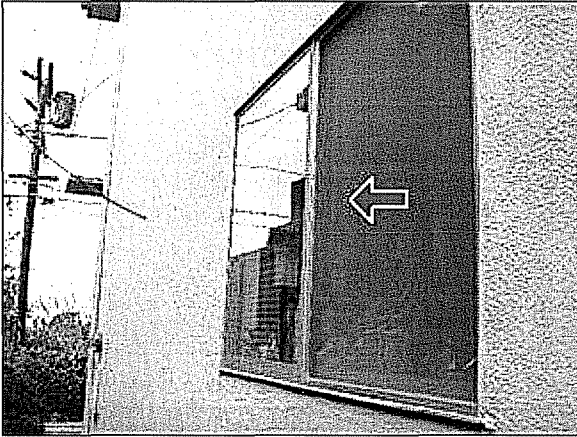
1.2 Picture 1

- House with old aluminum windows type. In need of upgrading.(Picture 1)
- Cracked glass, not tempered glass noted at living room windows. Damaged wood frames noted at windows - have it checked by a qualified termite inspector.
- Have it checked by a qualified contractor(s).

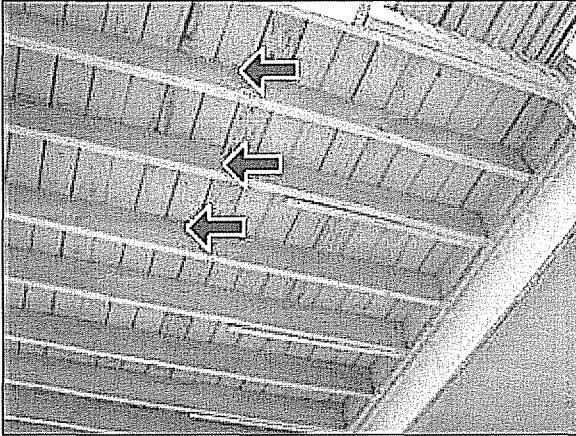
1.4 Picture 1

- Weathered, damaged wood boards noted at rear wood deck. Have it checked by a qualified termite inspector and contractor.(Picture 1)
- Damaged wood boards noted at rear elevation(Picture 2)

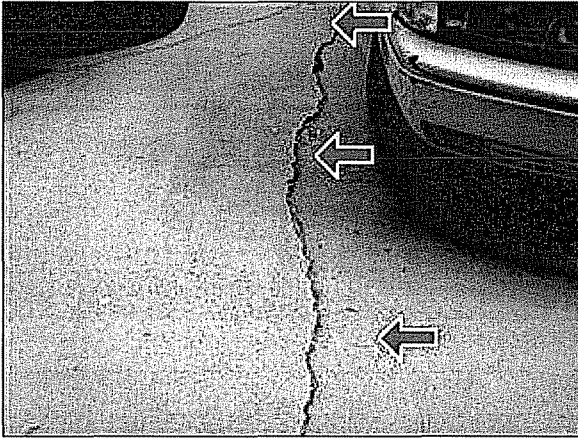
1.5 Picture 1

- House without drainage pipes. Possible water ponding at rear/ side elevations noted.
- Major cracks, trip hazards noted at driveway(Picture 1).
- Plants touch structure. Recommend to move sprinklers and vegetation minimum 2' away from house/ foundation.(Picture 2, 3, 4).
- Walks; exposed river rocks noted at front walk - may be slippery when it is wet. Poor design. Have it checked by a qualified masonry contractor.

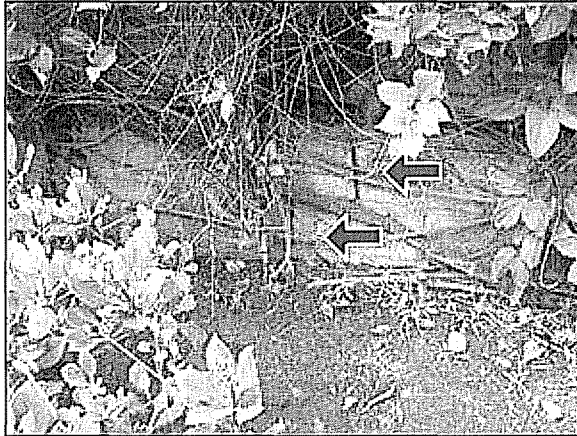
1.6 Picture 1

- Rear yard retaining wall was not fully visible at the time - inspection was limited. Some cracked blocks noted(Picture 1). Have it checked by a qualified contractor.

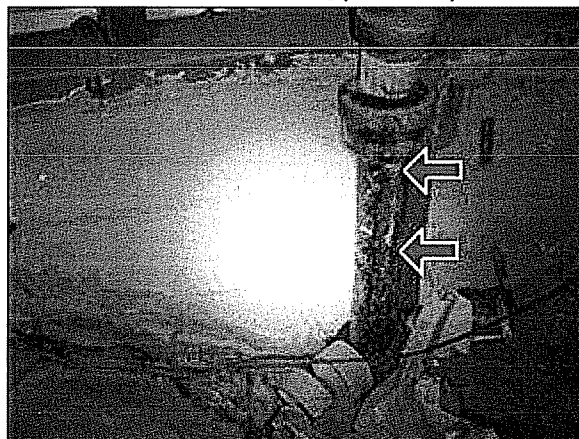
2.0 Picture 1

- The waste lines that go out to the sewer system are installed underground and are not visible. Their condition is unknown. The only way to determine what is going on with them is to have them checked out with a camera by a qualified specialist to determine their true condition/ needed repairs.
- **Video inspection of the sewer / waste pipes is recommended by this Property Inspection Company.**
- Most of the plumbing pipes not visible at this inspection. Check the records for any known defects/repairs.
- All drains flowed properly at the time of inspection.
- **House with old/ rusted sewer pipes type. Further evaluation by a qualified plumber recommended. Periodic inspection recommended. limited life left.** (Picture 1)

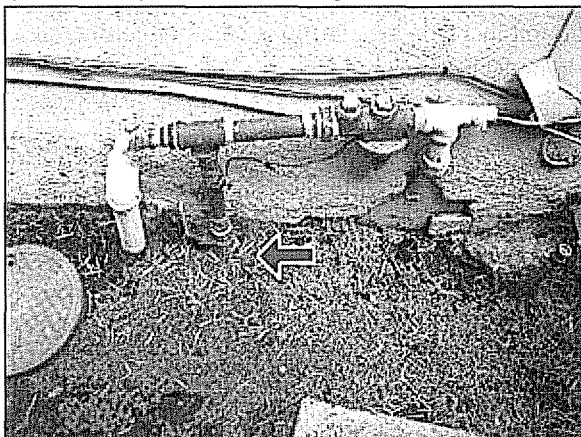
2.1 Picture 1

- Hose Bibs: missing anti-siphon valve at hose bibs ( An anti-siphon (or, anti-syphon) valve is a device that prevents liquid from returning to the line from which it came if a siphon action occurs). Recommend to install.

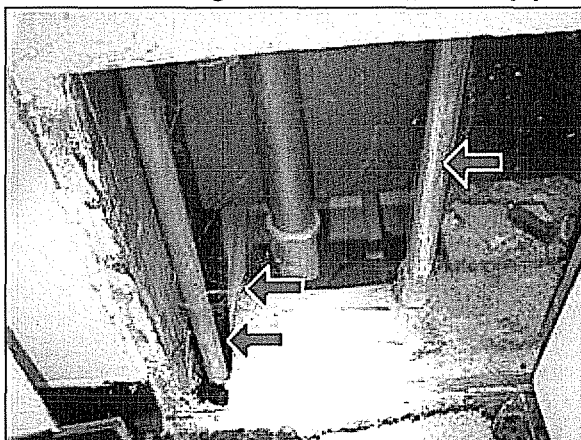
2.2 Picture 1

- Most of the plumbing pipes not visible at this inspection. Check the records for any known defects/repairs.
- **Active galvanized water supply pipes were noted - type is considered to be at or near end of life, of limited remaining life. Recommend to re-pipe. Have it checked by a qualified plumber.**

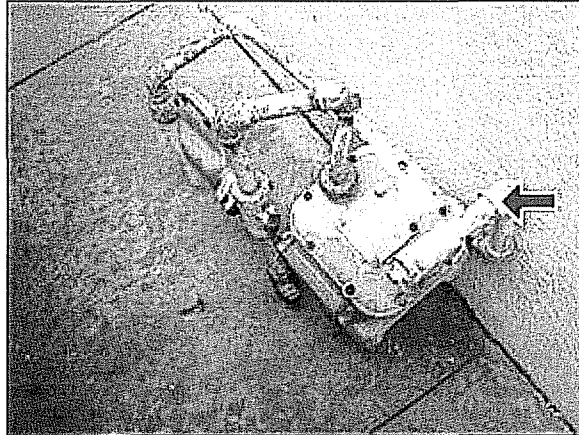
2.4 Picture 1

- Gas meter - seismic shut off was not present at the time of inspection(Picture 1).
- Most of the plumbing pipes not visible at this inspection. Check the records for any known defects/repairs.

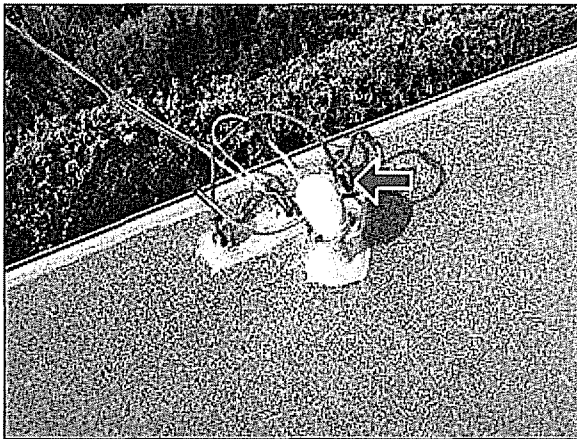
3.0 Picture 1

- Service wires too close to the roof ( not with today's standards for safety) - recommend to upgrade.  
(Picture 1)

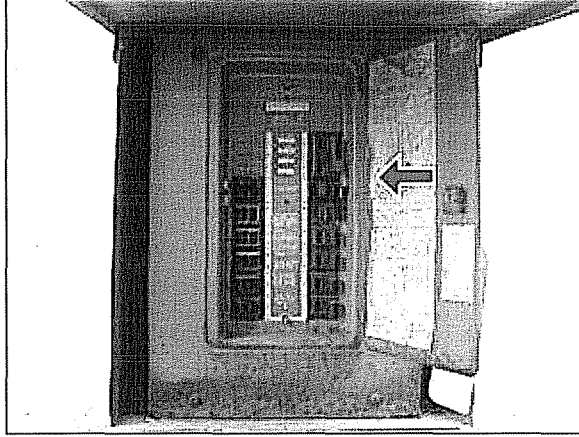
3.1 Picture 1

- Electrical Service panel. (Picture 1)
- House with 100 amp panel type - not adequate for this size house. Have it checked by a qualified electrician.
- Panel is a Zinsco / Federal Pacific brand panel - an older brand which is known by industry professionals to be problematic in certain cases. Recommend further evaluation for safety by a qualified Electrical Contractor. Panel cover not removed at this inspection.

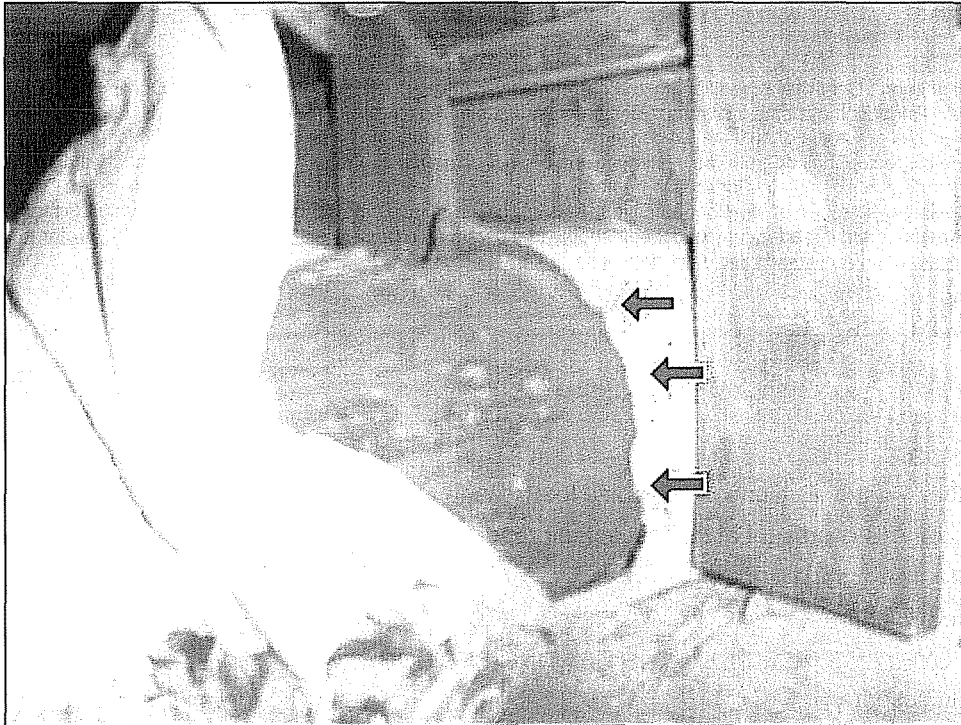
4.3 Picture 4

- Old, rusted ducts found in crawl space (Picture 5)
- Asbestos-like materials were noted on the ducting - further evaluation / testing for abatement / removal is recommended. This is a health concern(Picture 4)

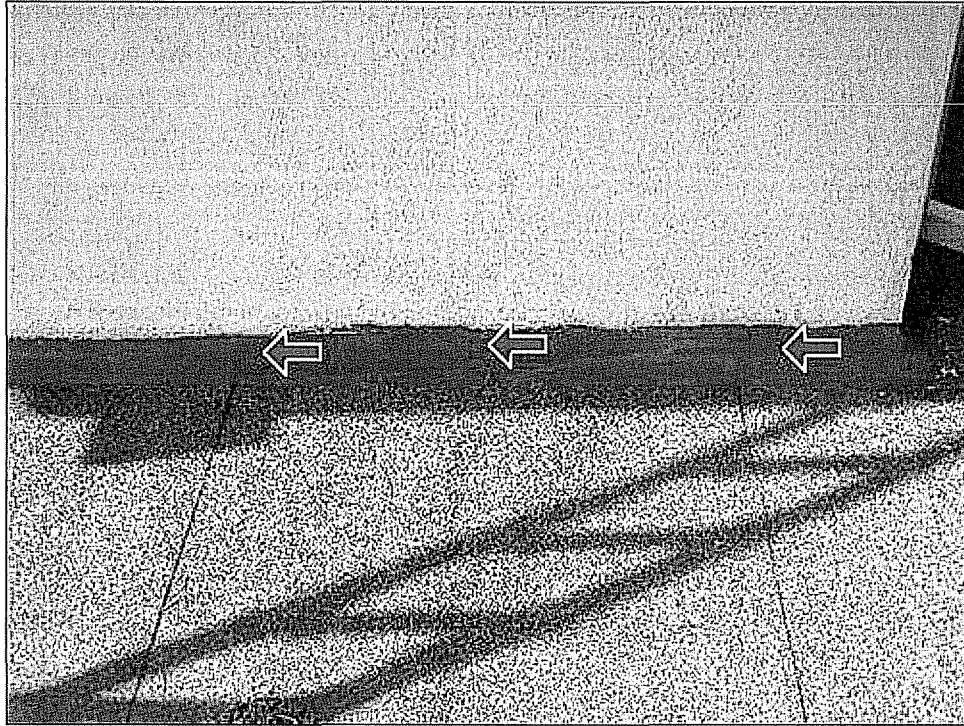
6.1 Picture 1

- Roof to wall flashing not visible/ covered with mastic. Periodic maintenance required to prevent leaks.(Picture 1). Cracked mastic noted - leak hazard. (Picture 2)
- Rusted flashing/ caps noted(Picture 3) - may need replacement.
- Cracked/ worn mastic at flashings noted. Recommend to re-seal to prevent leaks. (Picture 4)

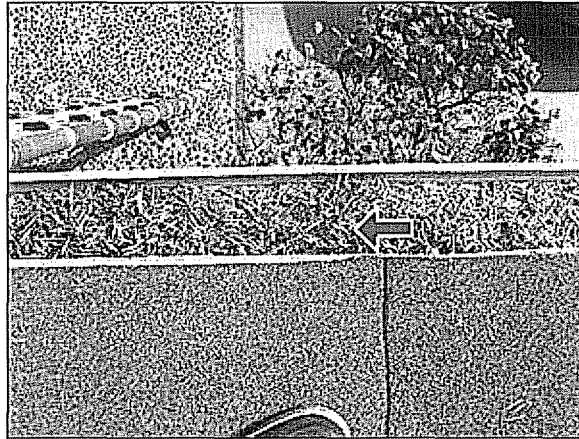
6.4 Picture 1

- Downspouts terminate at foundation - poor location. Recommend to extend away.
- Gutters are full of debris in areas and need to be cleaned. The debris in gutters can also conceal rust, deterioration or leaks that are not visible.

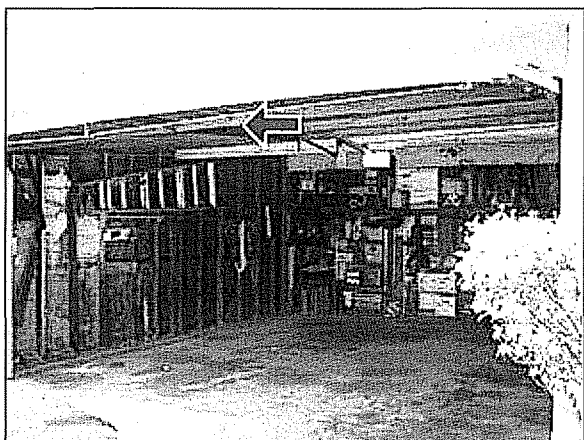
7.0 Picture 1

- Garage vehicle door shows moisture damage, wear, and appears warped - repairs/ replacement by qualified Contractor are recommended.

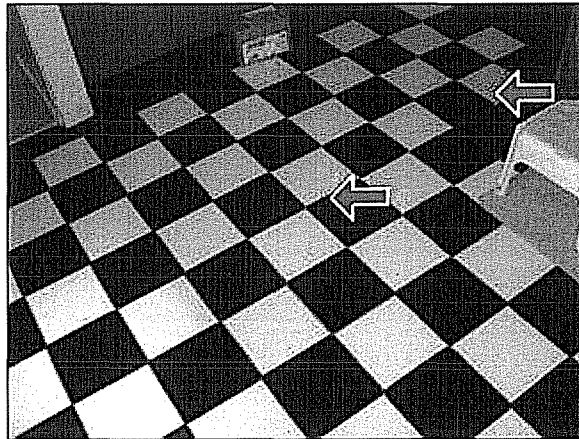
8.2 Picture 1

- House was occupied at the time of the inspection ( walls/floors were not fully visible) - recommend to check the records for any known defects/repairs.
- Squeaky sub floors at various areas noted at the time.
- Aged, worn floor covering noted.
- Loose floor tiles found at kitchen floor.(Picture 1)

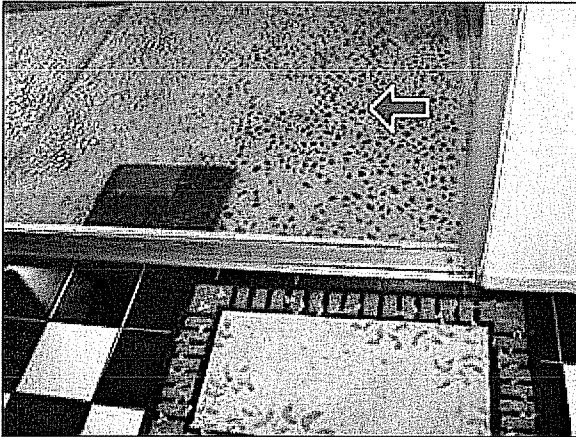
8.3 Picture 1

- Recommend to install door stops to prevent wall damage.
- Sliding doors : glass not tempered type. Recommend to upgrade - safety concern. (Picture 1)
- Door frames were not square - an indication of settlement or movement - further evaluation and corrections by qualified Contractor are recommended. (Picture 2)
- Bathroom area pocket door did not work(Picture 3)

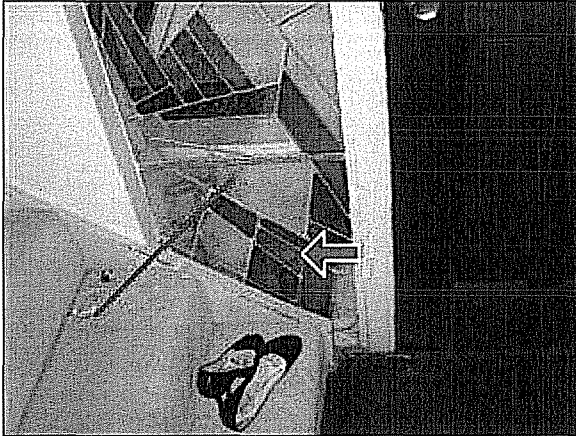
8.4 Picture 1

- Missing proper railing/ guard at stairs area windows(Picture 1) - safety concern. Have it installed. Glass was not tempered type - safety concern. Recommend to replace.
- Windows were difficult to operate at various locations of the inspected property, slide rollers worn, other general common age defects were present.
- Window glass was within 18" off of the floor line ( glass was not tempered) - recommend to upgrade for safety.(Picture 2).
- Cracked glass and gaps noted at windows. Water damaged wood frames noted...
- House with old windows - in need of replacement. Have it checked by a qualified contractor.

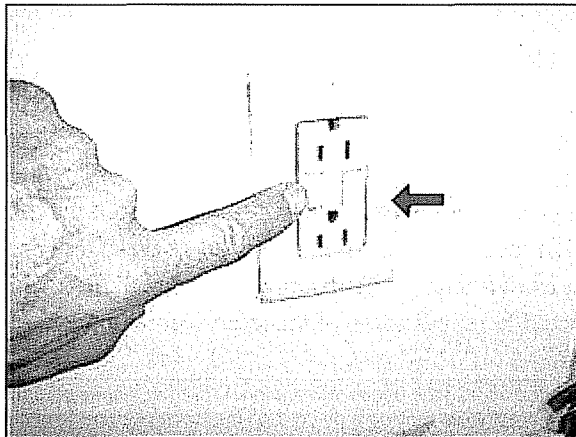
9.1 Picture 1

- Recommend to install GFCI type outlets at Bathrooms and test them periodically. This is a safety upgrade.
- Defective outlet and or wiring noted at Lower Bathroom( had no power at the time)(Picture 1)

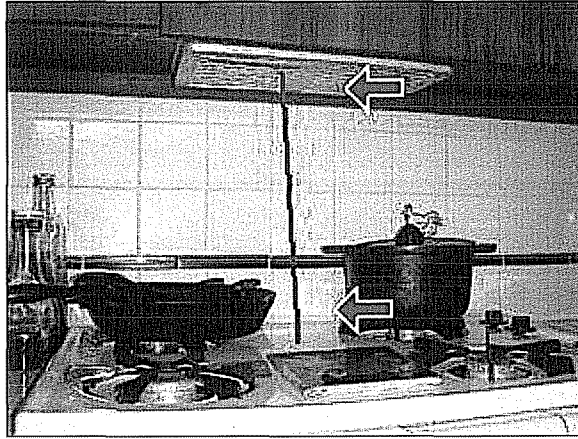
10.4 Picture 1

- **Hood/cabinet was installed too close to the cook top/burner(Picture 1) - improper for fire safety. Recommend to correct. Old hood noted - in need of replacement.**

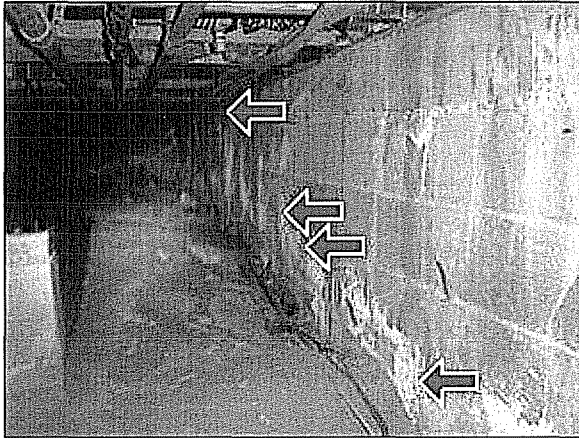
12.0 Picture 1

- Efflorescence was noted present on the foundation wall - recommend to keep moisture around the inspected property to a minimum.(Picture 1)(Picture 2)
- Cracks considered common in size and type were noted at the time of inspection.

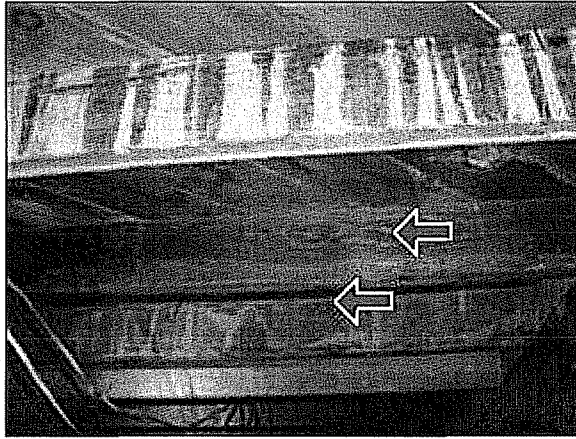
12.3 Picture 1

- Sub floor was not insulated(Picture 1). Recommend to install approved type insulation.
