**1342 West Adams Blvd.
DEMOLITION: Guttled without permits**

1342 W ADAMS BLVD

Description: ANY CHANGES DONE TO A PROPERTY IN AN HISTORICAL AREA

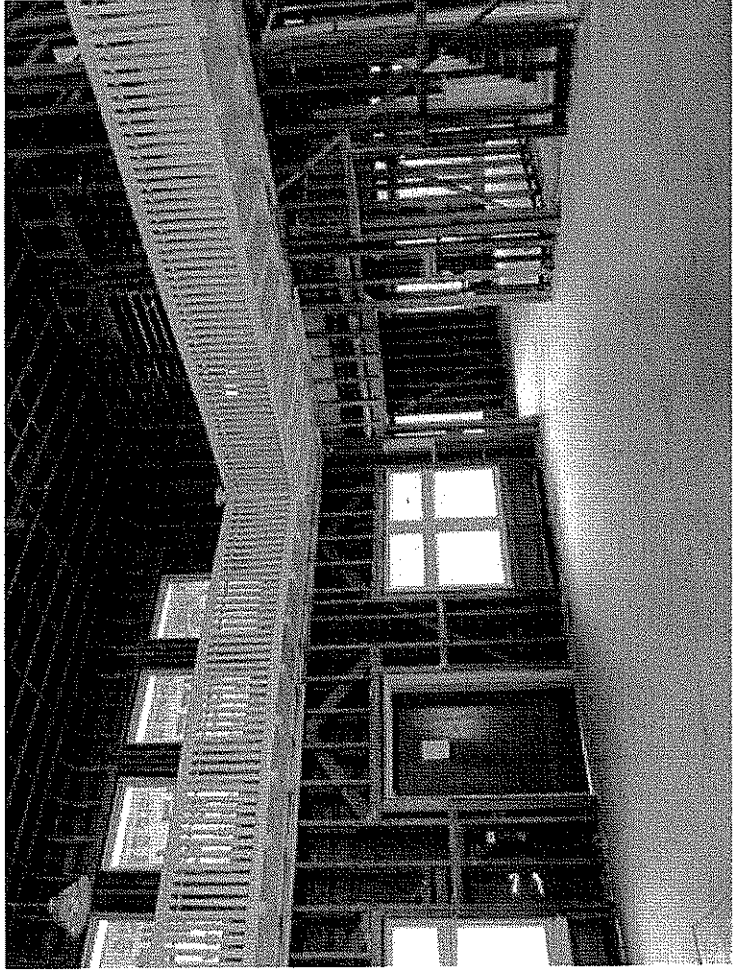
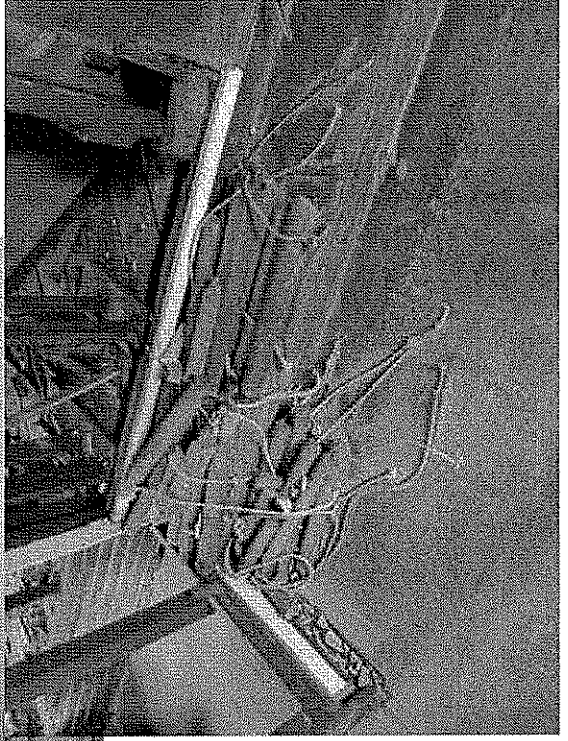
Entry/Great Room BEFORE (above), and AFTER (below).

This room has been used for 80 years as an auditorium, church sanctuary and gathering place accessible to the public. Note the coved ceiling.

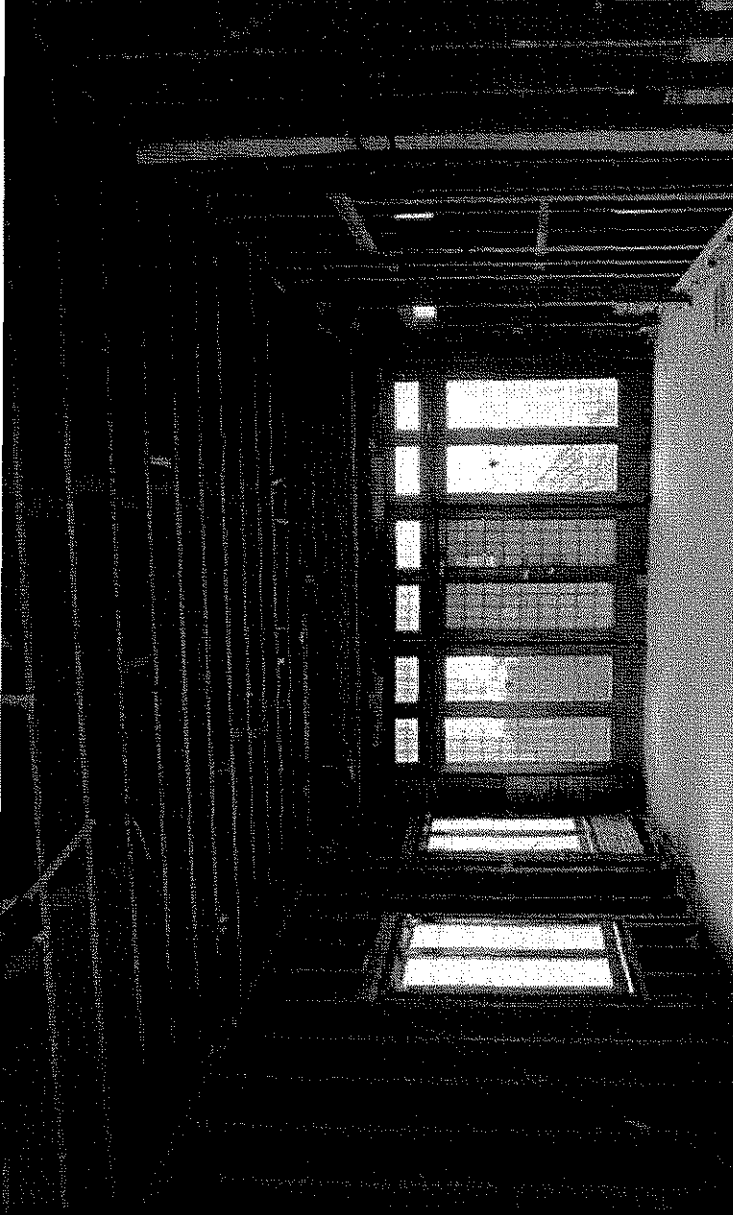
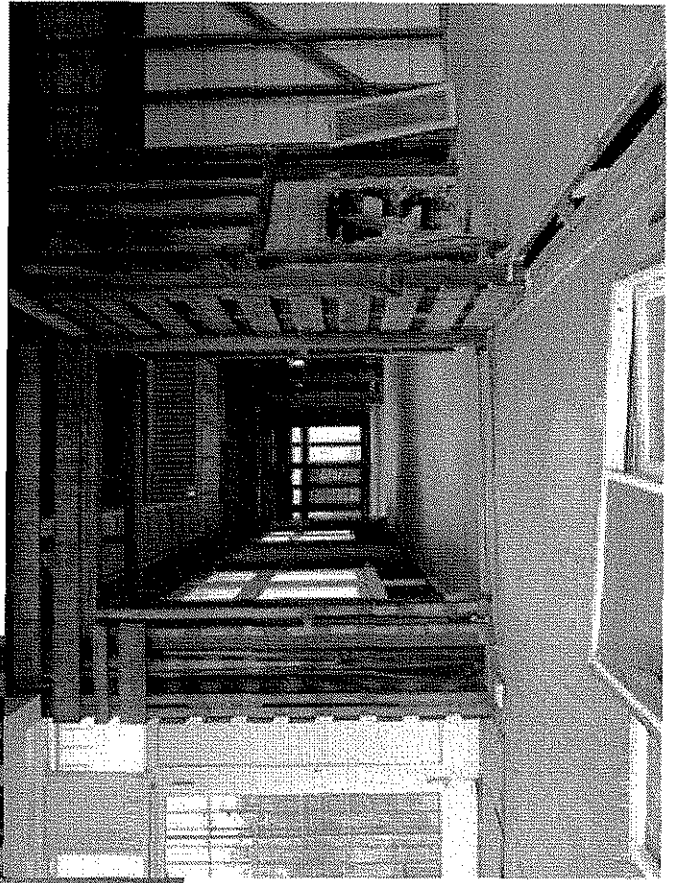
Leaded glass windows/French doors are a character defining feature.

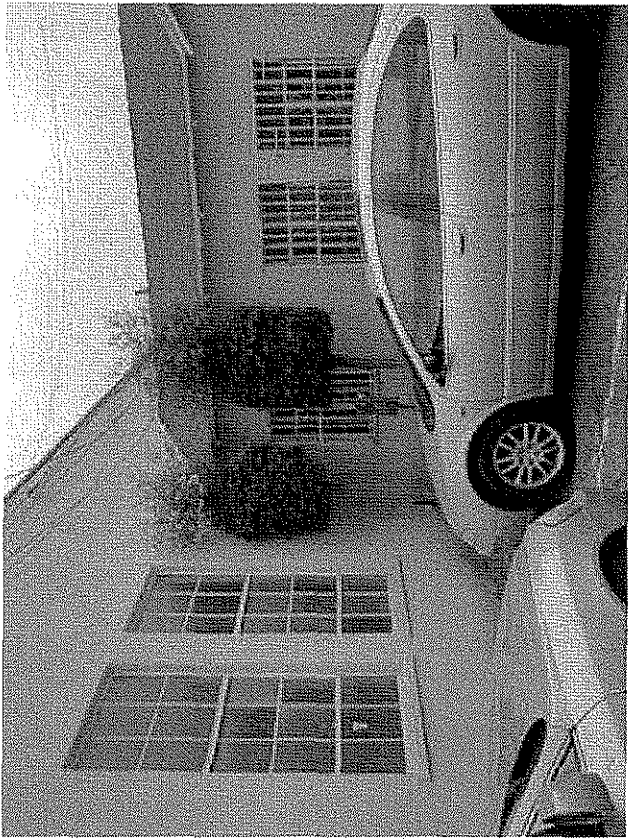
Carriage House is attached to the Church/social hall building -- a zero-foot setback.
