Neighborhood Council: Hermon

Council File Number: 14-0163-S17

Summary: The Hermon Community is a peaceful and tranquil place to live. However, there are issues that any neighborhood will have to contend with. In 2016 it was the homeless population that overpopulated the Arroyo. In 2017 petty crimes involving car break ins were rampant. Those issues, for the most part, have dissipated. In 2018, our top priority is sidewalk repair. In August 2018, the Hermon Neighborhood Council hosted an event with Councilmember Huizar with approximately 75 residents. The residents overwhelmingly voiced their concern with buckling and broken sidewalks that are a tremendous public safety hazard. Our community is made up of lots of families and elderly. Becuase of the failing sidewalks, families with kids that push their kids in baby carriages have a hard time maneuvering through broken sidewalks. The elderly find it difficult to meander their wheelchairs around broken sidewalks an at times have no choice but to meander into streets. The Hermon Neighborhood Council has put together an in-depth analysis focusing on sidewalk conditions in Hermon. This is our top priority and we ask the City Council an

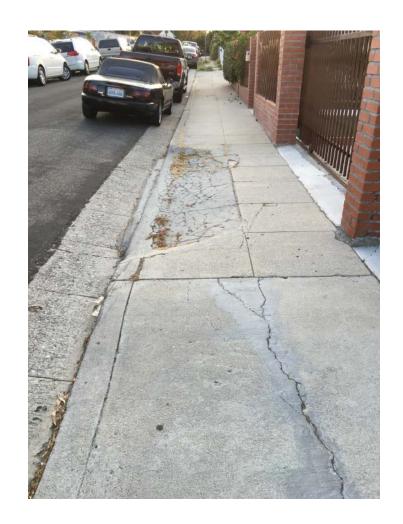
LOCATION: 433 & 437 Wheeling Way

DESCRIPTION: Driveway bibs Cracked & Spidering

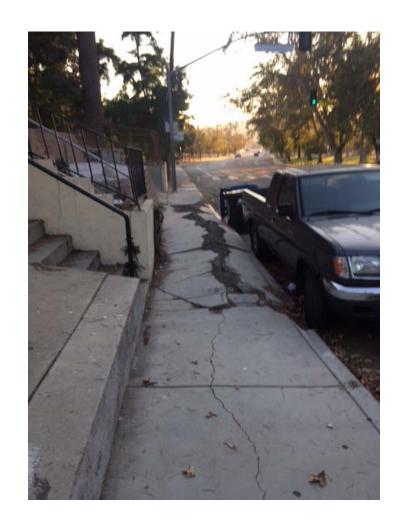
LOCATION: Via Marisol area West of Avenue 60

DESCRIPTION:
Problems in area is known
Complete street and sidewalk repair has been budgeted by the city of Los Angeles for 2019

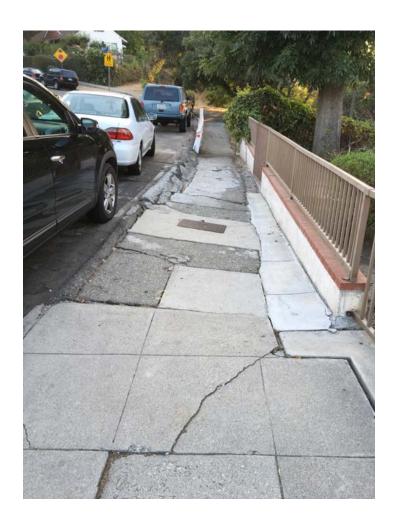
LOCATION: Wheeling Way

DESCRIPTION: Sidewalk crossing above stepstreet broken and sinking.

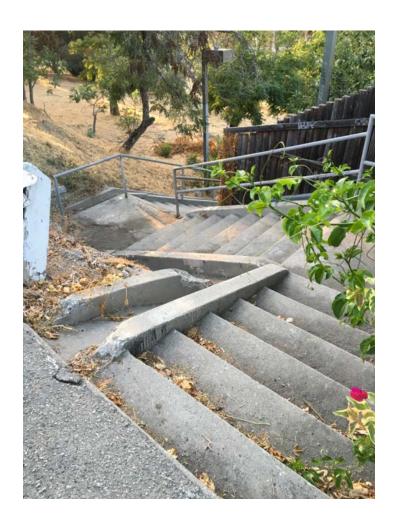
LOCATION: Wheeling Way step street down to Via Marisol

DESCRIPTION: Steps and edging broken, shifting and in disrepair

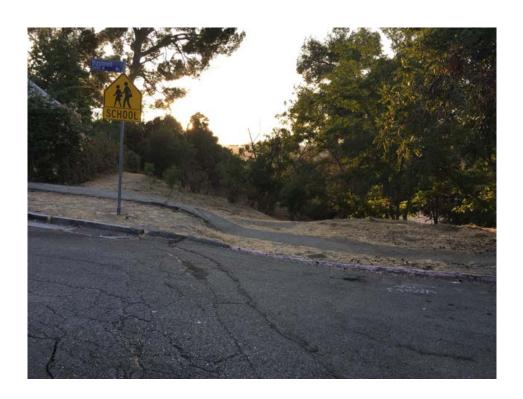
LOCATION: Bushnell Way at Wheeling Way

DESCRIPTION: Sidewalk missing and severly dropped area from ground movement.

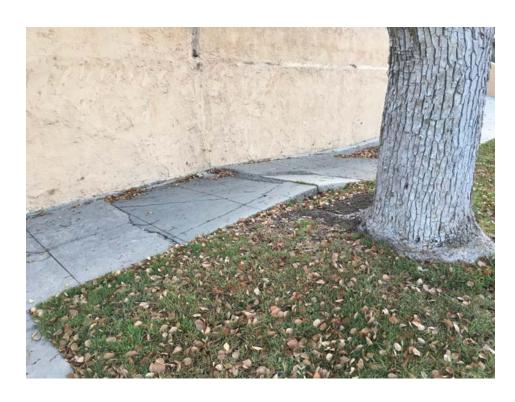
LOCATION: Kendall at Monterey Between 432 Kendall and Monterey Road

DESCRIPTION:
A few lifted areas
around trees. Prevoiusly patched with
asphalt

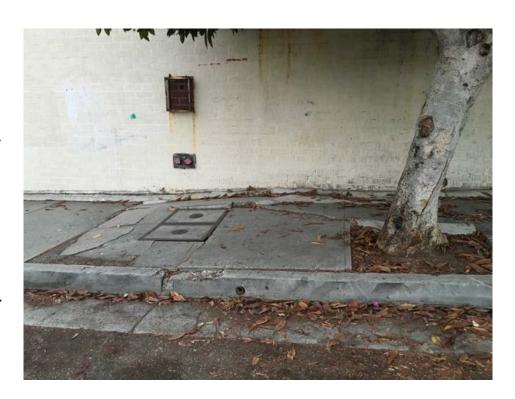
LOCATION: Across the street from 5916 Ebey Way (Behind Fresco Market)

DESCRIPTION: Cracked and lifted section around water connection and tree.

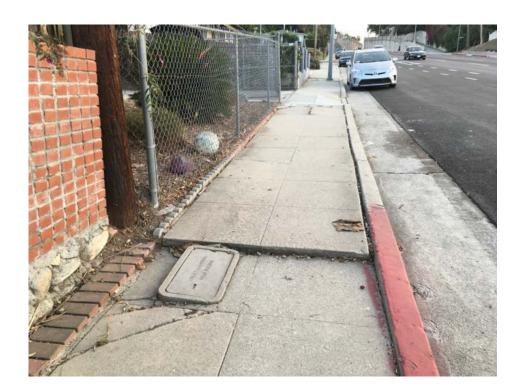
LOCATION: 5444 Monterey Road (Just South of Kendall)

DESCRIPTION: Drop in sidewalk around water meter. cracking at corners

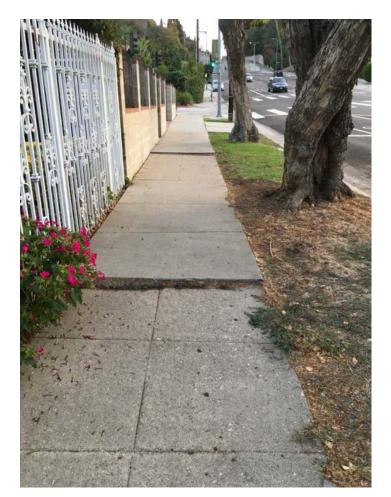
LOCATION: 5500-5506 Monterey Road (Just North of Kendall)

DESCRIPTION: Lift in sidewalk. previous repair is broken and worn.

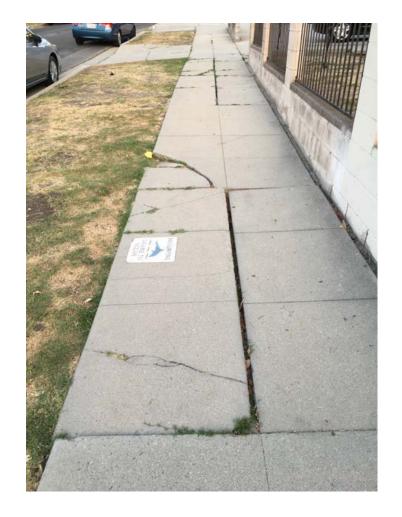
LOCATION: 502-510 Colman Ave (at Monterey Road)

DESCRIPTION: Lift in sidewalk. previous repair is broken and worn.

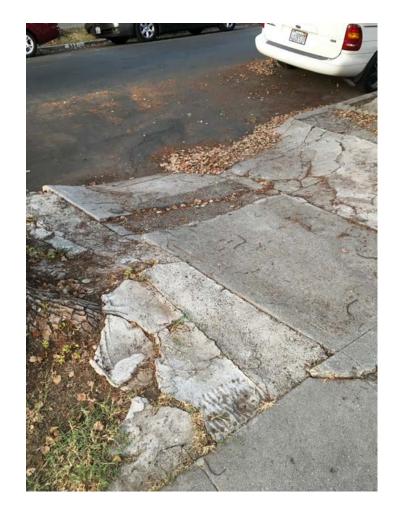
LOCATION: 520 Redfield Ave

DESCRIPTION: Spidering and cracking driveway bib and sidewalk edging.

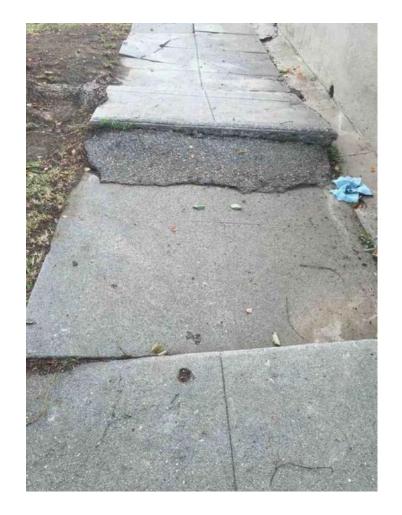
LOCATION: Redfield Ave exact address unkown

DESCRIPTION: Large lifted sections. Previous repair is worn and chipped

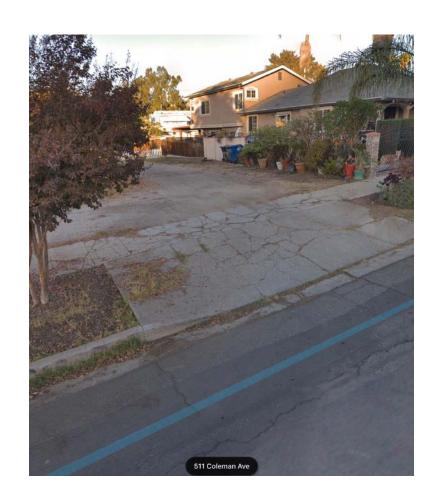
LOCATION: 511 Coleman Ave

DESCRIPTION: Spidering and cracking sidewalk and driveway bib.

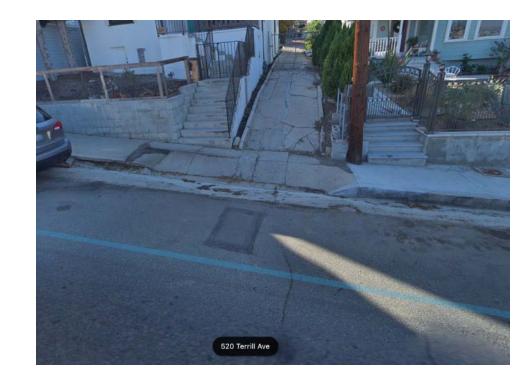
LOCATION: 520 Terrill Ave

DESCRIPTION:
Borken curb dropping and lifting of sidewalk and driveway bib.

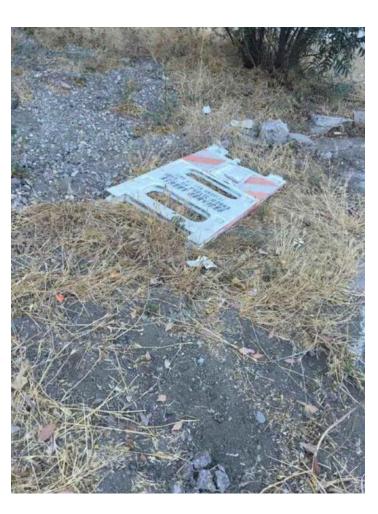
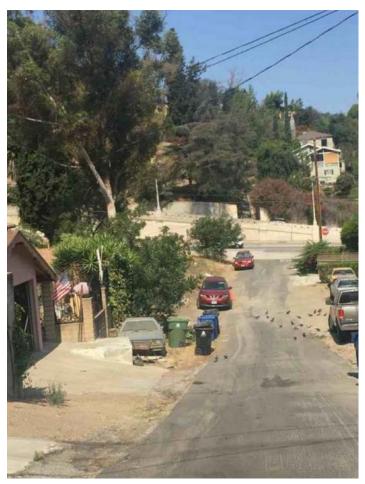
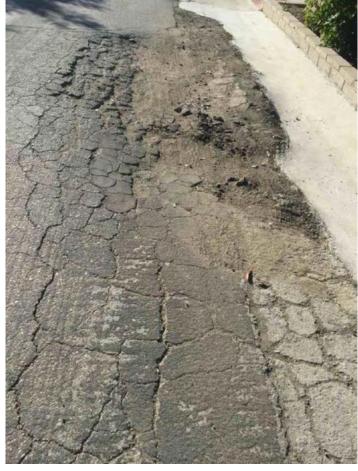
# LOCATION: Pullman Way

DESCRIPTION:
No sidewalks or
curbs. Images show
street and gutter
conditions.
Street is asphalt with
no curb.
Unfinished repair and
equipment.

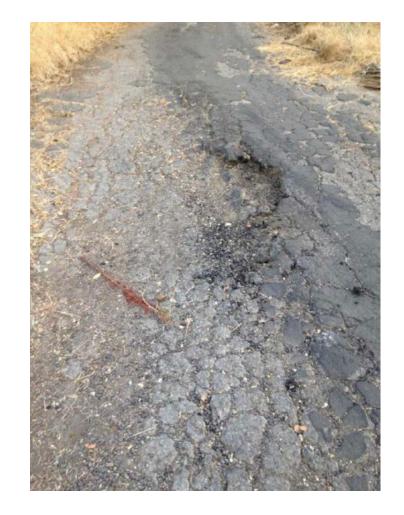
LOCATION: Hawley Ave

DESCRIPTION:
No sidewalks or
curbs. Image shows
crumbling street and
gutter condition.
Street is asphalt with
no curb.

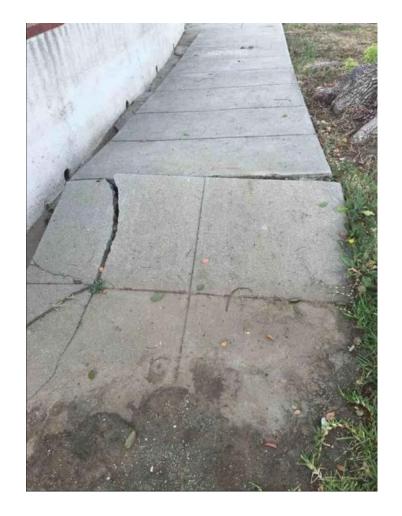
LOCATION: Redfield Ave exact address unkown

DESCRIPTION: Large lifted section with loose piece.

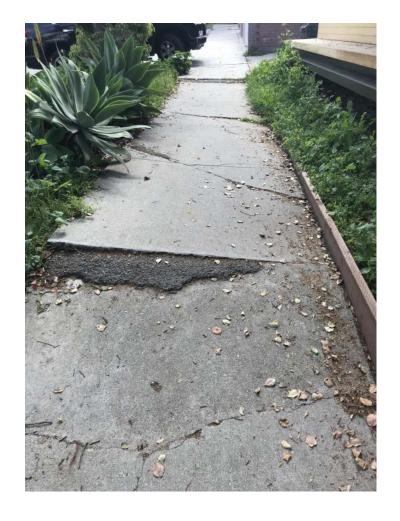
LOCATION: 508 Redfield Ave

DESCRIPTION: Worn Patch Areas

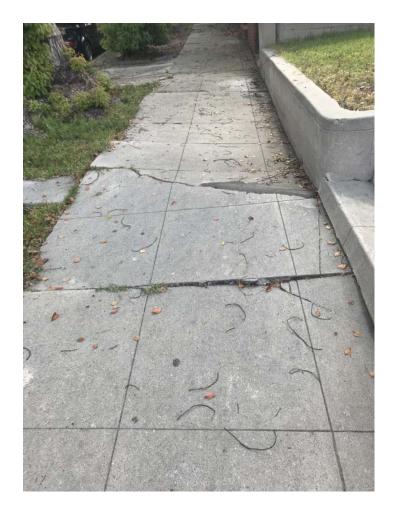
LOCATION: 518 Redfield Ave

DESCRIPTION: Worn Patch Areas

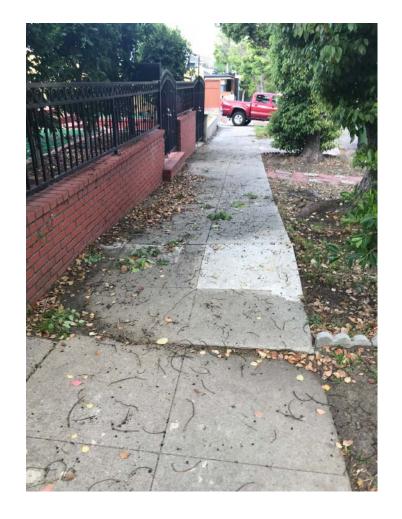
LOCATION: 520 Redfield Ave exact address unkown

DESCRIPTION: Large lifted section with loose piece.

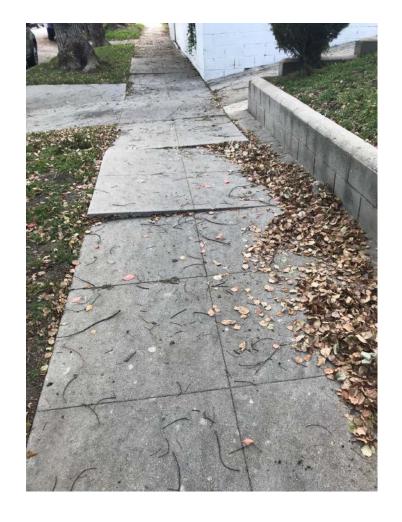
LOCATION: 524 Redfield Ave

DESCRIPTION: Lifted section

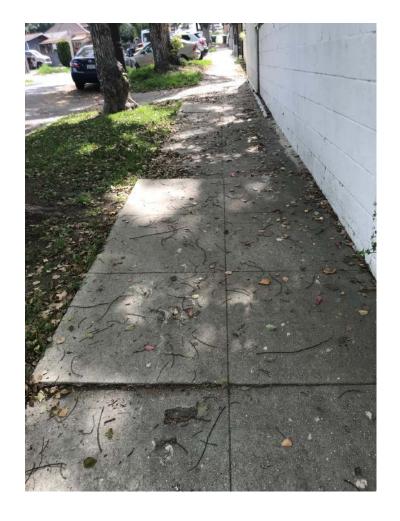
LOCATION: 528 Redfield Ave

DESCRIPTION: lifted section

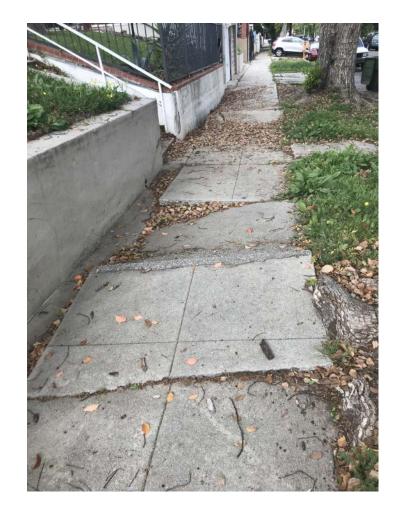
LOCATION: 544-548 Redfield Ave

DESCRIPTION: Large lifted section Worn Patch Areas

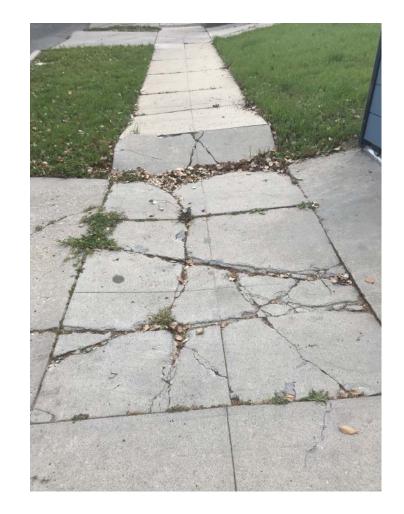
LOCATION: 552 Redfield Ave

DESCRIPTION:
Large lifted section
with loose piece. Spidering and cracking.
Drop and lifting in
sections.

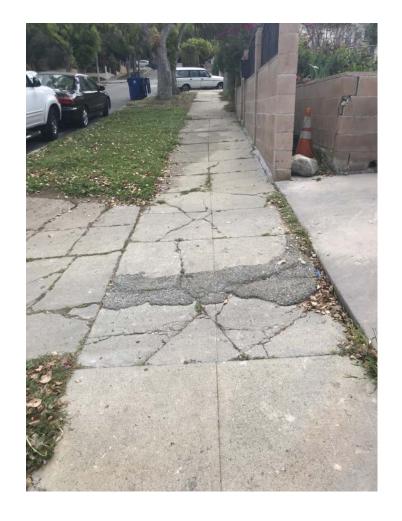
LOCATION: 560 Redfield Ave

DESCRIPTION: Worn Patch Areas

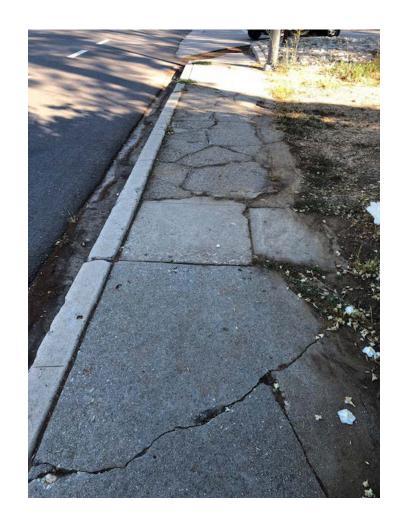
LOCATION: Between 457 S. Ave 60 and 110 frwy on ramp

DESCRIPTION: Cracking & Spidering depression on vegitation side. Previously repaired with asphalt fill.

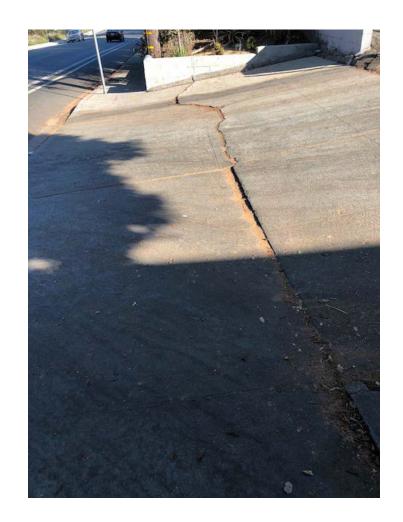
LOCATION: Ave 60 at Monterey sidewalk and driveway in front of Union 76 gas station

DESCRIPTION: Cracking & gaps

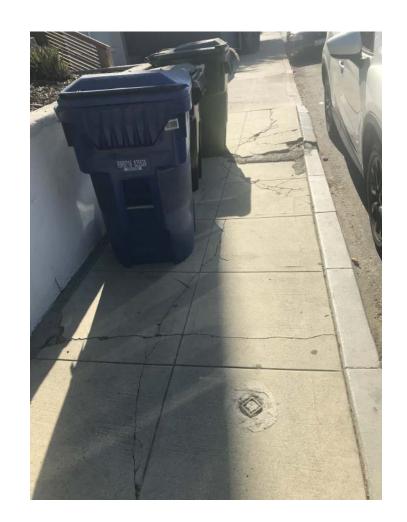
LOCATION: 617 S Ave 60

DESCRIPTION: Cracked and lifted section of sidewalk and curb. Previously patched with asphalt.

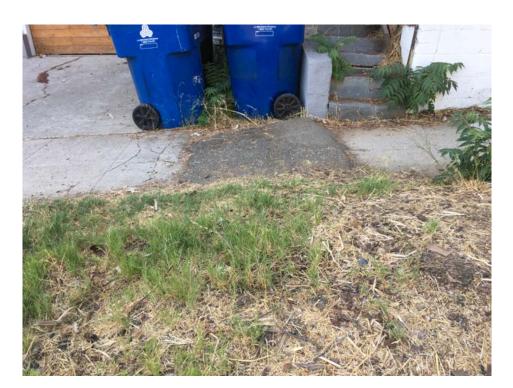
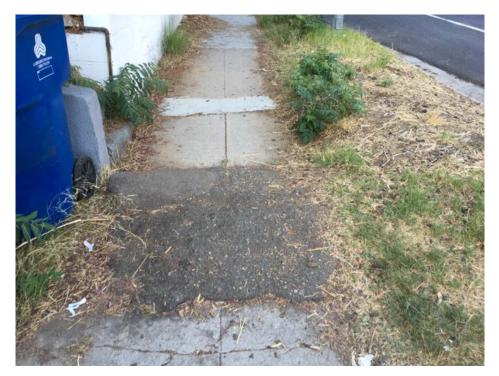
LOCATION: 6215 Monterey Road

DESCRIPTION: Lift in sidewalk with asphalt patch repair

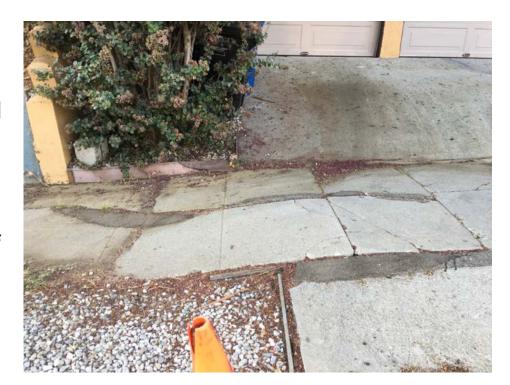
LOCATION: 6209 Monterey Road

DESCRIPTION: Lift in sidewalk with asphalt patch repair. long crack at base of lifted area.

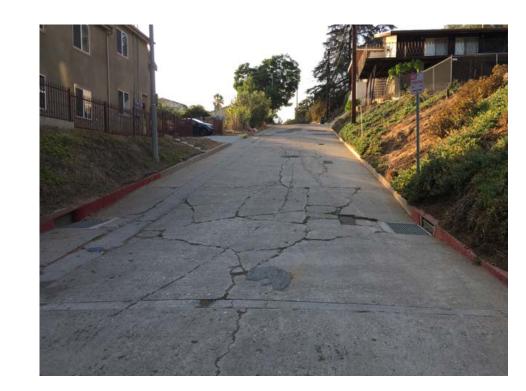
HERMON NORTH LOCATION: Hardison Way

DESCRIPTION:
No sidewalks.
Images show street and curb condition.
Street is concrete with curb.

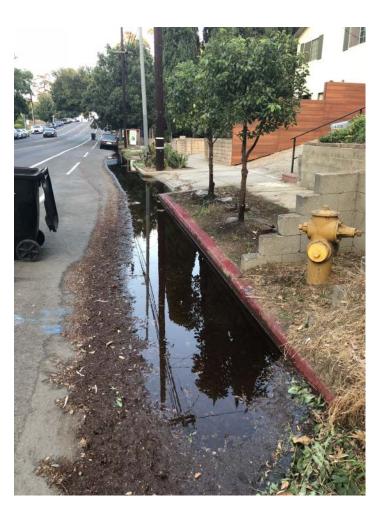
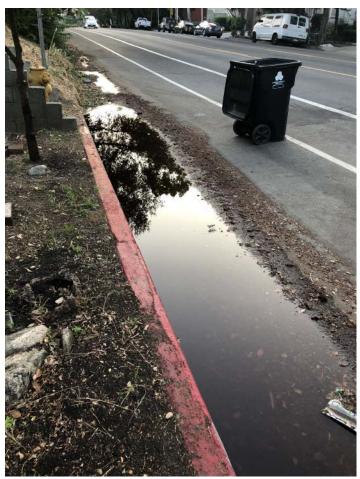
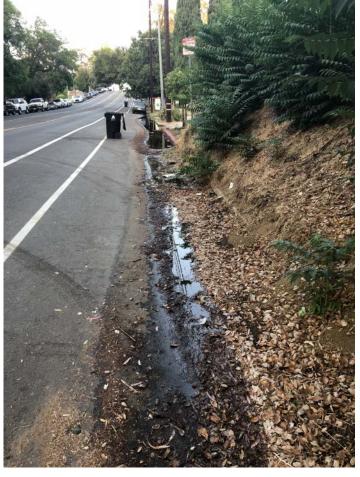
# HERMON NORTH LOCATION: 6336 Monterey Road

DESCRIPTION:
Street edge along
gutter collects water
and does not properly drain. Water will sit
for days until it evaporates. Water source
is unknown.
