Street Damage Restoration Fee Study

City of Los Angeles

Bureau of Street Services

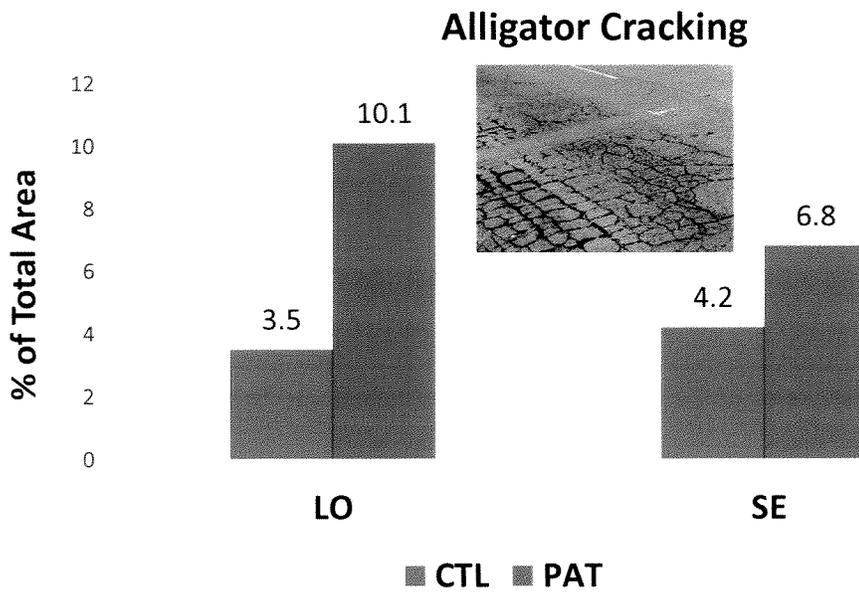
Alligator Cracking and Rutting are two distresses that are load related. It is to be expected that more of these distresses will occur when the pavement has been structurally weakened. This is clearly the case when comparing these distresses between the CTL and the PAT sites as illustrated in **Figures 3.5, and 3.6**. In Local streets; Alligator cracking measured at 10.1% of the total surveyed PAT sites as compared to 3.5% in the CTL sites. In Select streets; Alligator cracking measured at 6.8% of the total surveyed PAT sites as compared to 4.2% in the CTL sites. The measured increases are drastic by any standard.

Figure 3.5 – Comparison of Alligator Cracking % Areas between CTL and PAT Inspection Units for LO and SE Sites

2. There is a higher percent of load related distresses (Alligator cracking and Rutting) in Patched areas vs. Control (**Figures 3.5 and 3.6.**). Most of the distress percentages are at the medium and high severity levels of the distresses (**Figures 3.7 and 3.8.**)

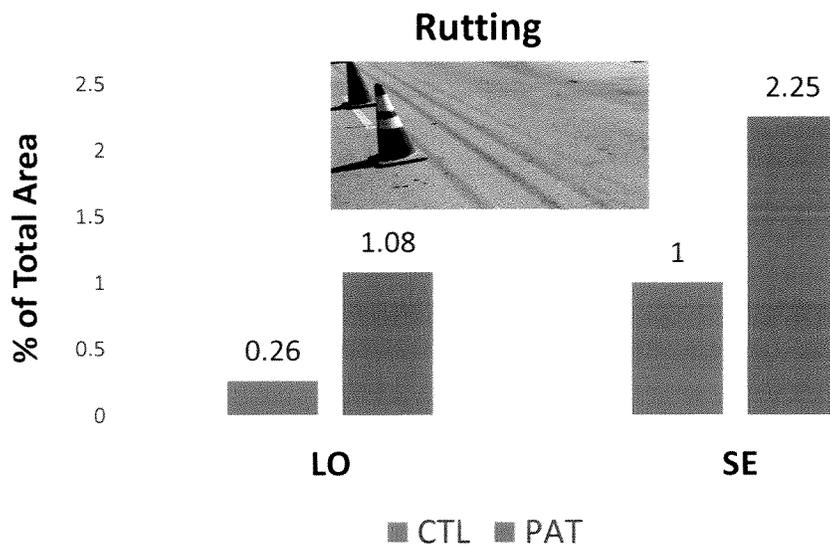
Similar results were observed for Rutting as observed for Alligator cracking. In Local streets; Rutting measured at 1.08% of the total surveyed PAT sites as compared to 0.26% in the

CTL sites. In Select streets; Rutting measured at 2.25% of the total surveyed PAT sites as compared to 1.0% in the CTL sites.

Figure 3.6 – Comparison of Rutting % Areas between CTL and PAT Inspection Units for LO and SE Sites

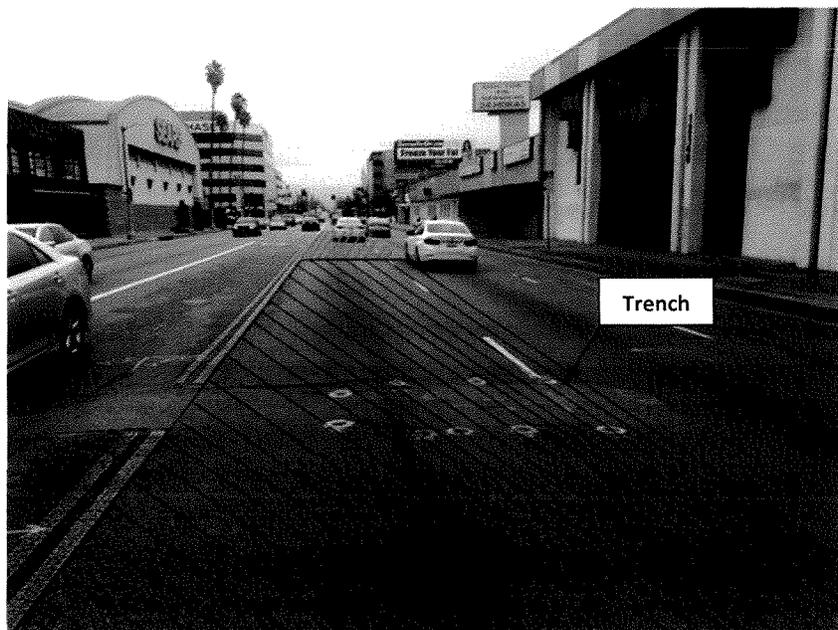
Figure 4.1: Shows both Trench and Control area (S37)

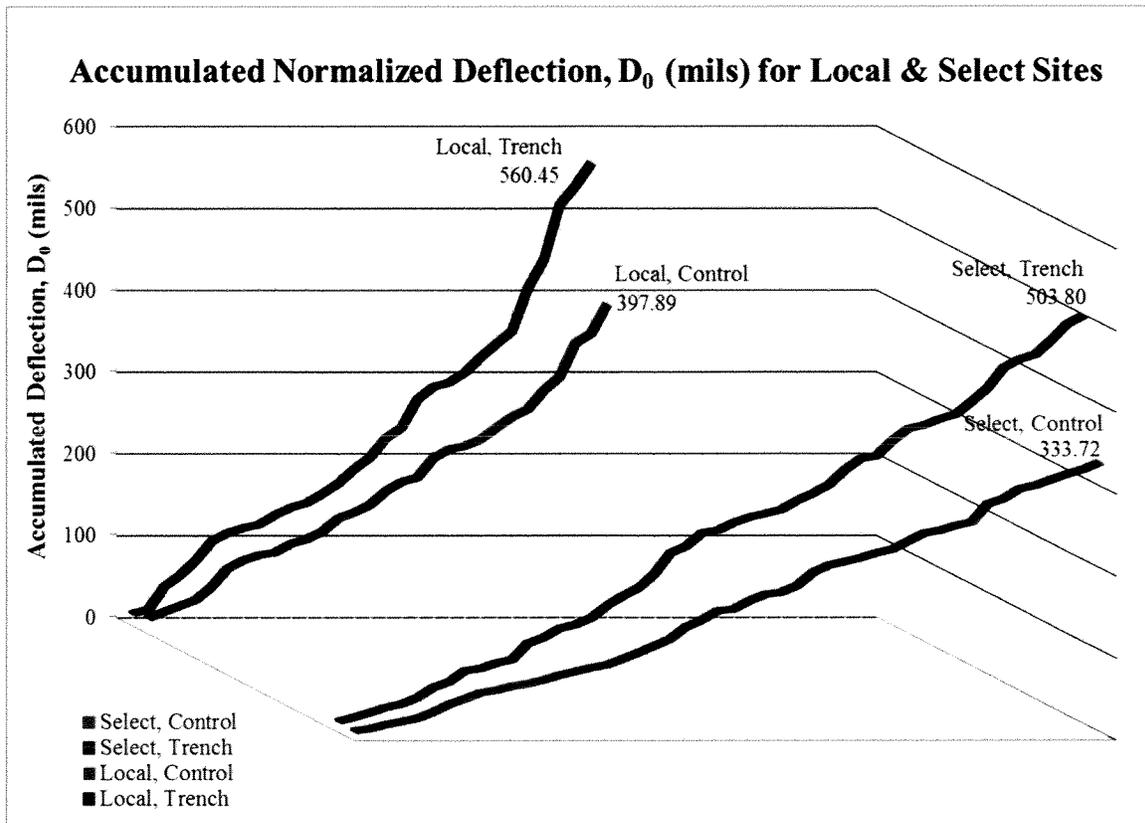
Accumulated deflection, D_0 (Normalized to 9 Kips and 68° F) of Local Sites and respective Controls clearly show higher accumulated deflection on trenches than controls. The values are 560 mils and 398 mils, correspondingly. The same observation is seen in Select Trenches vs. Controls where the values are 504 mils and 334 mils, respectively (**See Figure 4.3**). The average normalized deflection (D_0) of Local Trenches was 41% higher than their corresponding Control. The average normalized deflection (D_0) of Select Trenches was also 51% higher than their corresponding Control (**See Figure 4.4**). This shows that the pavement surrounding each trench has been weakened more than the rest of the pavement section, thereby

accelerating pavement failure under traffic. It was also observed that the deflection ratio (around patch/ control) was higher among select streets than local streets.

Figure 4.3 – Comparison of Control and Trench (PAT) Accumulated Deflections

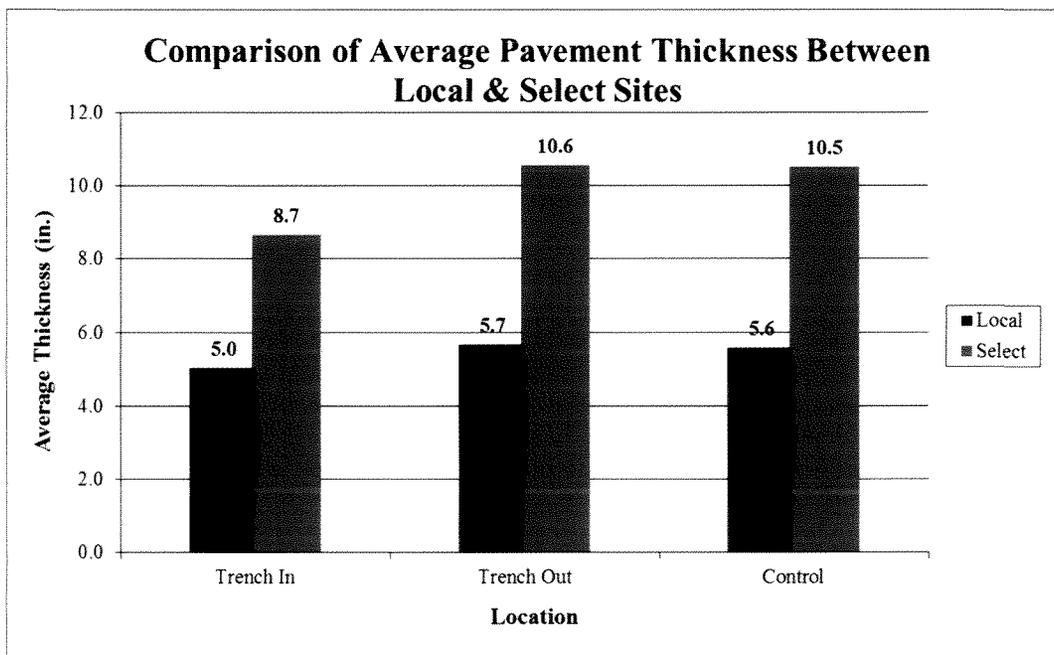
Figure 4.6 – Average Pavement Thickness

The comparison of the average pavement thickness between Local and Select streets (**Figure 4.6**) demonstrates that in both classifications (**Local and Select**), the pavement thickness inside of the trench (**Trench-In**) was less than outside (also near) the trench (**Trench-Out**) and its respective control. Furthermore, this difference is more significant among Select

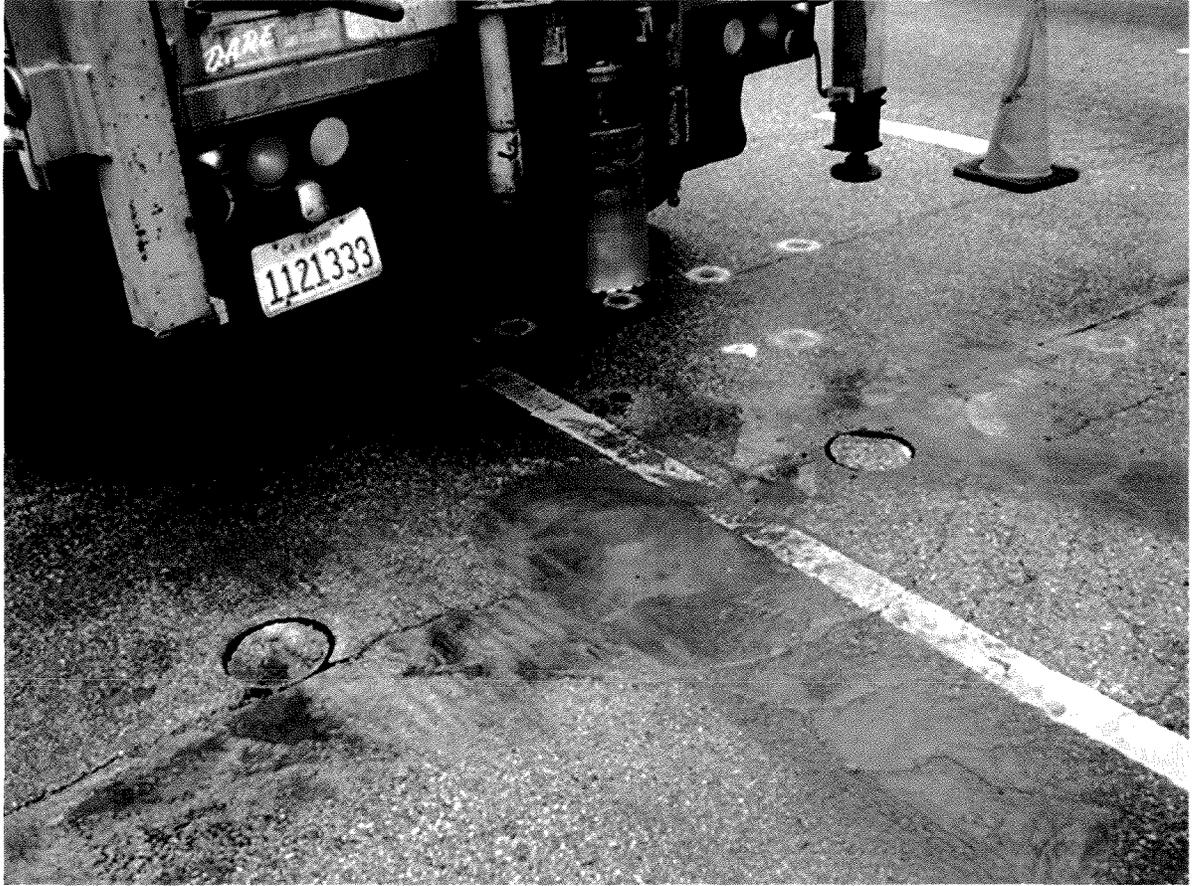
Coring data shows that inside of trench (**Trench-In**) asphalt concrete thickness is much less than outside of the trench (**Trench-Out**) see **Figure 4.6**.

Figure 4.9: Existing pavement thickness determination Trench-in & Trench-out.

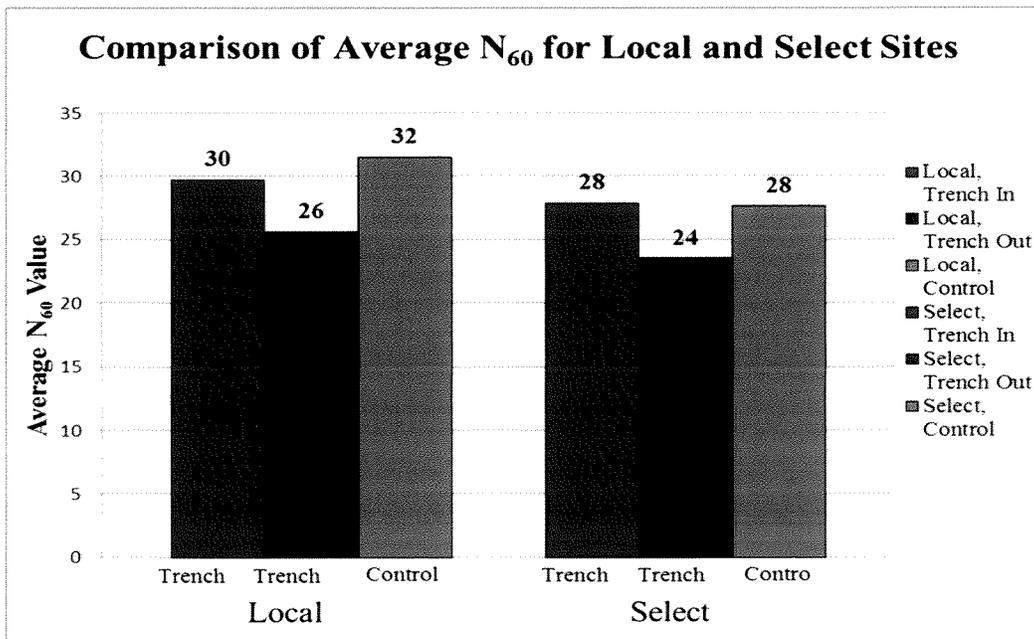
Figure 4.10 – Comparison of relative Soil Strength

In this comparison, both classifications exhibit the Control N₆₀ values higher than the Trench-Out which indicates that the utility trench disturbed and debilitated the strength of the

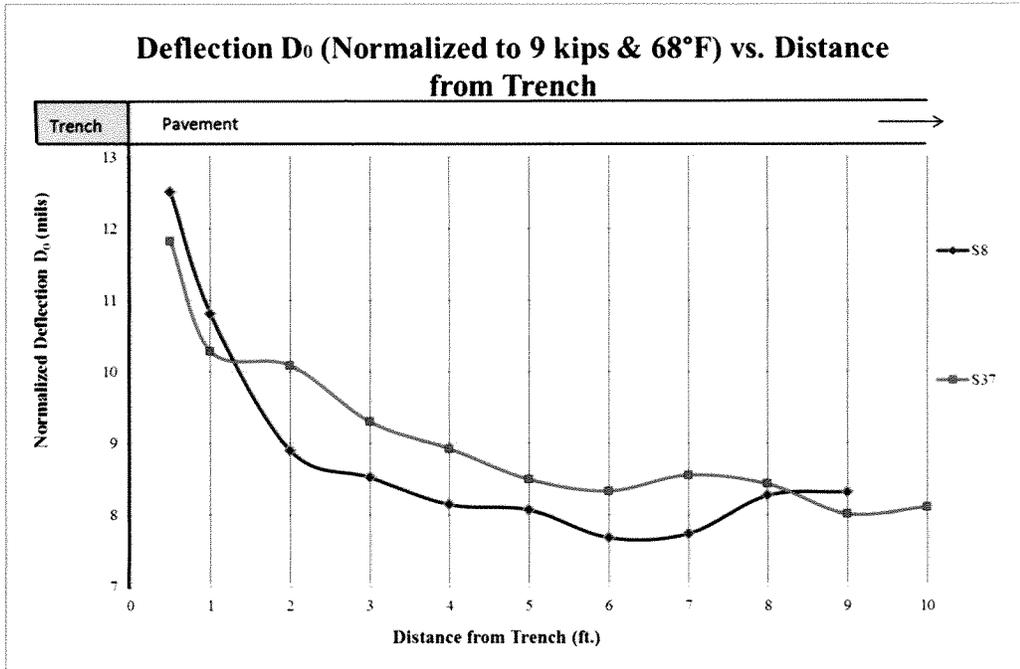
Figure 4.16 – Example Width of Influence Testing for two Select Trenches (S8 and S37)

1. The deflection ratio around the edge of the patch compared to away from the patch ranges from 1.25 to 2.74 with an average of 1.59.
2. The Utility Cut Patch Width of influence ranges from 2.5 ft. to 10.0 ft. with an average of 5.2 ft.
