**CALIFORNIA GEOLOGICAL SURVEY  
FAULT EVALUATION REPORT FER 253  
SUPPLEMENT NO. 1**

**THE HOLLYWOOD FAULT  
in the Hollywood 7.5' Quadrangle  
Los Angeles County, California**

by  
Janis L. Hernandez  
Engineering Geologist  
November 5, 2014

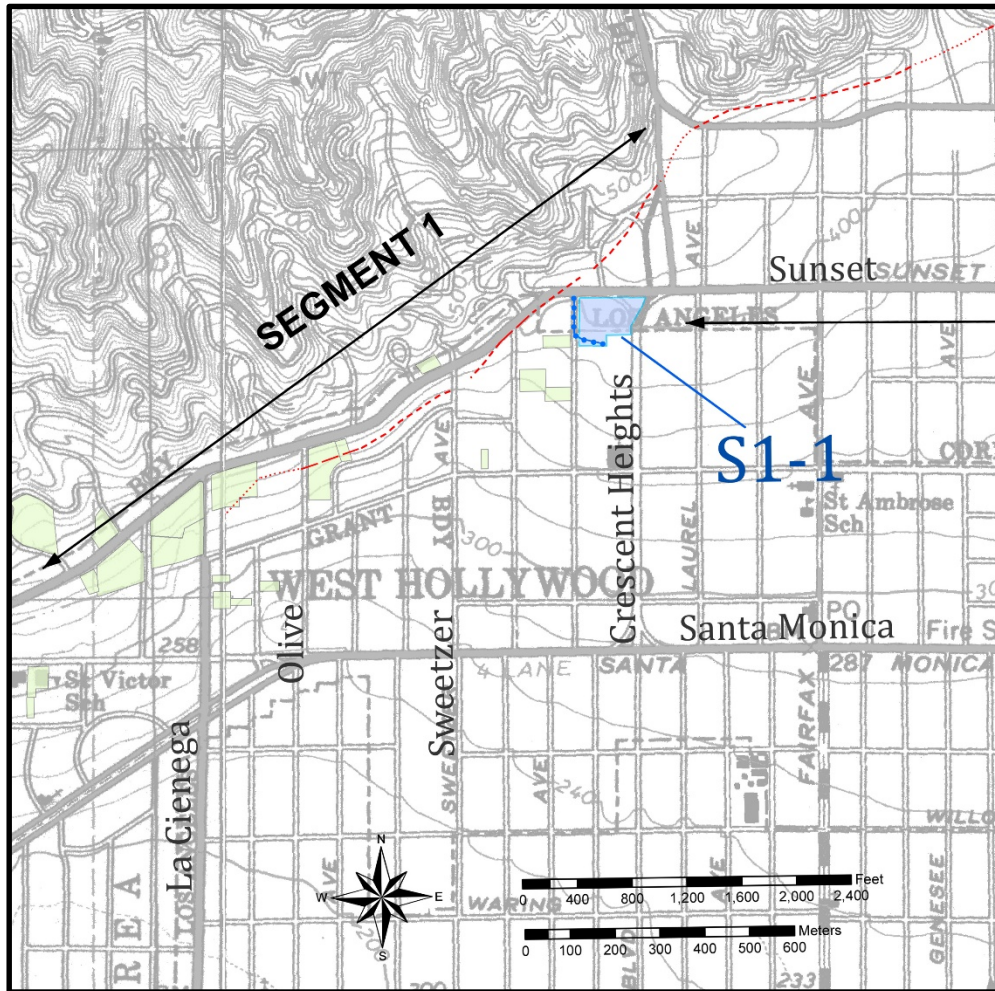
Golder Associates, Inc. (2014a, b) prepared a Surface Fault Rupture Hazard Assessment and Geotechnical Exploration study for a residential and commercial development located on the southwest corner of Sunset Boulevard and Crescent Heights (locality S1-1) as shown on Figure 3. Golder's site evaluation included a CPT transect and hollow stem auger boreholes along the western and southern site boundaries. They interpreted this transect to show continuous alluvial stratigraphy across the site. They reported silts and gravelly sands deposited less than 7 thousand years ago (ka) to depths of about 40 feet. Lower deposits ranged in age from 9 ka to 13 ka at depths of about 60 to 80 feet. They concluded the site has not had major disruption from Holocene faulting.

***The data presented by Golder Associates are consistent with the interpretation presented in the initial FER that the Hollywood Fault lies north of this site as shown on the preliminary Alquist-Priolo Earthquake Fault Zone map.***

**Figure 3** – Study site locality S1-1 indicated in blue shaded area. Boring transect shown as dark blue patterned line. Previous study sites included in the initial FER shown in light green.

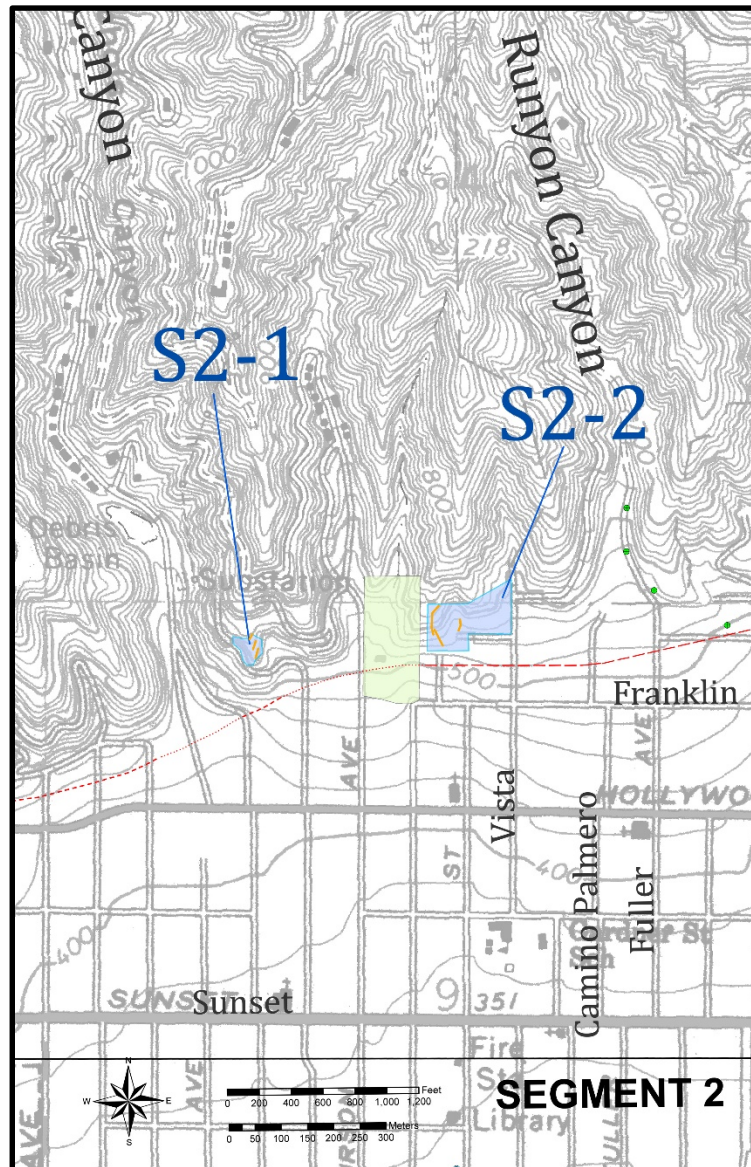
Irvine Geotechnical, Inc. (2014) performed a fault investigation for a residential project located near the base of the Santa Monica Mountains at locality S2-1 (Figure 4). Geologic mapping and shallow trenches were performed as part their study. A geologist for the City of Los Angeles observed the excavation during the study, where un-faulted quartz diorite bedrock was exposed.

Grover Hollingsworth and Associates, Inc. (2014) conducted a fault investigation for a project located along the southern edge of the Santa Monica Mountains, near Runyon Canyon at locality S2-2 (Figure 4). They excavated three fault trenches across the site and observed a thin layer of soil overlying quartz diorite bedrock. Caliche-lined faults were observed in Trenches 1 and 3, but clay gouge and slickensides were not observed in the fault zone. With field review and discussion with the City of Los Angeles geologist, Grover Hollingsworth considered these faults to be pre-Holocene.

**The data presented by Irvine Geotechnical and Grover Hollingsworth and Associates for localities S2-1 and S2-2, respectively, is consistent with the interpretation that no Holocene faults cross these sites north of the fault shown on the preliminary Alquist-Priolo Earthquake Fault Zone map.**

**Figure 4** – Index map showing new localities S2-1 and S2-2. Trench locations indicated as orange line segments. Previous studies included in original FER shaded green.

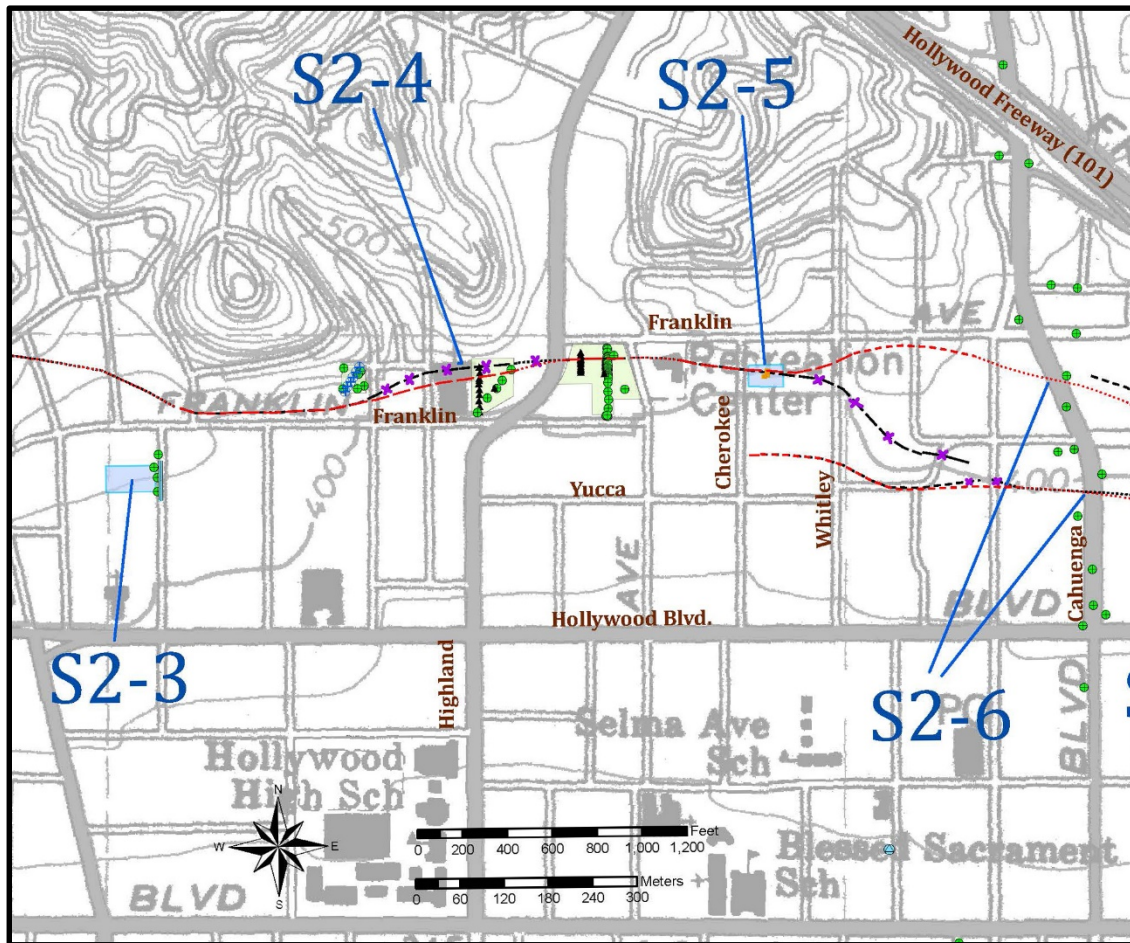
Byer Geotechnical, Inc. (2014) prepared a fault rupture hazard investigation for a site south of Franklin Avenue near La Brea Avenue at locality S2-3 (Figure 5). They utilized continuous core borings and seismic refraction for their study. An age date from bulk AMS C14 samples collected near the base of the young alluvium was reported as 7.1 ka. Bulk samples just below the upper contact of the old alluvium yielded ages of 20.1 ka, and 22.0 ka. Their analysis indicated unbroken stratigraphy underlying the site and they concluded there is no direct evidence for the presence of active faulting at the site.

***The data presented by Byer Geotechnical is consistent with the interpretation presented in the initial FER that the Hollywood Fault lies north of this site as shown on the preliminary Alquist-Priolo Earthquake Fault Zone map.***

At locality S2-4 (Figure 5), (locality 12 in Hernandez and Treiman, 2014), CGS re-evaluated the fault strands at this site and compared them to the well-defined and well-constrained fault data immediately east of this location (Hernandez and Treiman, 2014), locality 13), as well as new data to the east at locality S2-5 (described below). There were several fault strands indicated in investigations at this site, and the re-assessment of the data led us to select a different strand as the dominant trace.

CGS made observations of two fault trenches at locality S2-5, south of Franklin Avenue and N. Cherokee Avenue (Figure 5). Two separate visits were made to this site by J. Treiman (CGS). The southern trench, first visited on December 31, 2013, exposed southeast dipping Topanga Formation siltstone and sandstone, with interbedded or injected volcanics. No faults were observed in this trench at this time. A northern trench, visited on January 15, 2014, revealed a broad fault zone (about 20 to 30-feet wide) within the Topanga Formation. Bedrock to the north and south of the fault zone dipped moderately to the northeast. Within the fault zone, bedding and shears had an east-west strike with steeply north to vertical dips. Shearing increased toward the northern margin of the zone which had a sharp vertical shear and a soil-filled fissure. The north margin of this soil-filled fissure appeared planar, indicating the soil was faulted, rather than just falling into a shaking-related fracture. A visit to a freshly cleaned exposure at the initial southern trench, also on January 15, showed a shallowly north-dipping shear within the bedrock to the graded surface. Soils overlying the bedrock in the northern trench appeared to be very young. To date no report has been submitted by the owner to the City of Los Angeles or CGS.

***Our observations confirm the location of the northern strand of the Hollywood fault as presented in the initial FER.***

**Figure 5** – Localities within Segment 2; S2-3 through S2-6. Red lines indicate mapped fault trace locations for the Official Zone Map. Black fault traces with purple hachures indicate where the fault trace was modified from the preliminary zoned trace. Green and black symbols are boring/CPT locations or transects. Orange lines are trench locations. Light blue shaded areas indicate reports received subsequent to the issuance of the FER.

***Based on our re-evaluation of these data, we suggest a modification of the fault trace slightly to the south to project through this preferred trace, connecting the well-located fault to the east with better defined scarps to the west.***

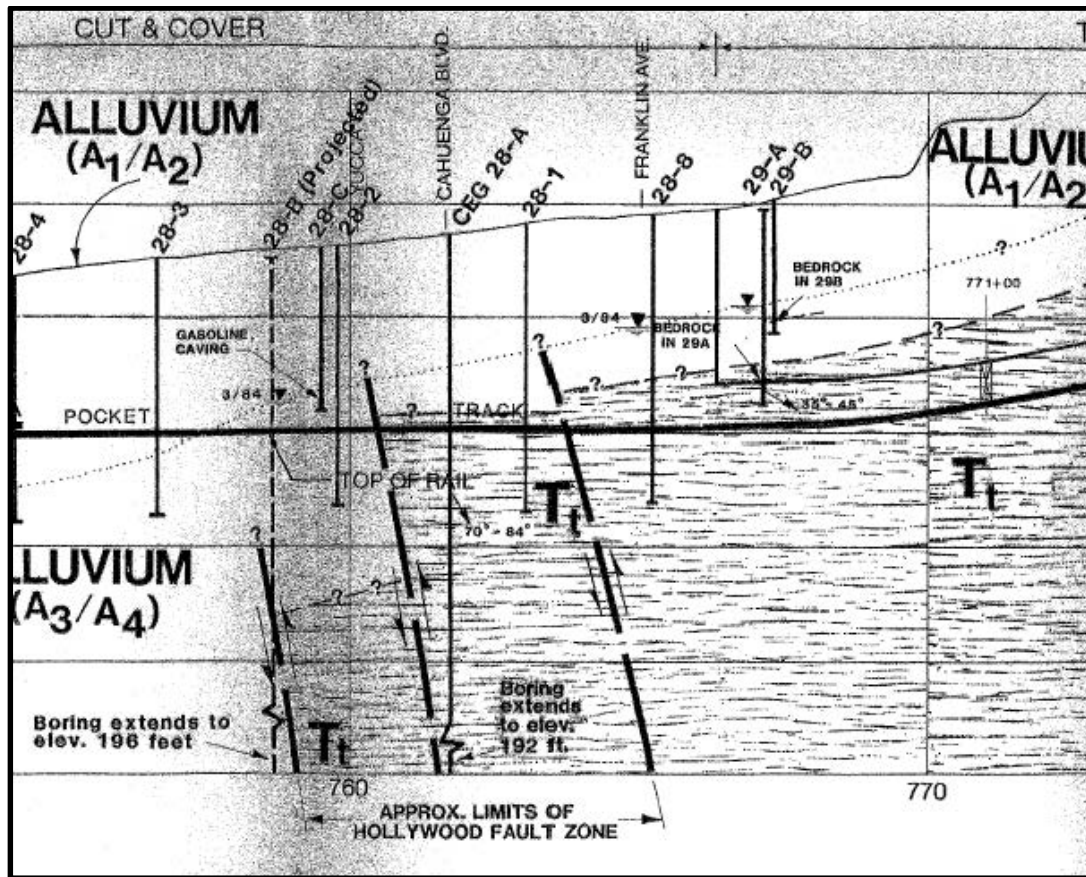
***The data presented by Converse Consultants et al (1984), specifically a cross section (Figure 6 herein) and boring logs, combined with observations of the fault at locality S2-5, support an eastward continuation of the northern fault trace, rather than the southeast trending orientation shown in the initial FER (that was based on Dolan et al., 1997)(Figure 7). We find the stratigraphy within the MTA boreholes reveals lateral discontinuities within the upper alluvial soils above the principal fault strands, in addition to offset bedrock as illustrated in the cross-section (Figure 6). The Converse Consultants data also supports the location of the southern trace of the fault where it crosses Cahuenga Boulevard as shown on the preliminary Alquist-Priolo Earthquake Fault Zone map. Additionally, the cross section shows a third fault that projects toward***

*the ground surface at Yucca Street, roughly between the northern and southern strands (Figure 6). Due to uncertainty as to how the various strands of this complex fault zone connect to the east and west we are only depicting the northern and southern fault traces on the Official Zone map.*

Figure 6 – Cross section from the Metro Red Line subway project. Portion of figure from Converse et al, 1984.

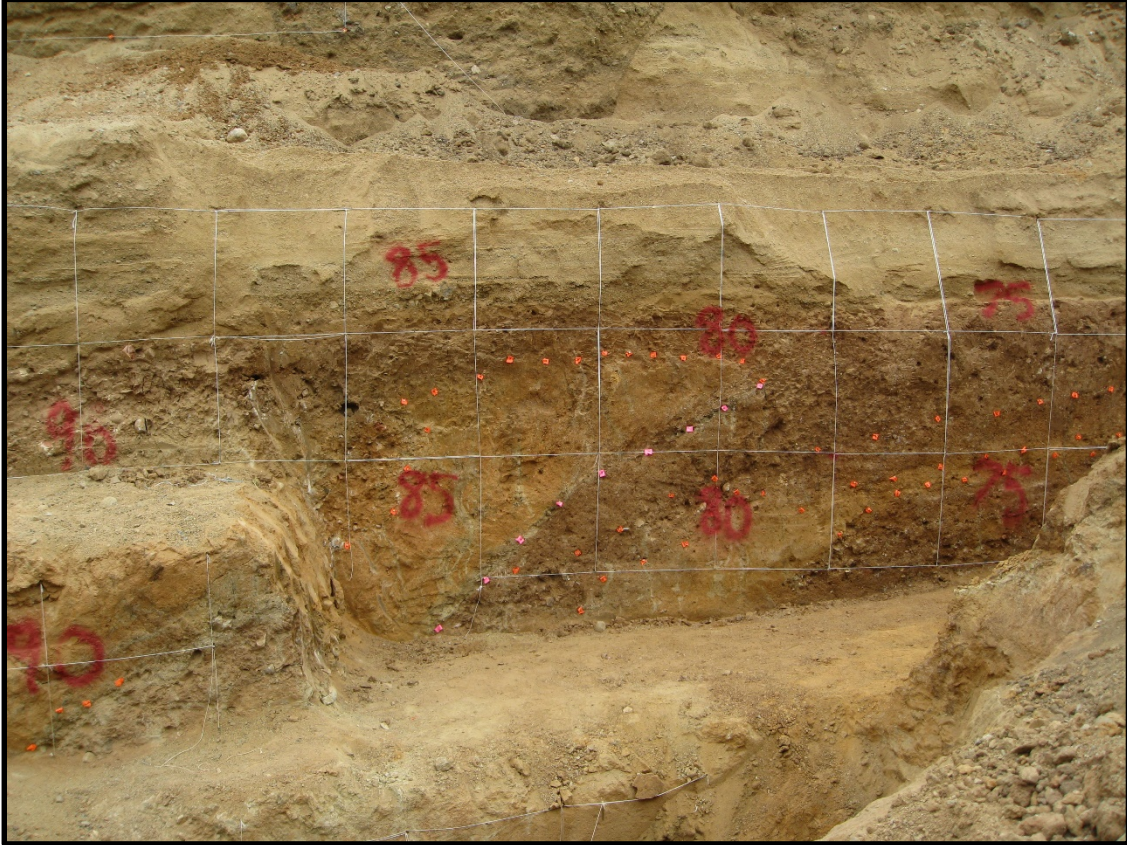
***CGS viewed several stages of the eastern trench investigation that was placed to potentially expose faulting that may project onto GDC Sites 1 and 2 from GDC Site 3 (to the east). Faulting was observed in this east trench at approximately 80 feet from the northern trench end, placing this fault at about the same location and orientation as the trace mapped by CGS in the Preliminary EFZ map. Further observations of this fault during June and July, 2014, revealed that age of faulting appeared to be constrained by an overlying, unfaulted mudflow deposit and paleosol, estimated to be about 30 ka by R. Shlemon (GDC, 2014c). The soil structure within the soil that overlies the fault does not exhibit rotation of pedogenic faces and appears undisturbed by movement along this particular fault trace. Two older faults, below and cut by this fault, were also observed in the tilted fan deposits but were not logged by GDC.***

**Figure 9** - View looking west at south dipping pre-Holocene bedding plane fault with a possible reverse sense of displacement in GDC's east trench. This trench was excavated across the southeastern portion of Site 2, and extends into Site 1; fault noted by pink flagging in the center of the photo. The upward termination of this fault, located right of Station 80 (about station 77), is within a fissure fill, which upon close inspection, is overlain by a mudflow deposit and soil, reported to be about 30 ka. In this photo, the Pleistocene age older alluvium (debris flow deposits) are overlain by a thin mudflow deposit, overlain by sands of the Argyle Channel.

***Based on this new trench data, as well as other data, we have relocated the northern fault strand to project along Yucca Street toward the north. The southern fault strand is also modified in this area based on data from locality S2-9 (GDC Site 1), described below.***

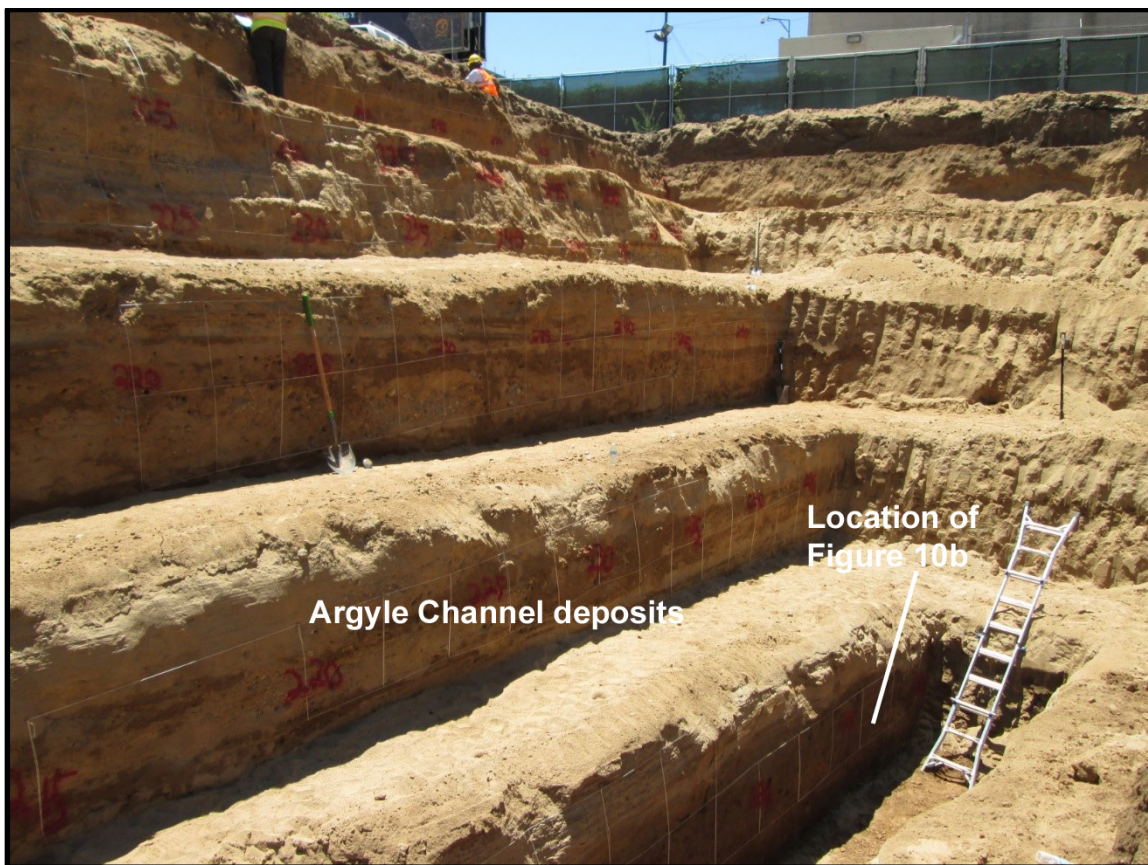
***CGS was invited to the site for periodic trench review between June 30, 2014 and July 11, 2014, where we observed unbroken Argyle Channel deposits overlying an older unbroken unit that was tentatively correlated by GDC staff to mudflow deposits observed to the north. In the northern portion of Site 1 near the boundary with Site 2, the late-Pleistocene mudflow unit appears to be draped over the underlying folded debris flow units, and what may be the same unit appears near-horizontal as it extends to the southern end of the trench (Figure 10a).***

***We received no logs of this part of the trench to clarify these relationships. Figures 10a, 10b show the stratigraphy in the south end of the trench. Our review of the CPT data for this site, and some earlier core borings (from GDC Site2) indicates a discontinuous south-dipping Quaternary stratigraphic section, with a prominent stratigraphic break toward the southern end of the property indicative of a fault. The orientation of this break appears to be north-dipping, projects upward toward the ground surface near the southern property boundary (south of the trench exposure), is in alignment with the fault scarp located north of Carlos Avenue immediately to the east, and is in alignment with an inferred fault trace from the Langan data west of Vine Street (locality S2-7) to the west. On the basis of these observations, the southern trace of the Hollywood Fault has been moved to the southern boundary of locality S2-9, just south of the trench exposure.***

**Figure 10a** – View looking southeast at the southern trench portion of the long eastern trench that extended from GDC Site 2 into Site 1. Trench reveals unbroken Argyle Channel deposits extend in depth possibly to about the upper string line at the lowest bench, just left of the ladder. A bioturbated layer and thin gravel bed of uncertain age below the bottom string line below the lowest bench also appears unbroken (see **Figure 10b** below).

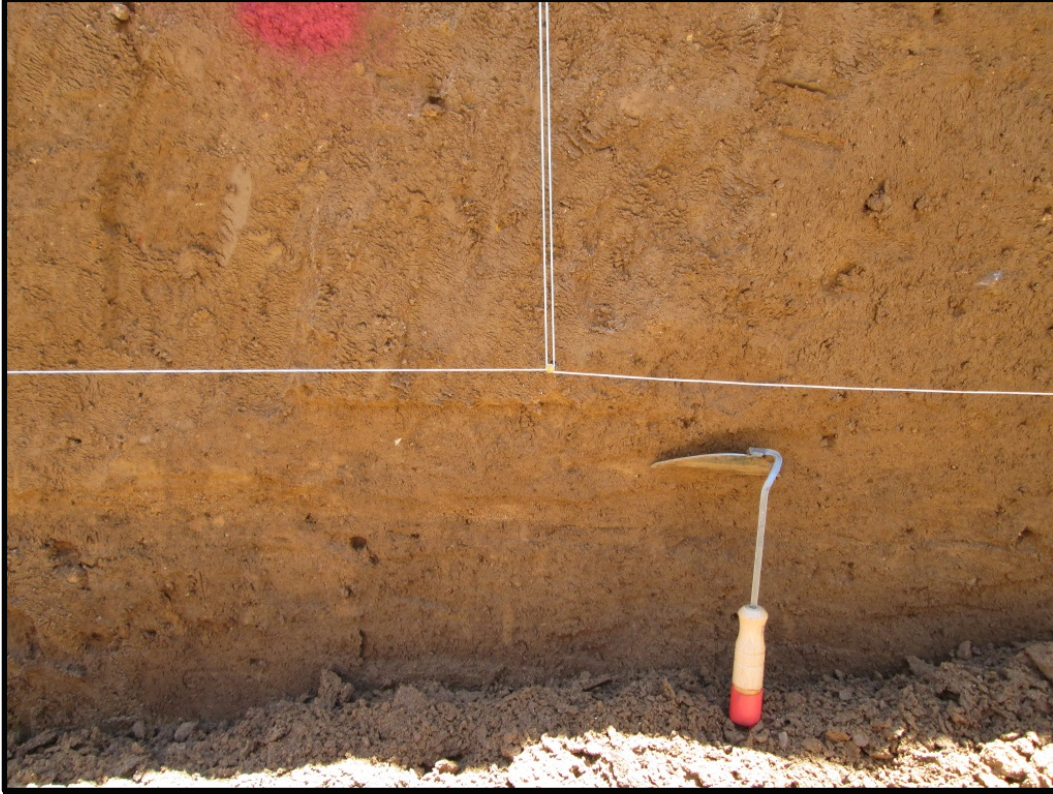
**Figure 10b** – View looking at east wall at about station 235, of east trench, GDC Site 1. Close-up of poorly sorted fine-grained deposits that underlie Argyle Channel deposits. Contact with a darker, bioturbated layer is near the base of the trench, just below the blade on the scraper tool. Where exposed, unit appears continuous and unbroken through the southern end of trench bottom. Total length of trench at base is approximately 240 feet extending across GDC Site 2 toward the southern boundary of Site 1. Bottom of southern trench end is approximately 45 feet north of the southern property line.

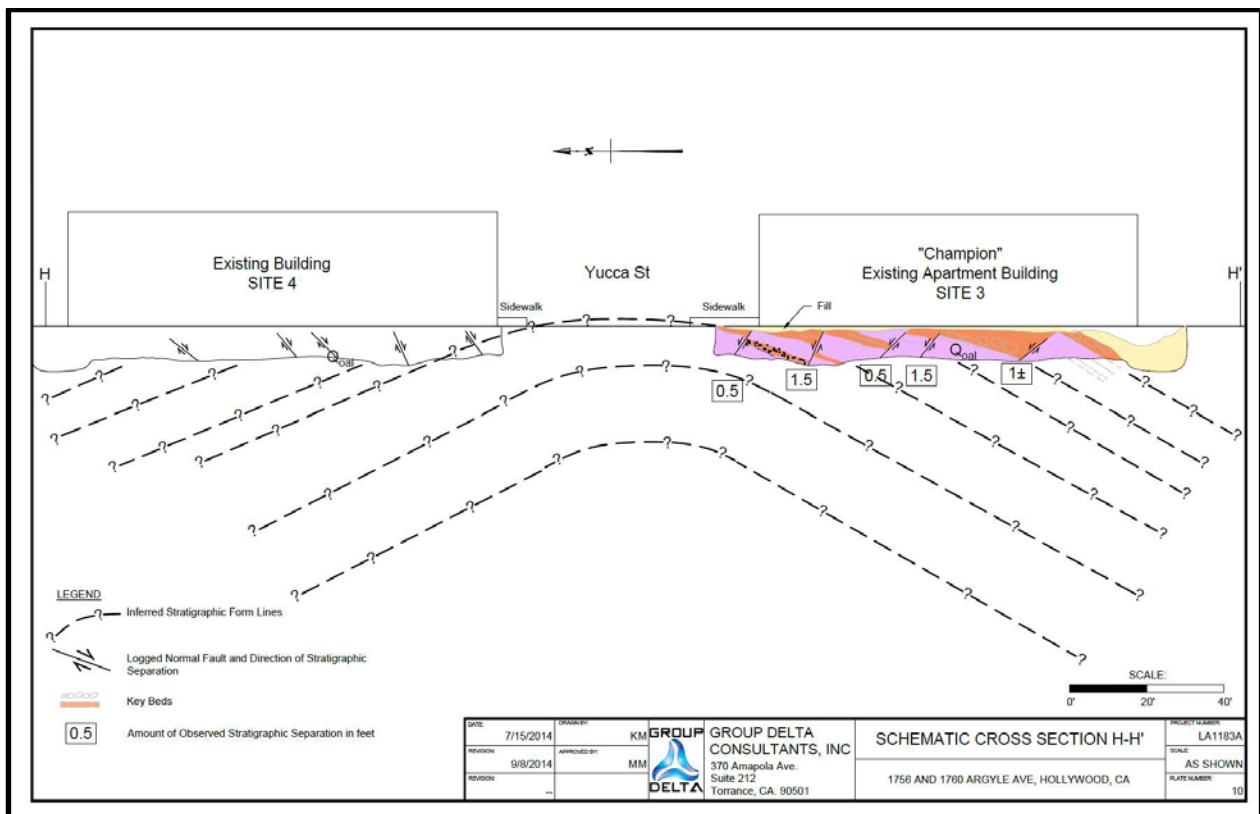
At locality S2-11, (GDC Site 3, Figure 8), Group Delta (2014c) reported the site is underlain by fill materials and older alluvial debris flows, which in turn are underlain by Modelo Formation. Their site investigation included both CPT and core borings, and an approximate 8-foot deep trench on the west side of the site. GDC reported the older alluvial unit consists of Pleistocene debris flows, and state that this unit is faulted. They associated this fault with a localized west-northwest oriented anticline, which extends north to GDC Site 4, as shown in their cross-section (Figure 11). They interpret these features to be due to regional transpression and not to seismogenic faults. They report the age of the faulting at this site is older than 35 ka based on unbroken mudflow deposits found to the west at Site 2.

**Figure 11** – Cross-section from GDC Site 3 showing anticlinal folding of Pleistocene debris flow deposits, inferred stratigraphic form lines and faults that offset this unit. Numbered annotation at each fault reflects GDC’s observed stratigraphic separation at each location. Figure from GDC, 2014c.

***The data presented in the GDC report is consistent with the interpretation that the deposits are of Pleistocene age although it is unclear why these “debris flow” deposits are differentiated from the similarly comprised and deformed older alluvial fan unit exposed and described at site 2.***

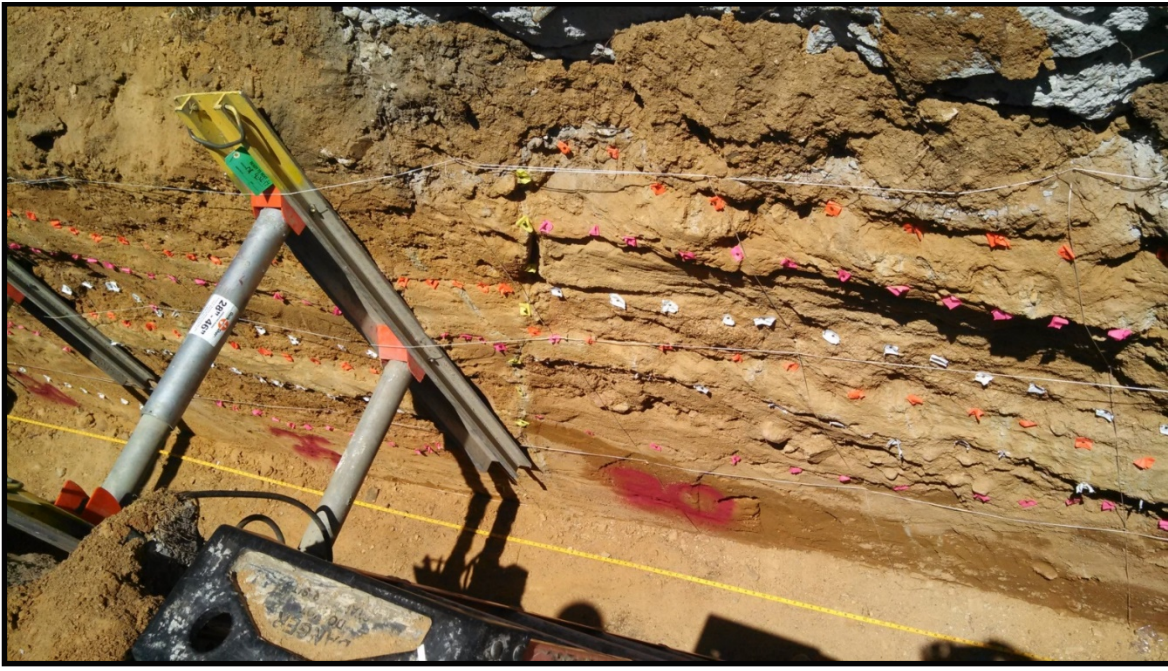
***Interpretation that the faults are local bending moment faults is not consistent with CGS field observations within the trench. CGS noted a significant lack of correlation across the southernmost fault, and that thickness of units changed across most of the faults, which indicates a component of lateral displacement (Figure 12). The southernmost fault appeared to be a prominent fault, as correlative units across the fault were not found, suggesting this fault trace may have seen the most displacement. No evidence for, or against, Holocene faulting was reported on this site because Holocene deposits, if present, were likely removed during site development.***

**Figure 12** – At GDC Site 3, locality S2-11, view looking easterly at faulted Pleistocene alluvial fan deposits, yellow flag indicates fault to right of shoring near the center of the photo. Gray zone at the top of the photo is concrete. Bedding gently dipping to the south (right), with steepness increasing to the south. Of the 7 faults CGS observed, most faults indicated a difference in unit thickness across fault. The southernmost fault did not have any correlative units across the fault.

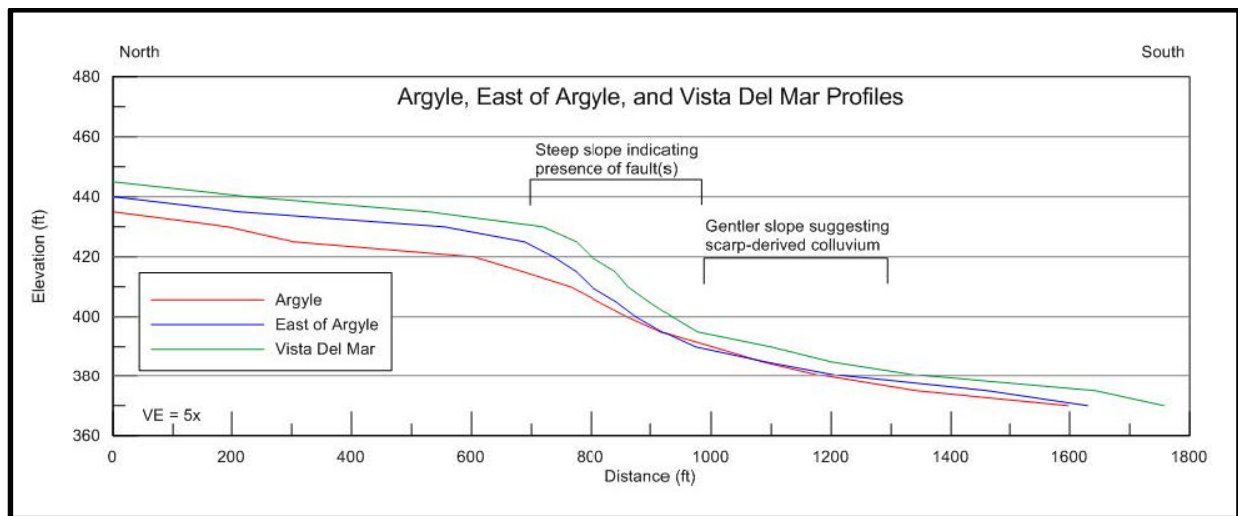
LCI stated that in addition to the prominent break in slope located immediately north of their site, a subtle break in slope is expressed across the southern portion of the site. They reported this southern slope break is located south of the southern discontinuous fault trace mapped by CGS. They suggest that subtle breaks in slope can be related to several factors: change in slope direction on the ground surface, or thickness and directional changes within the alluvial fan system. Their analysis noted that the subtle slope break is coincident with an east-west trending apparent scarp mapped by Hill et al. (1979), and a possible fault scarp mapped by Weber et al. (1980). In their review of the 1926 topographic maps, they indicated that Argyle Avenue did not yet exist at this location, and that possibly the subtle break in slope observed in the street may have been created during subsequent construction of Argyle. Alternatively, they concluded that this subtle break in slope reflected in the composite topographic profiles (Figure 13), is most likely related to scarp-derived colluvium from the steep break in slope to the north.

**Figure 13** – Topographic profiles constructed from 1926 historical topographic maps, located within and adjacent to the BLVD 6200 project. These profiles prepared by LCI, indicate steep portions of scarps suggest they were created by fault movement, whereas gentle slopes suggest formation by down-slope movement of scarp-derived colluvium. Modified from LCI, 2014.

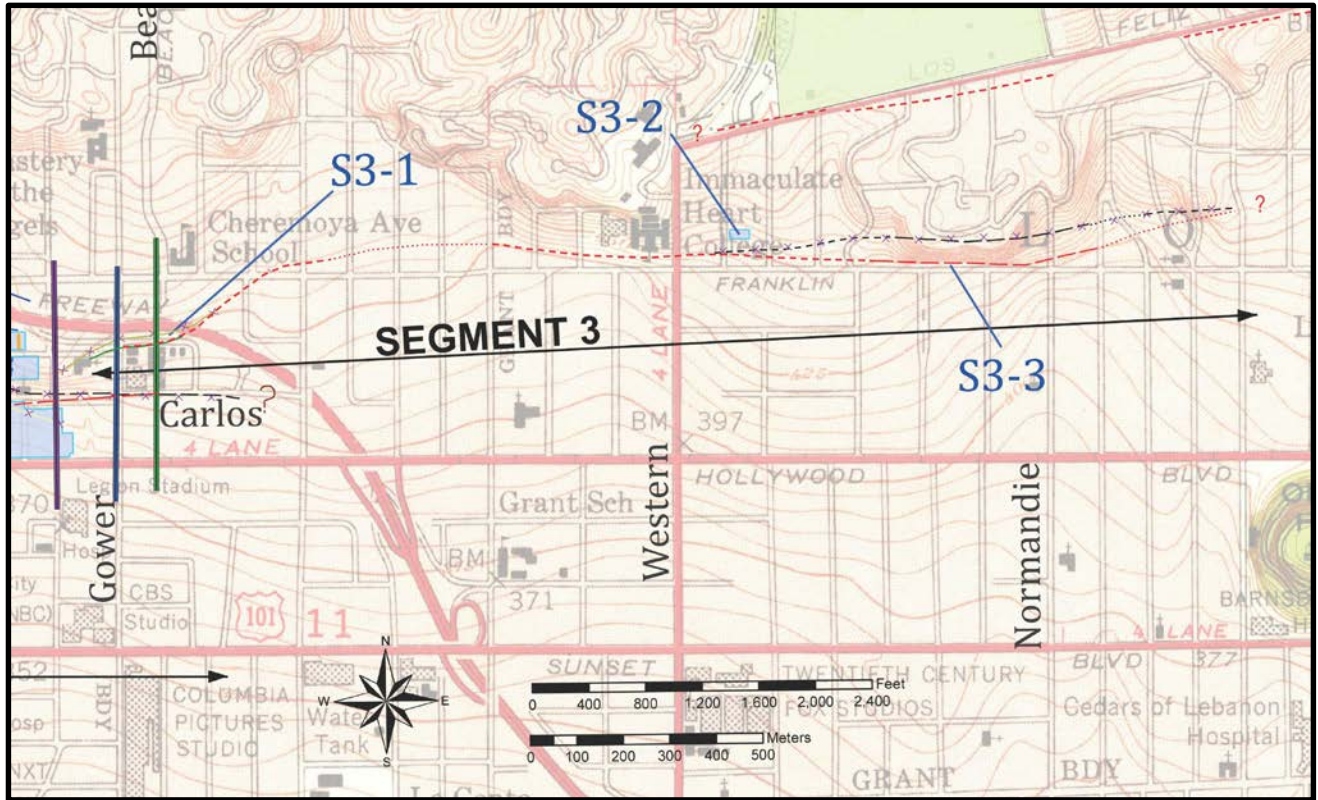
***The data presented in the LCI report is helpful for reviewing the magnitude of breaks in slope as they trend from west to east across this portion of Hollywood. As a result, the western portion of the fault trace along Segment 3 appeared to be mapped a few feet north of the base of a subtle break slope, as indicated in the LCI profiles. We have modified the fault trace closer to the base of the slope break as shown in Figure 14. This modification has no effect on the EFZ boundary at this location.***

**Figure 14** – Localities within Segment 3. North-south lines near Gower are elevation survey transect locations by LCI. At locality S3-1, the red fault trace indicates the revised fault trace location based on breaks in slope identified within the LCI surveys. Purple cross hatch on the black fault trace indicates location of fault trace as reported in the FER. Locality S3-2 is the Bay City Geology study site. Locality S3-3 indicates the modified fault trace (in red) based on revised interpretation of the scarp utilizing the 1926 topographic base map as described in the text.

Bay City Geology, Inc. (2014) performed an investigation for a site located within the Preliminary EFZ at locality S3-2 (Figure 14). Three large diameter borings were drilled, revealing a thin layer of older alluvium, underlain by weathered Topanga Formation siltstone and sandstone, grading to less weathered bedrock at about 21 feet bgs. Bedding planes in Topanga measured in the borings had northwest strikes, with dips to the southwest. Bay City stated that similar geologic units were encountered in all of the borings at similar depths, where they indicated this was positive evidence for continuous, unfaulted geologic units across the site. From these data, they inferred the Hollywood fault is located south of the site.

***As a result of this minor adjustment, the EFZ boundary has shifted slightly to the south.***

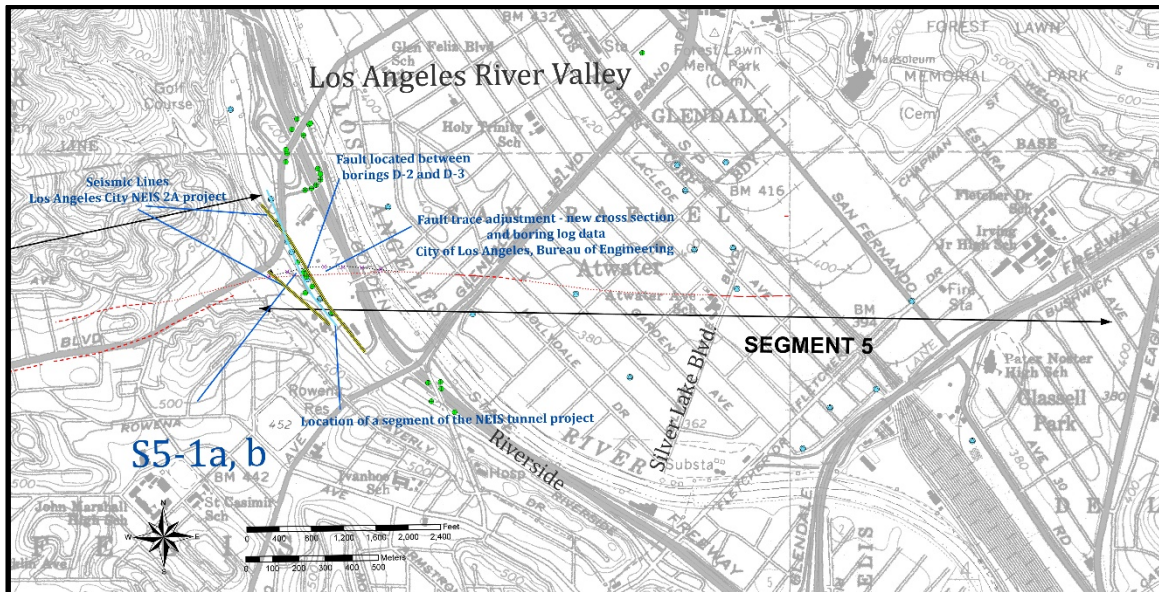
Patrick Schmidt, and Fred Burnett, (2014): Mr. Schmidt and Mr. Burnett of the City of Los Angeles Bureau of Engineering (BOE) provided CGS a technical paper they prepared in February, 2014 that was submitted to the Underground Construction Association's North American Tunneling Conference (NAT). In this paper, they discussed some of the exploratory methods implemented during the Northeast Interceptor Sewer project (NEIS), including: borings with down-hole geophysics, packer and pressuremeter testing, CPT testing, Remi surveys and surface geophysics lines. They reported some of the difficult conditions they anticipate encountering during tunneling along the fault zone, including: squeezing and running ground conditions, high methane gas concentrations, and up to 5 bars of water pressure. They reported the main Hollywood Fault was located between exploratory borings M08-B4 and M08-B5, where interpolation of the geophysical surface survey data identified two north dipping fault planes with three south-dipping secondary faults in the hanging wall that merge at depth.

***This technical paper describes conditions the City of Los Angeles BOE will encounter during tunnel excavation operations. No additional details regarding active faulting either outside or within the tunnel alignment were noted. However, their description of difficult tunneling conditions keys into the general width and local structure of the fault zone along the west bank of the Los Angeles River Valley.***

**Figure 15** - Localities S5-1a, b show where additional information was received from the City of Los Angeles, Bureau of Engineering Department for the NEIS 2A project. Figure shows adjusted location of the Hollywood Fault trace, based on these new boring logs, cross section, and consideration of comments received from D. Perry. Red lines are final fault trace, purple cross hatch on black fault trace indicates location of fault trace as reported in the FER. Light blue line represents a segment of the NEIS tunnel alignment. Yellow lines indicate seismic profile transects. Green and blue symbols along the alignment represent core borings and monitoring wells, respectively.

City of Los Angeles (2013) conducted an additional fault study that included 3 borings that were drilled during April - May 2013 for the NEIS 2A sewer project. These borings were drilled to further define the limits of the deep older alluvium associated with the active trace of the Hollywood Fault at locality S5-1b. The borings also helped to define the artesian groundwater pressures, depth of bedrock, and methane concentrations they will likely encounter during tunneling operations.
