RE: **LA TUNA FIRE RESPONSE AND RECOVERY SUMMARY REPORT**

BOE La Tuna Fire Burn Area Mitigation – Assessment and Recommendations W.O.
E1908261

SUBJECT: **La Tuna Fire Burn Area Mitigation – Assessment and Recommendations**
W.O. E1908261 **BOE-GED File No. 17-200**

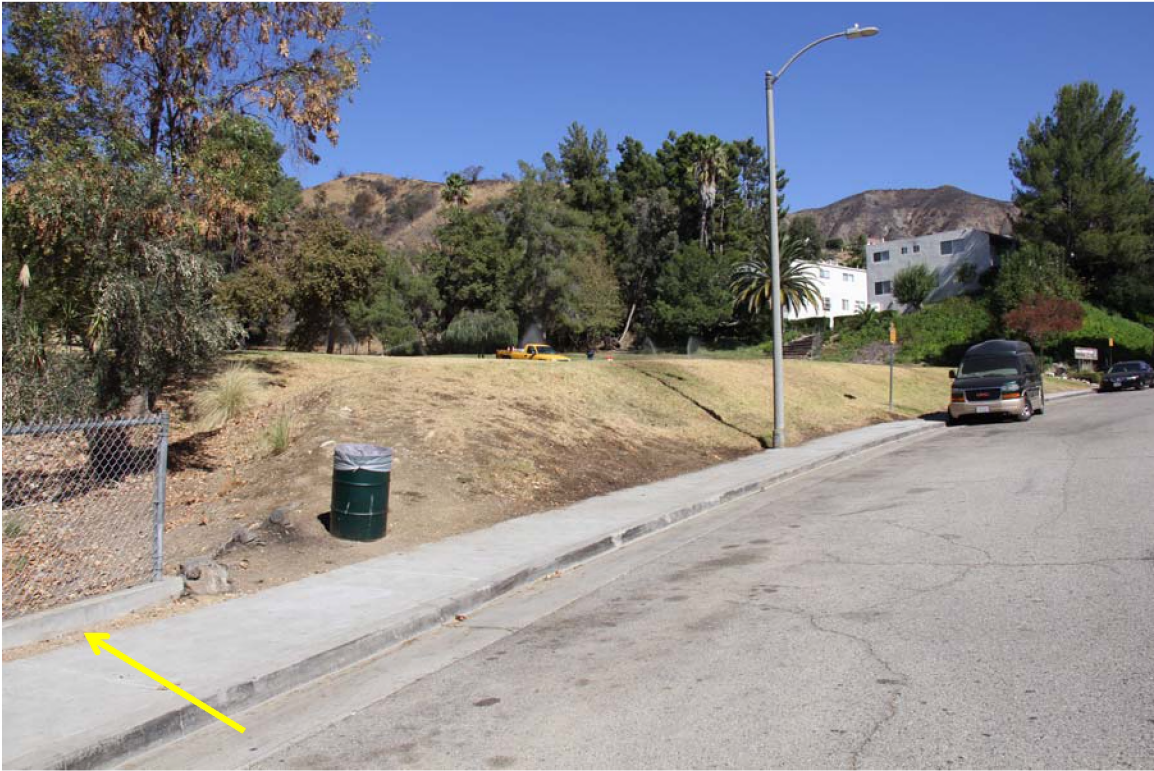
Site 1: Looking northeast across Cabrini Drive West towards Villa Cabrini Park. The yellow arrow points out a culvert inlet structure, which collects and directs runoff away from the park.

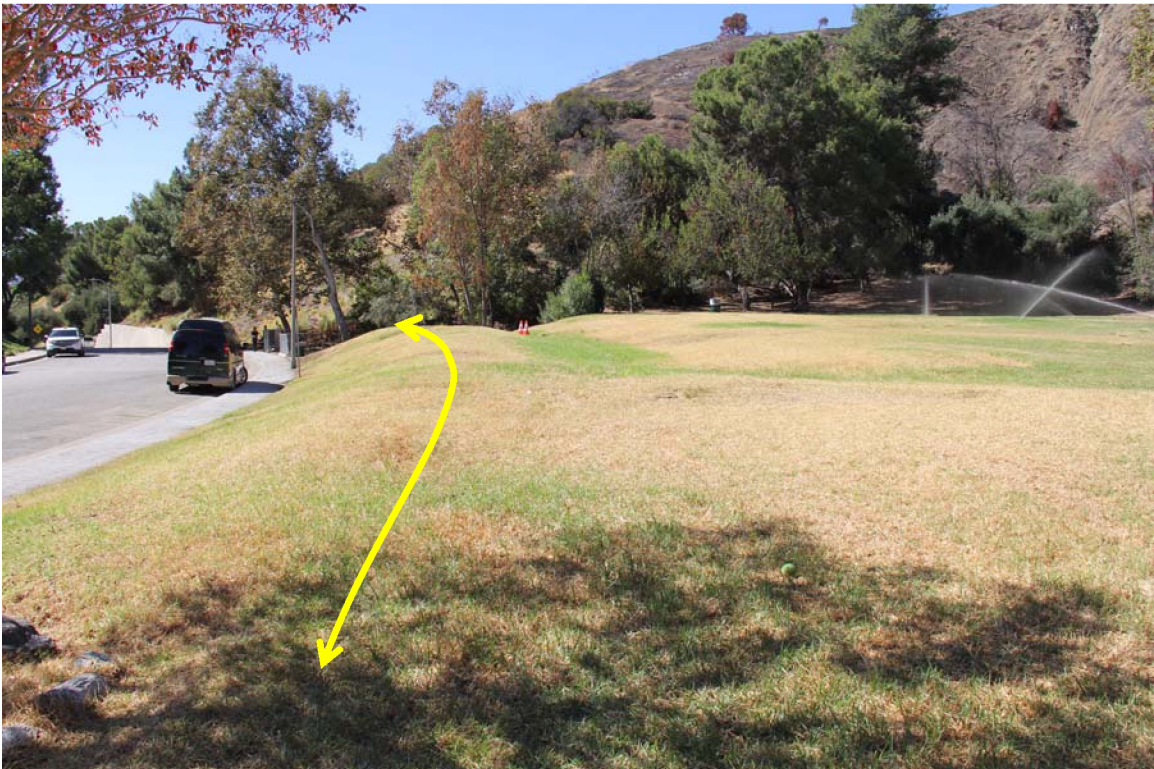
Site 1: Looking west across the front of the park. The double yellow arrow points out where 160 linear feet of K-rail has been recommended to be placed in order to prevent debris flow from entering the street.

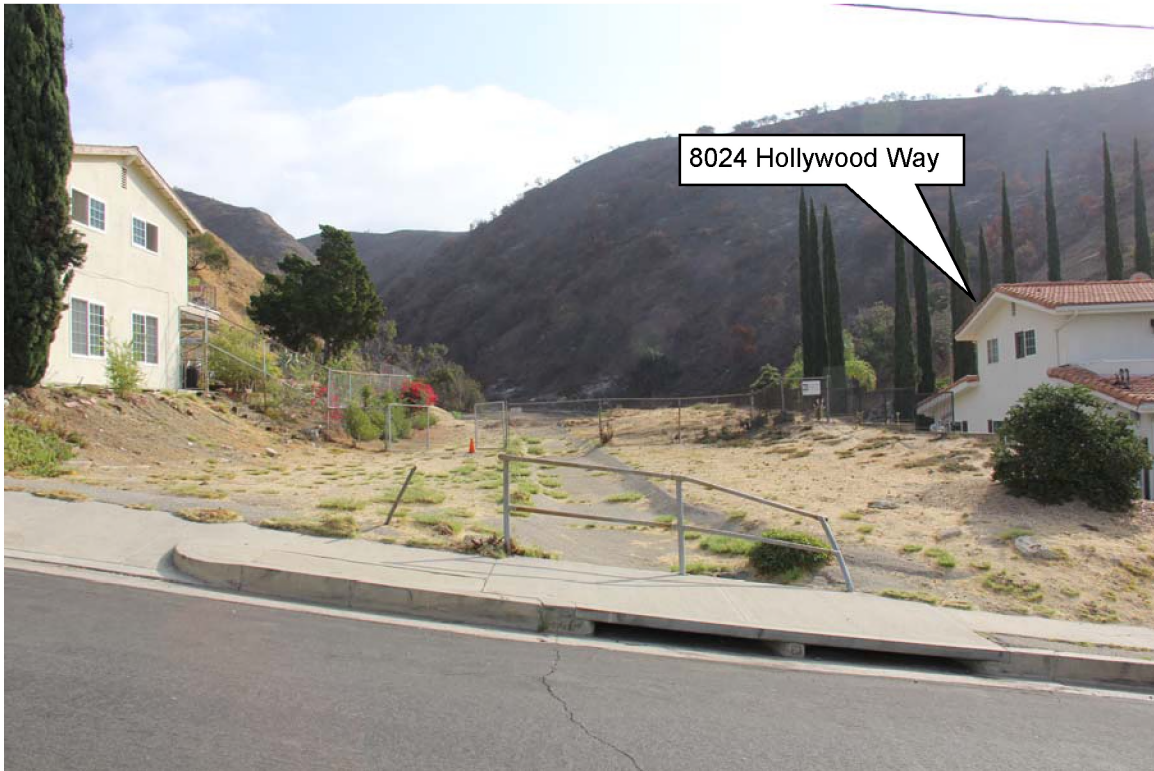
Site 2: Looking east across Hollywood Way towards a drainage swale located in the middle of Edmore Place.

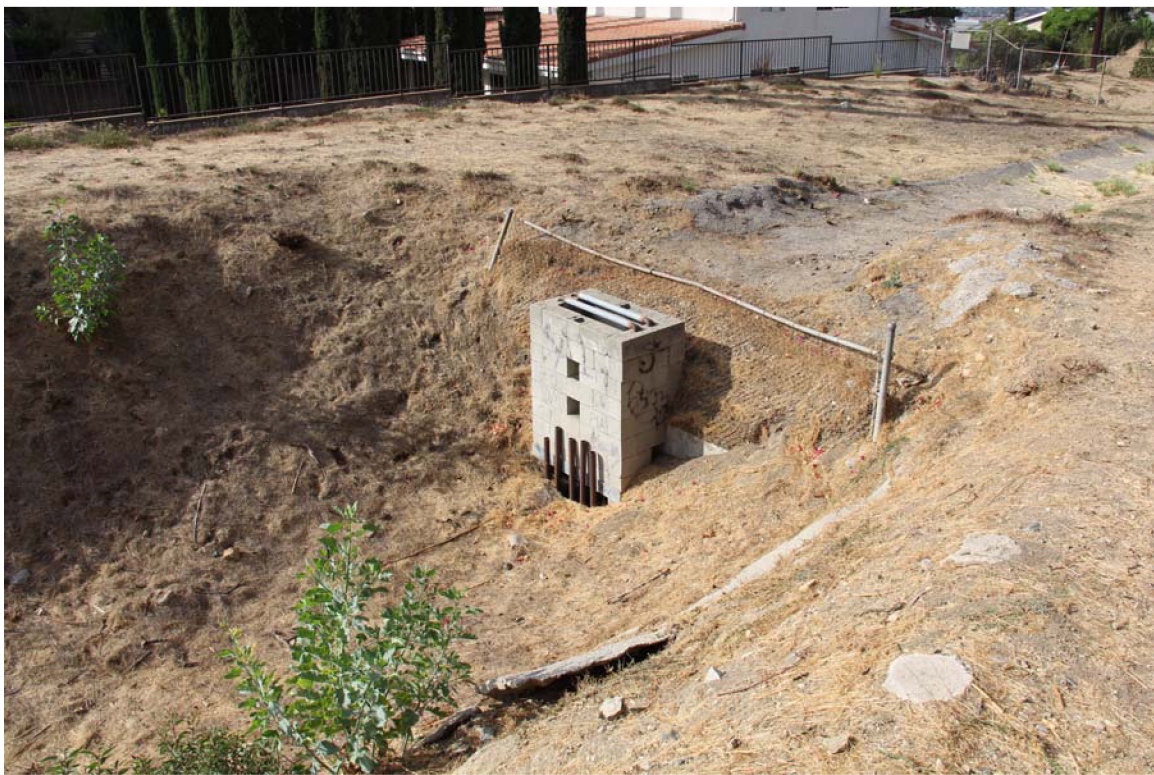
Site 2: Close up of a concrete block outlet structure located at the eastern end of the drainage swale.

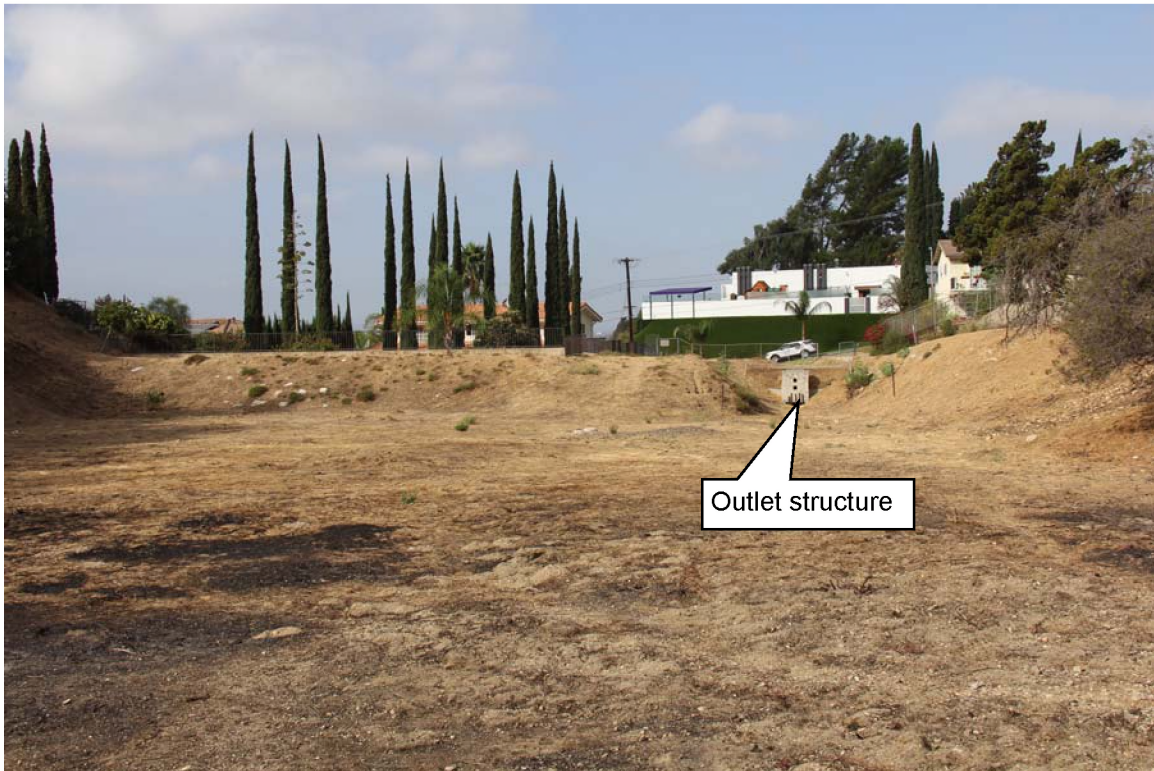
Site 2: Looking west across the debris basin towards the embankment comprising the western side of the debris basin.

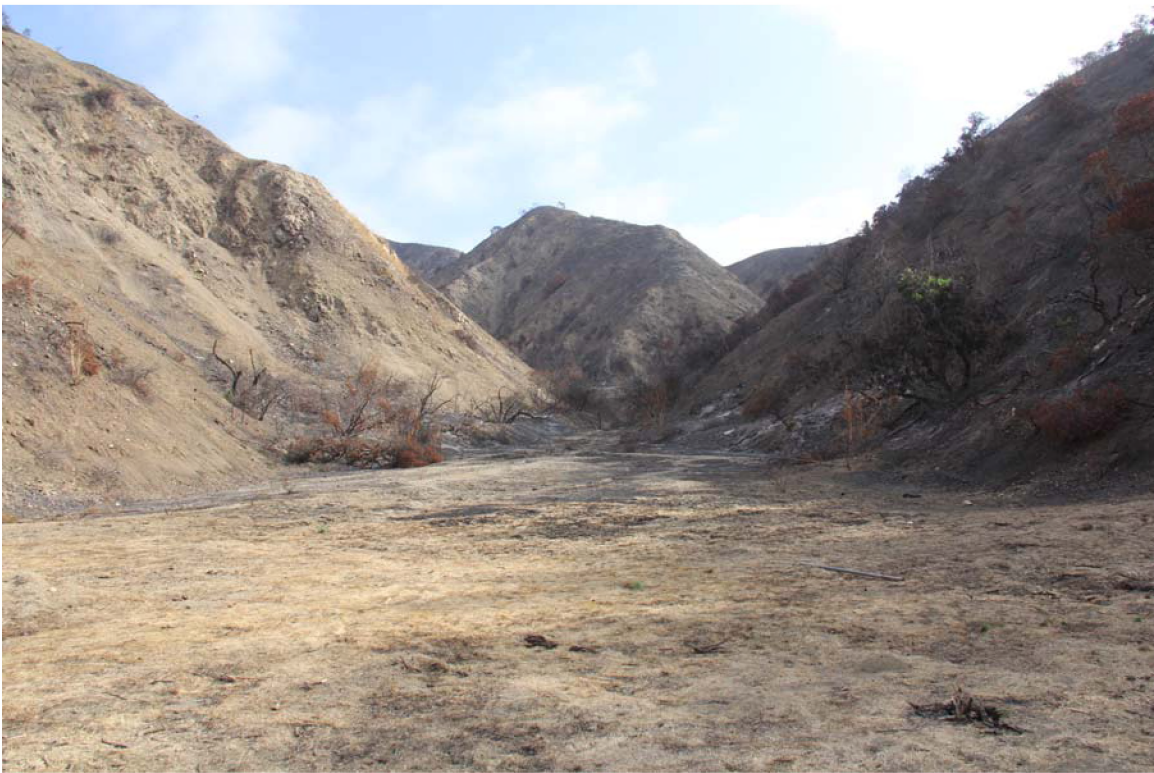
Site 2: Looking east across the debris basin and the burned and denuded slopes surrounding the basin.

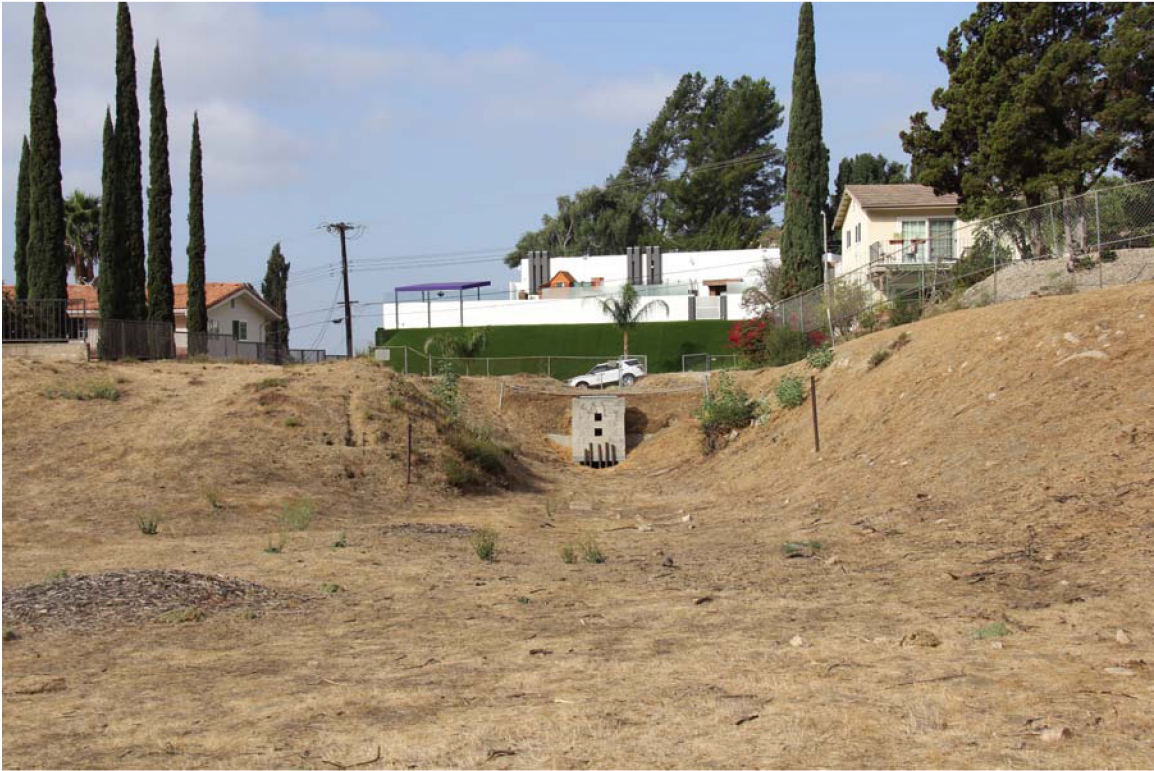
Site 2: Looking west towards the channel leading to the outlet structure.

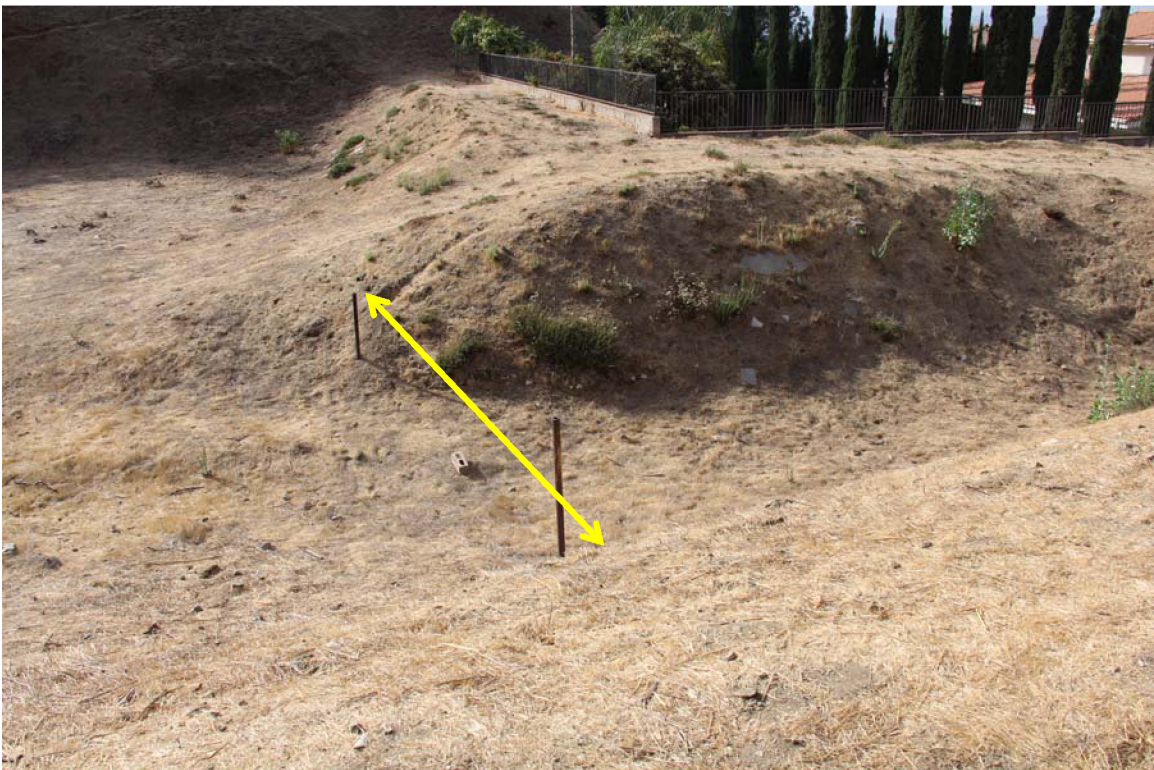
Site 2: Looking south across the channel leading to the outlet structure. The double yellow arrow points out where a 25' (L) x 10' (H) revetment or debris rack has been recommended to be installed across the channel to prevent the outlet structure from becoming clogged with debris.

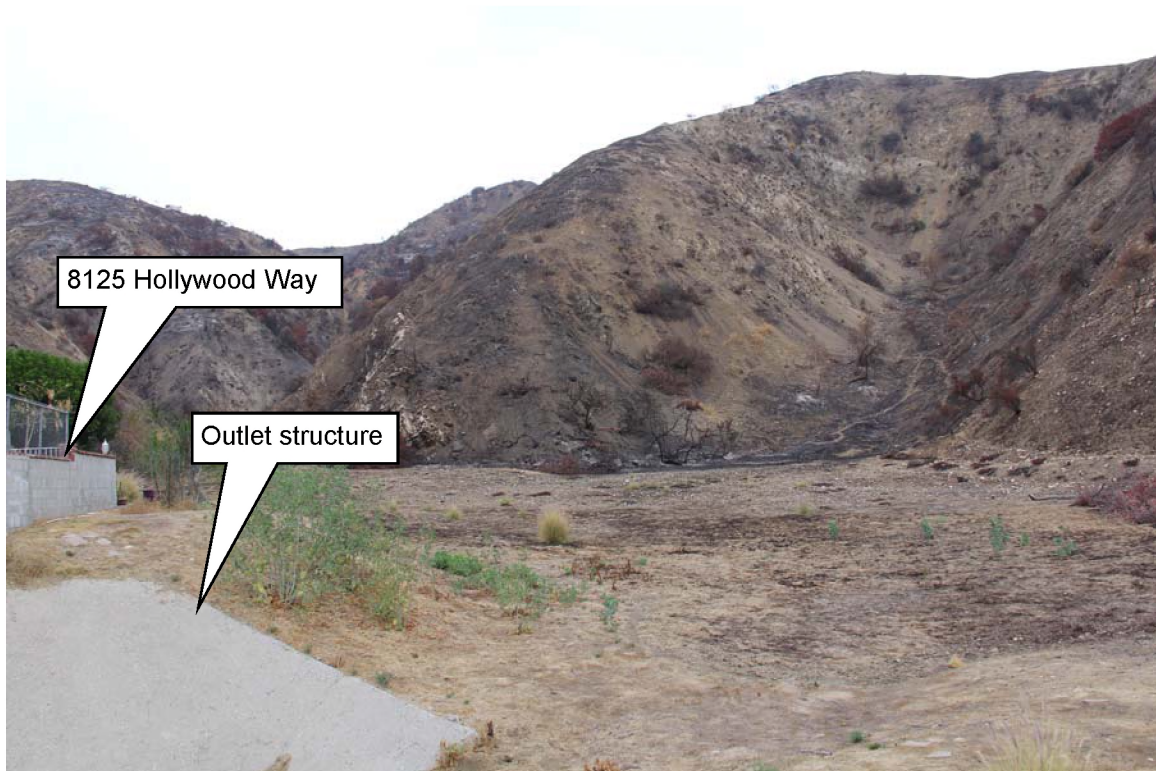
Site 3: Looking north across a debris basin located adjacent to the property of 8125 Hollywood Way. Note the amount of debris that has accumulated in the basin.

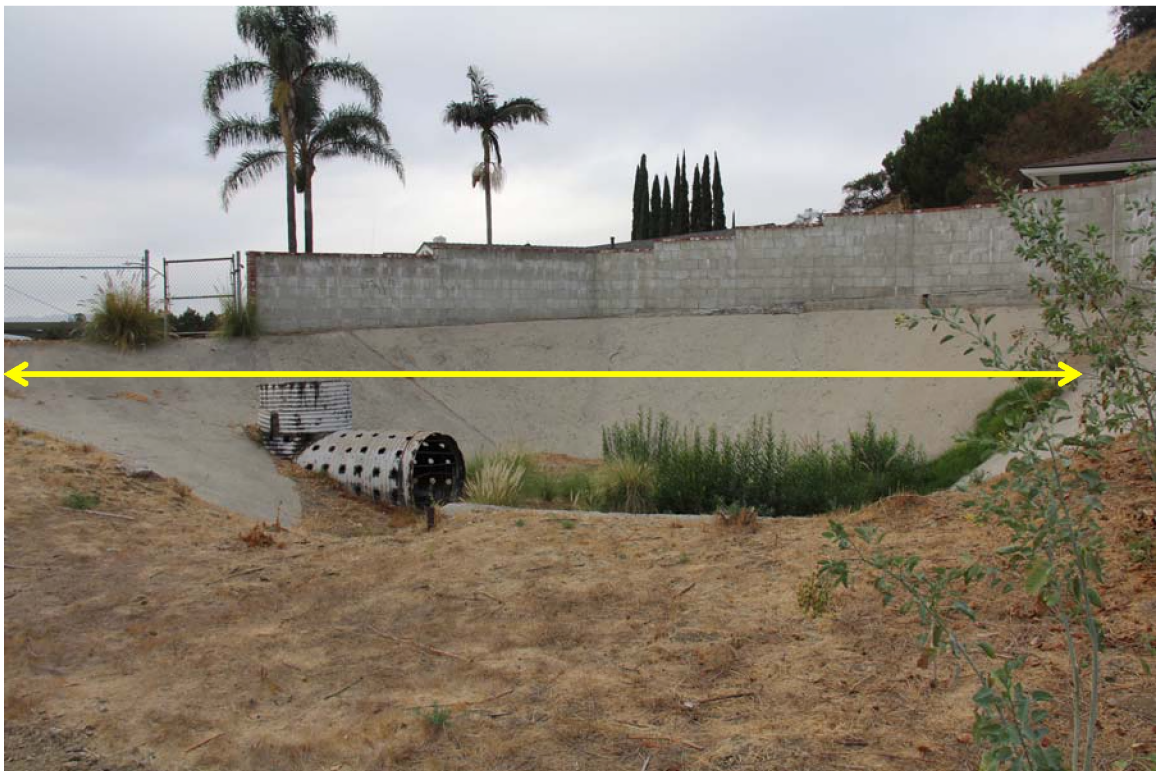
Site 3: Looking west towards the outlet structure. The double yellow arrow points out where 65 linear feet of debris fencing has been recommended to be installed in order to prevent the outlet structure from becoming clogged with debris.

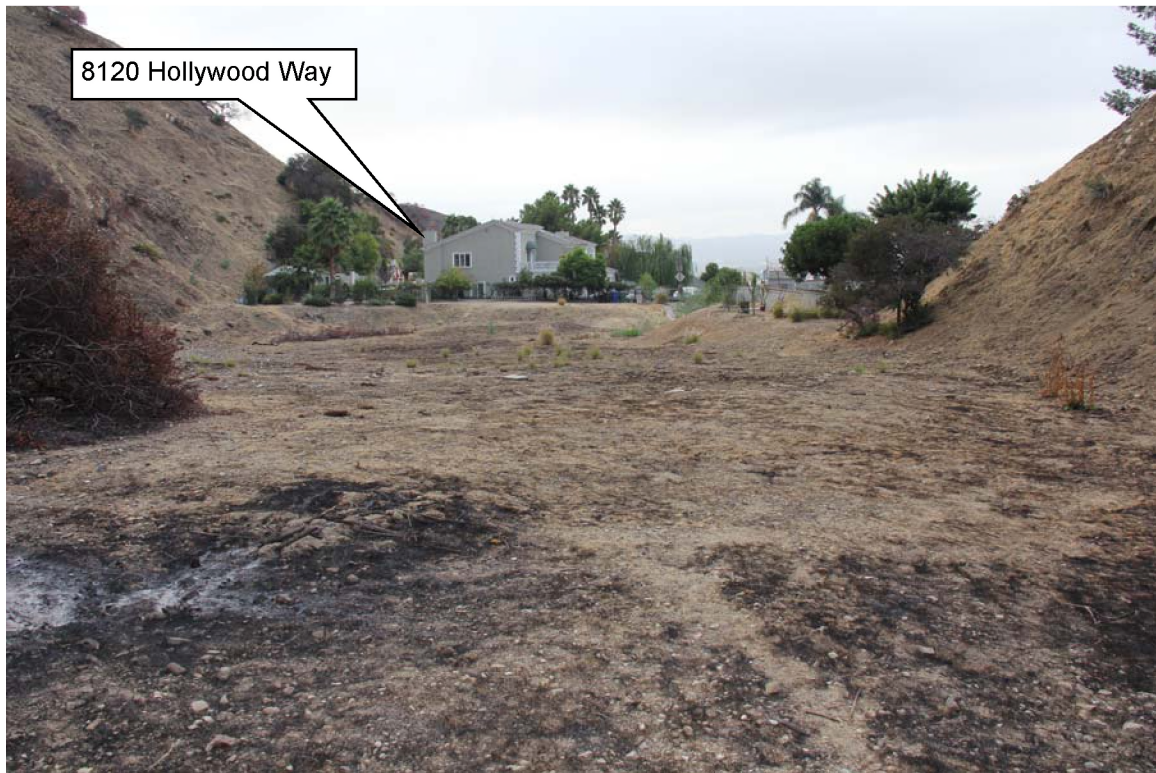
Site 3: Looking south across the debris basin.

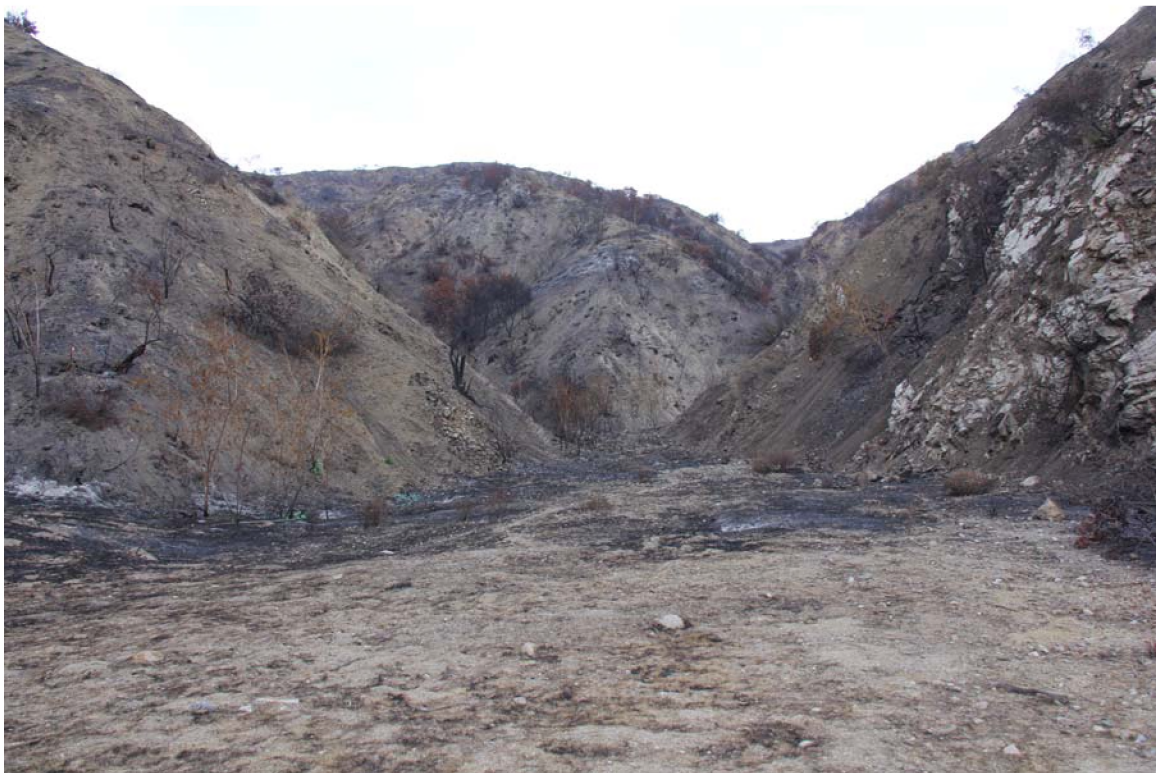
Site 3: Looking north and up the drainage which empties into the northern end of the debris basin. Note the amount of accumulated soil and rock in this portion of the basin.

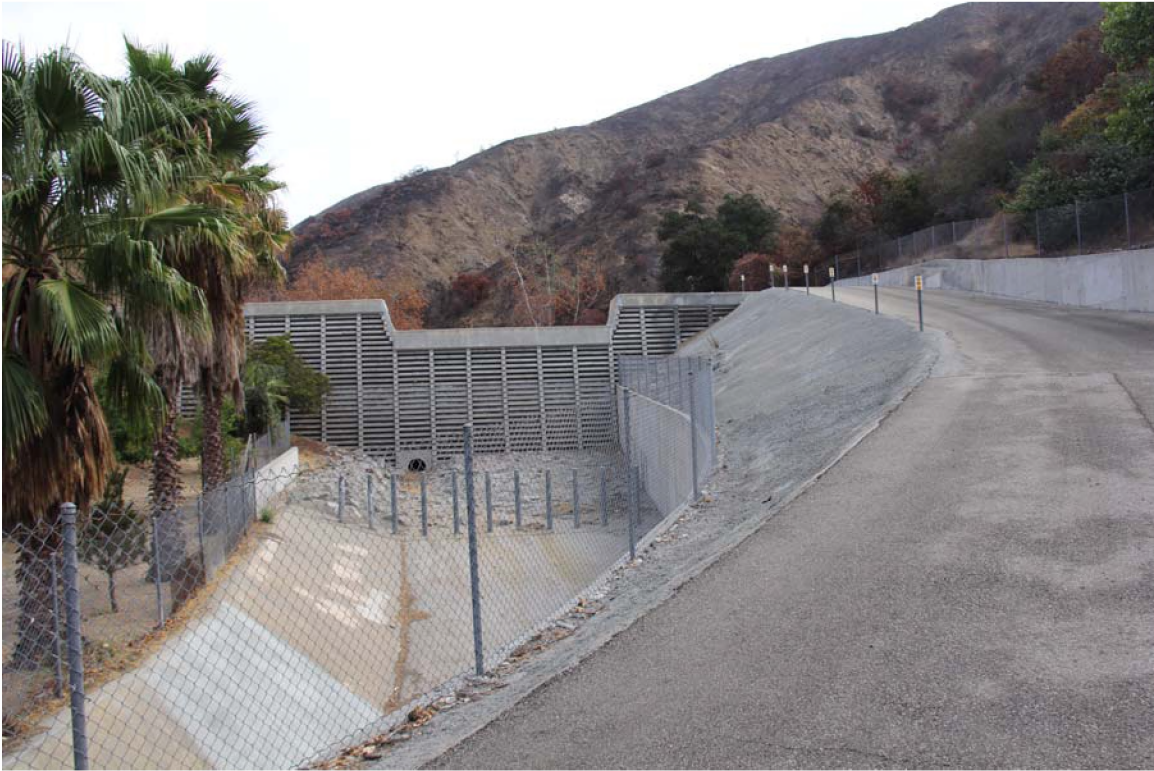
Site 4: Looking northeast towards Los Angeles County's Chandler Debris Basin. The property of 9901 Roscoe Blvd. is located left of the channel.

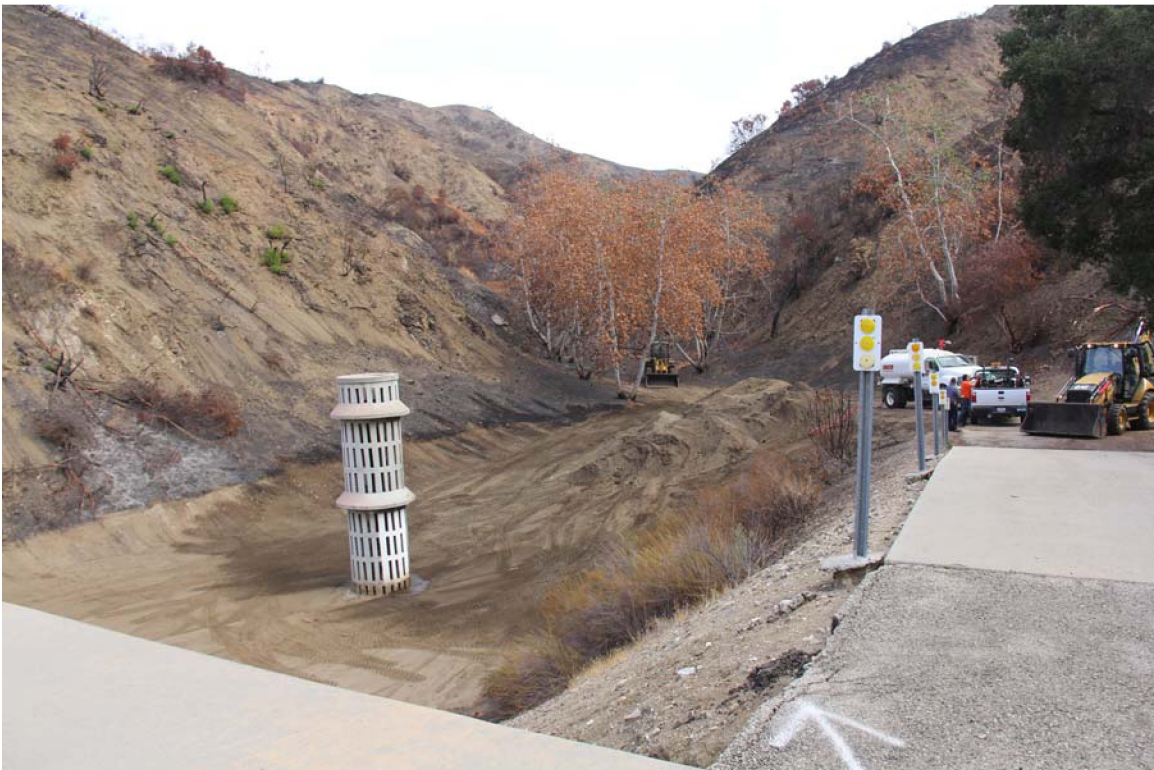
Site 4: Debris being removed from behind the Chandler Debris Basin.

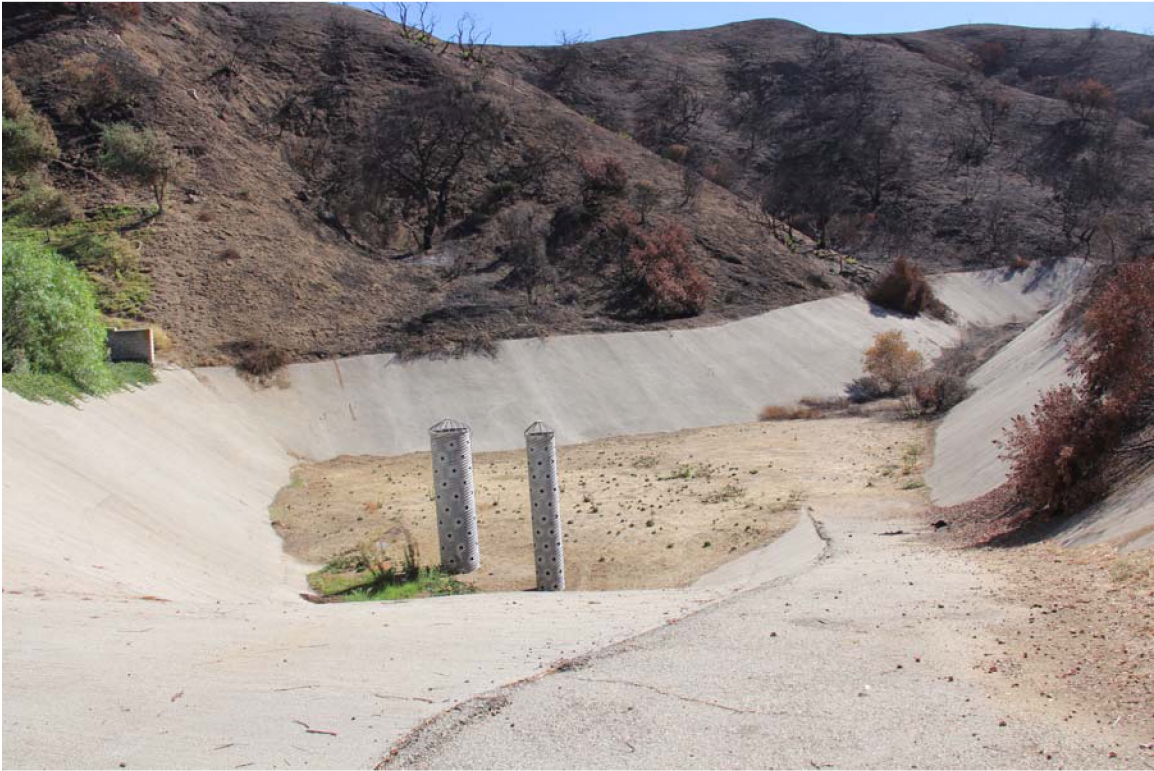
Site 5: Looking southeast towards a concrete-lined debris basin located on Santa Monica Mountain Conservancy property, which is located immediately adjacent to 8948 Morning Glow Way.

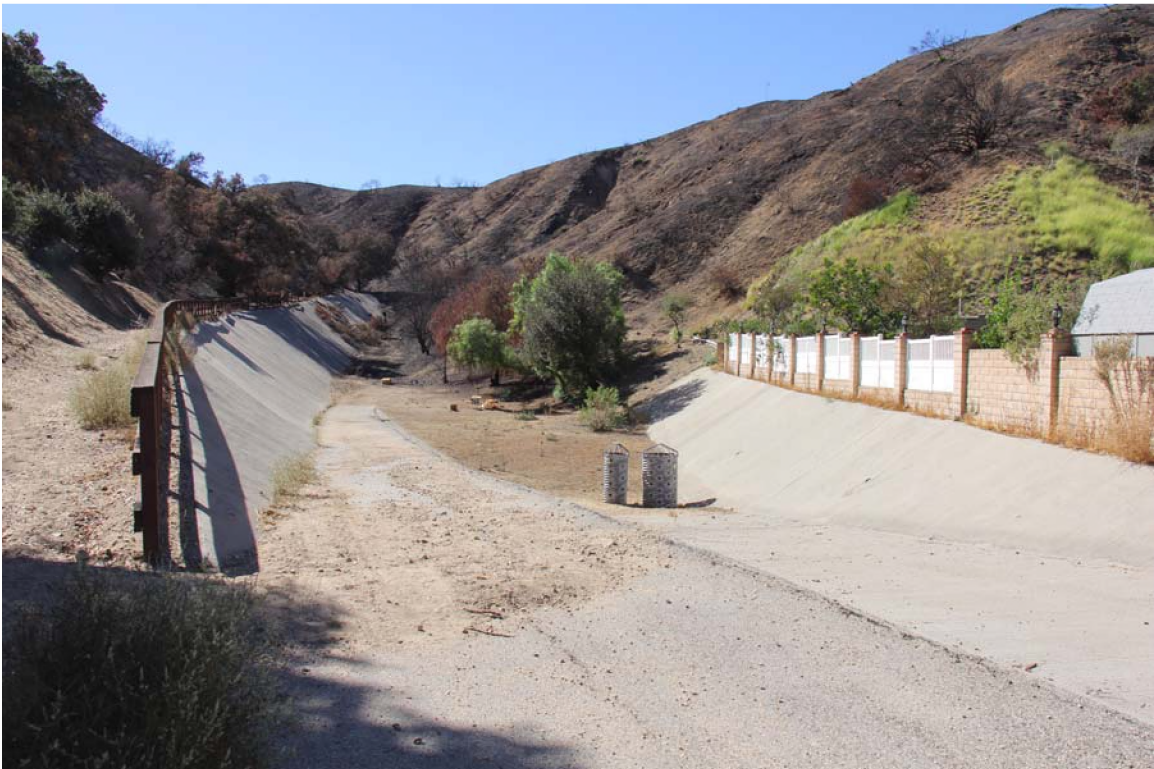
Site 5: Looking southwest towards a concrete-lined debris basin located on Santa Monica Mountain Conservancy property, which is located immediately adjacent to 8945 Morning Glow Way.

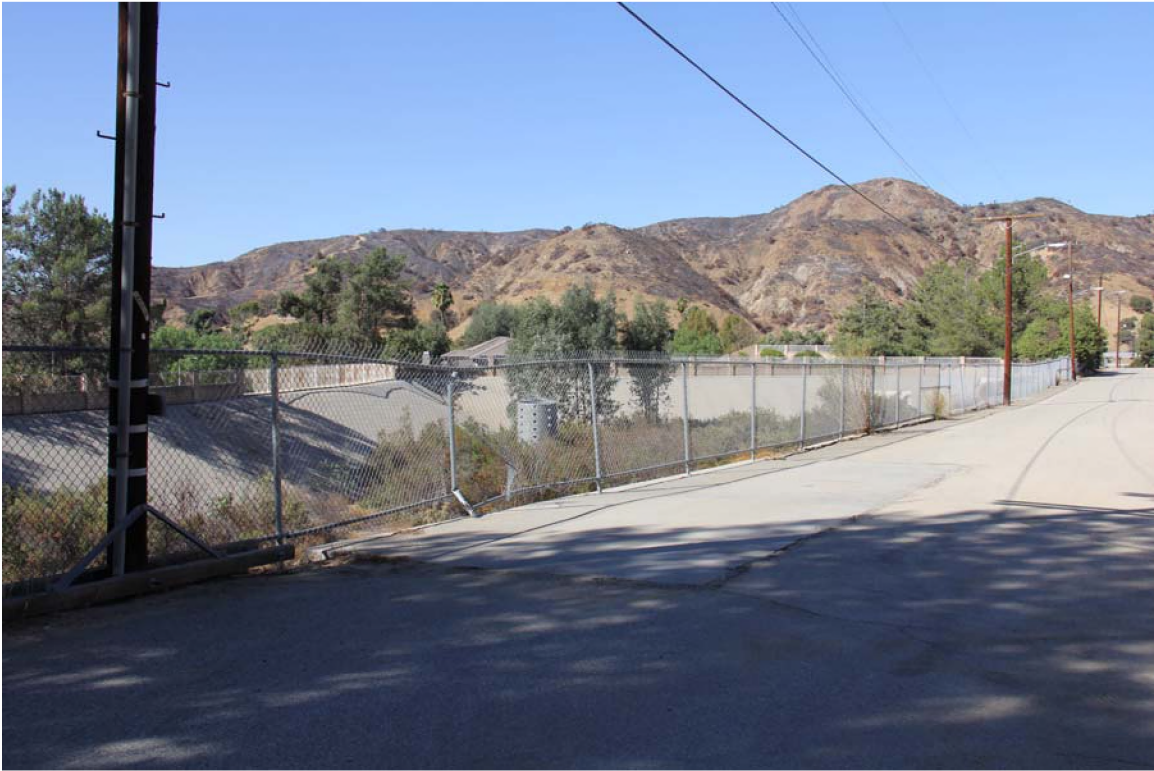
Site 6: Looking northwest across a private access road towards a relatively large concrete-lined debris basin located between 9046 Morning Glow Way to the north and Sun Glow Way to the south.

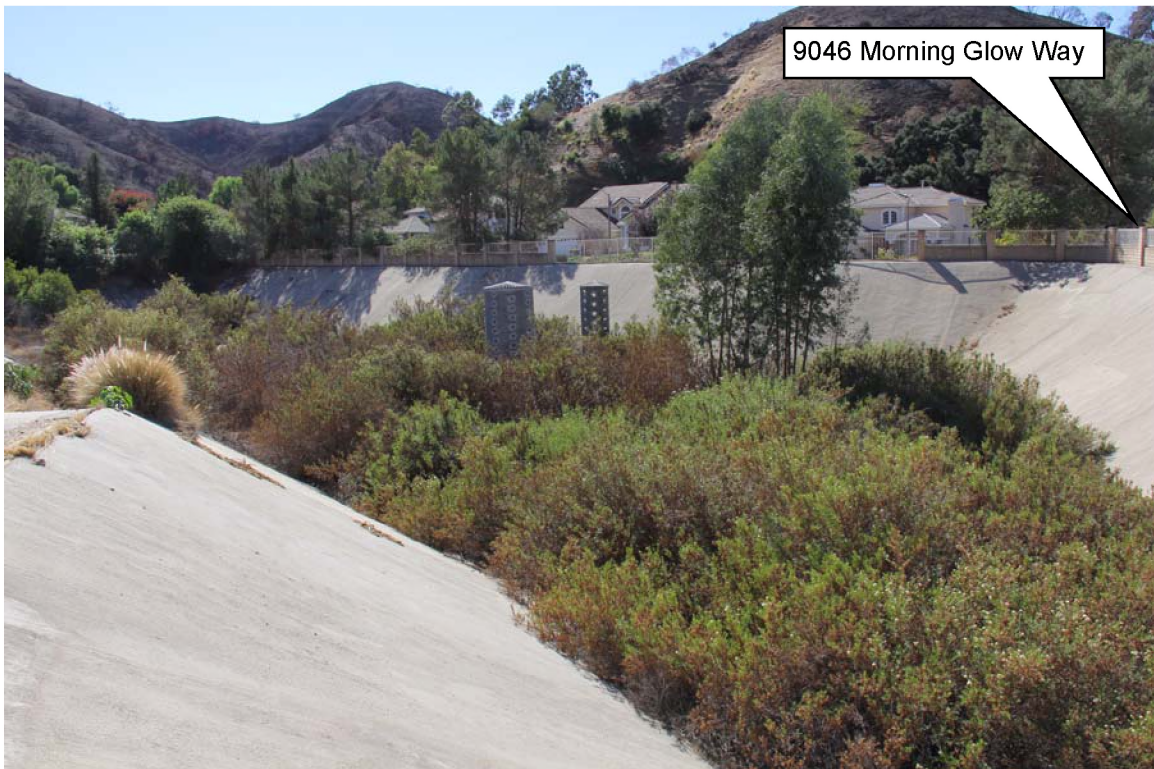
Site 6: Looking southwest across the debris basin. Note how the basin is overgrown and clogged with vegetation.

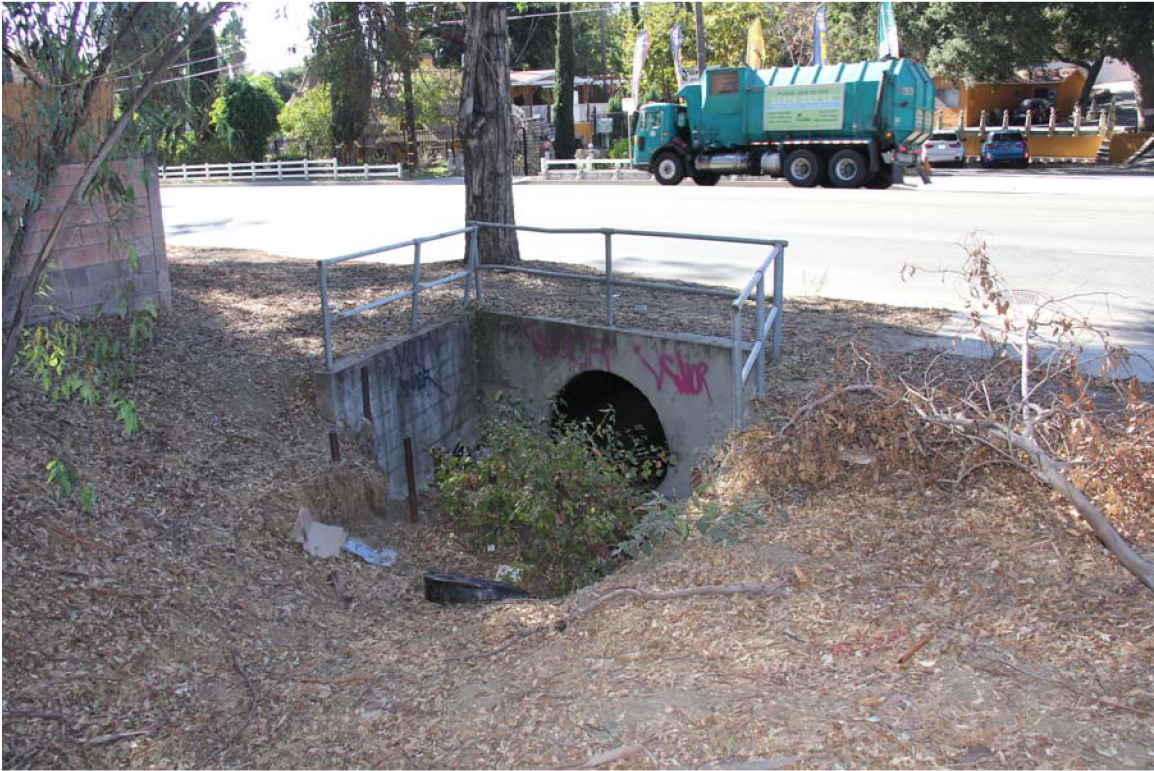
| Site No. | Location | Description | Recommendation |
|---|--|--|--|
| 8 | 9958 Sunland Blvd. | A large northwest-trending drainage directs runoff into and along the entire length of Teazle Canyon Road--a private roadway. The drainage course, which is located entirely in private property, was intensely burned and represents a high debris flow hazard. No debris containment devices or improvements are present. | If possible, have General Services Real Estate Division obtain a written agreement with the property owner and have Los Angeles County install a 70' (L) and 10' (H) revetment/debris rack across the drainage. |

Site 8: Looking west towards a culvert inlet structure, located adjacent to Sunland Blvd. and approximately 100 feet south of the intersection of Sunland Blvd. and Teazole Canyon Road (a private street), which directs runoff from Teazole Canyon to the City's stormwater collection system.

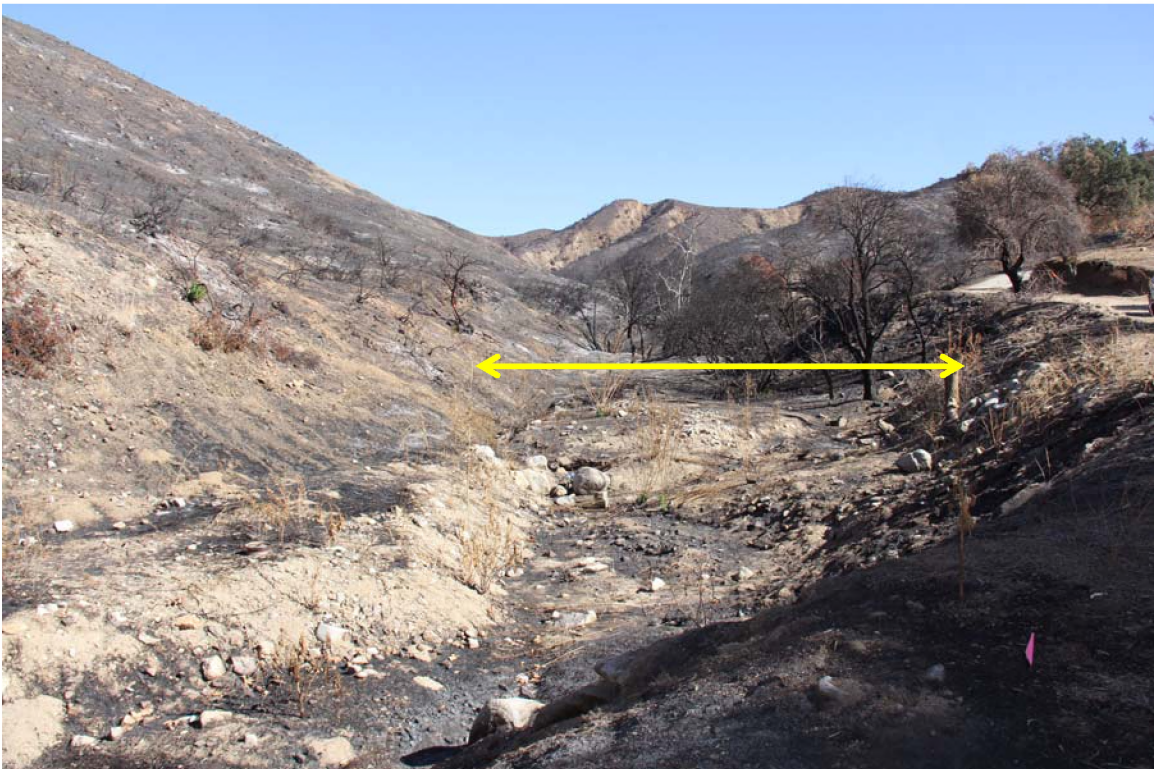
Site 8: Looking southeast and up Teazole Canyon which has been severely burned. The double yellow arrow points out where a revetment or debris rack has been recommended to be installed across the channel.

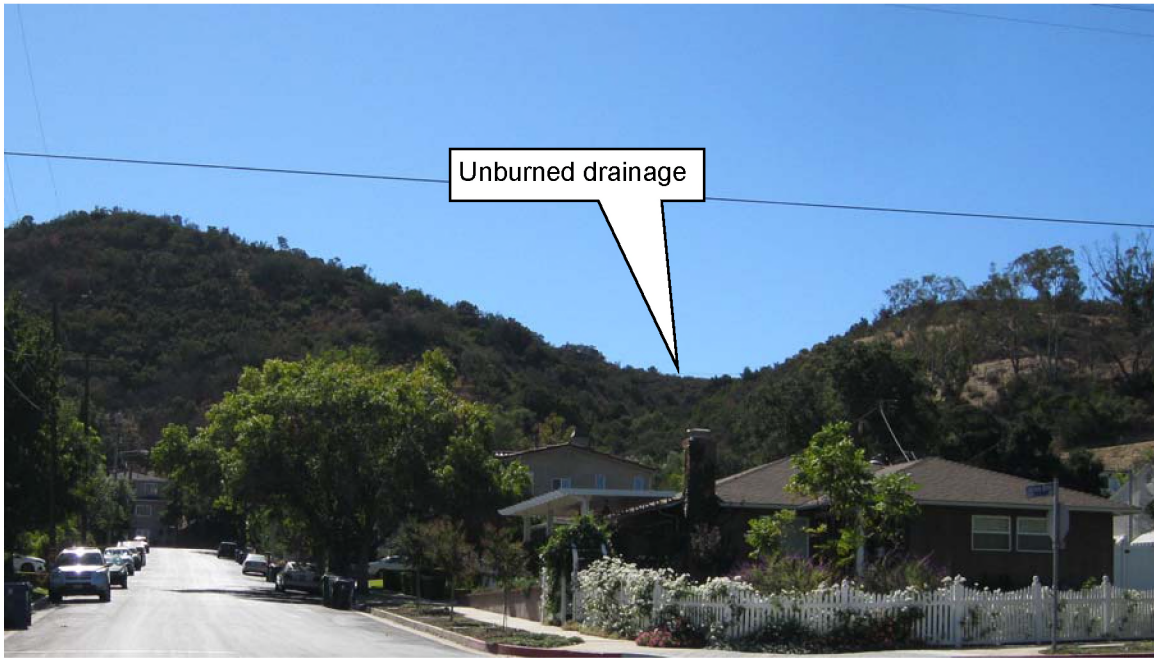
| Site No. | Location | Description | Recommendation |
|---|--|--|--|
| 11 | 8564 Day Street | A moderately sized drainage located on private property directs runoff towards the intersection of Sherman Grove Avenue and Day Street. The drainage was not burned by the fire. | No action is required. |

Site 11: Looking south towards the unburned drainage located southwest of the intersection of Sherman Grove Avenue and Day Street.

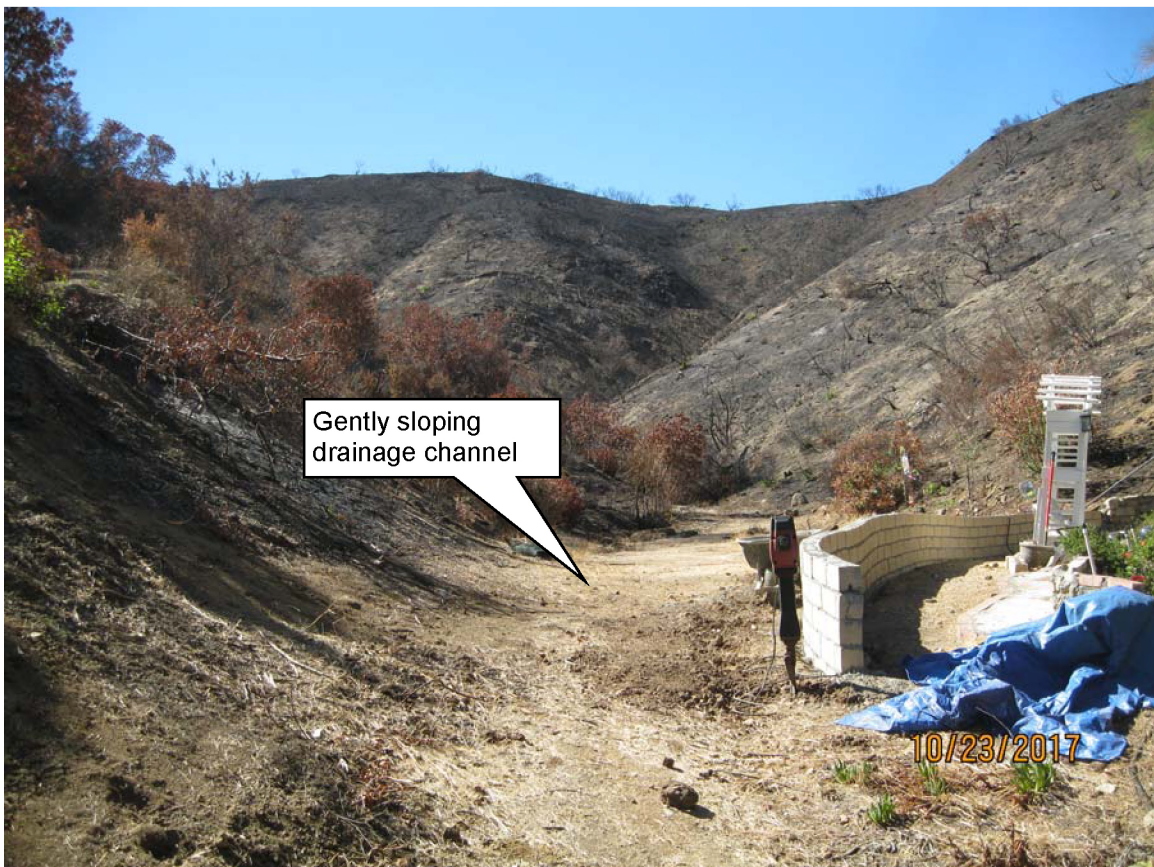
| Site No. | Location | Description | Recommendation |
|---|--|--|--|
| 12 | 8422 W. McGroarty Street | A drainage on private property directs runoff towards McGroarty Street near Oro Vista Avenue. The upper portions of the drainage burned with moderate intensity, while the lower portions were unburned. The drainage channel has a relatively long and gently sloping runoff on private property. | It is BOE-GED's opinion that debris would be contained on private property. No action is required. |

Site 12: Looking southwest towards the upper portions of the drainage which burned with moderate intensity. Note the drainage channel is relatively gently sloping.

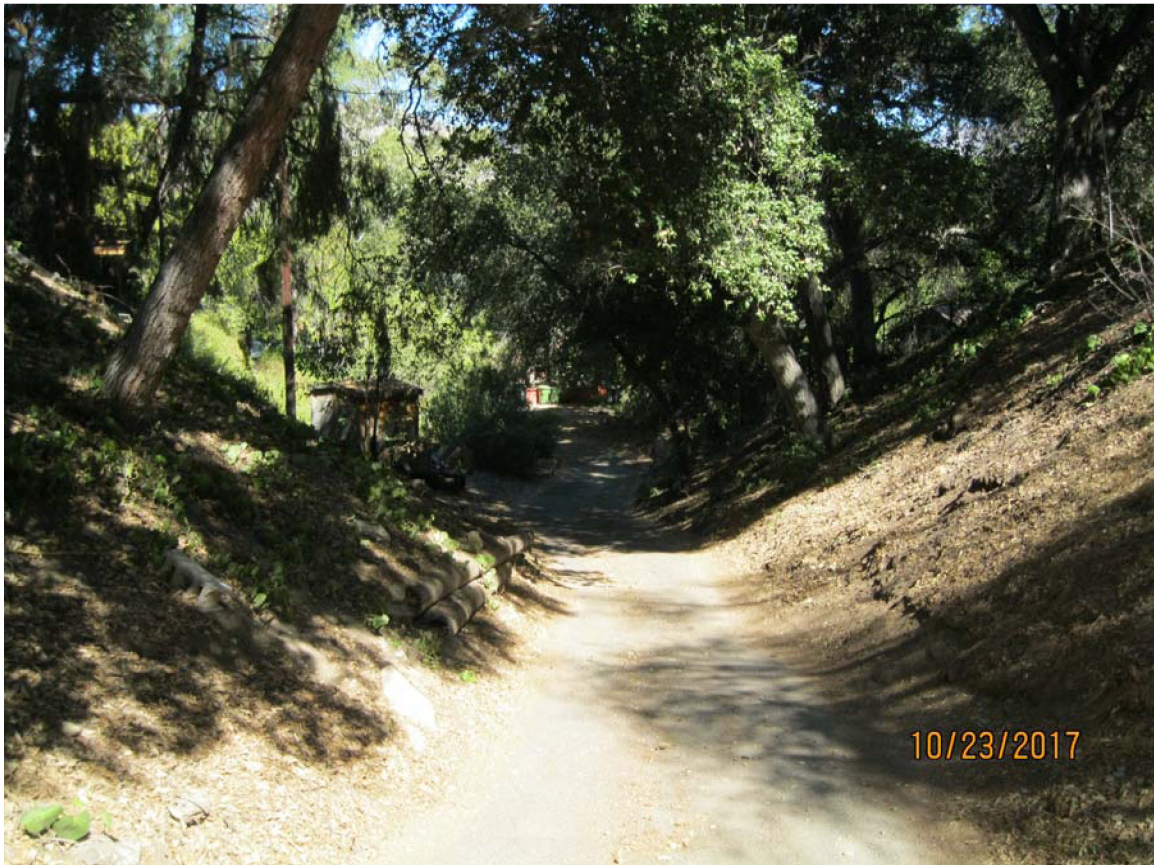
Site 12: Looking northeast along the unburned lower portions of the drainage. Note the drainage channel is gently sloping and has a relatively long runout on private property.

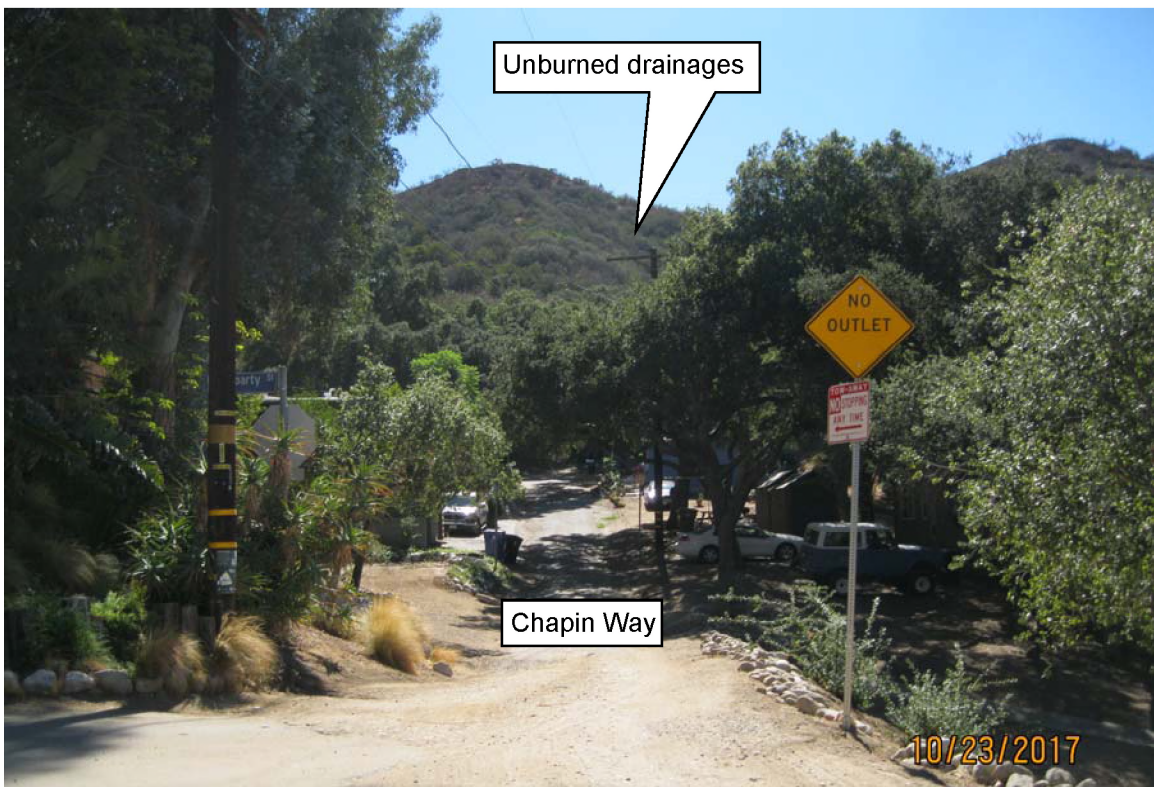
Site 13: Looking south along Chapin Way. Note the unburned drainages above Chapin Way.
