RE: **LA TUNA FIRE RESPONSE AND RECOVERY SUMMARY REPORT**

BOE La Tuna Fire Burn Area Mitigation – Assessment and Recommendations W.O.
E1908261

SUBJECT: **La Tuna Fire Burn Area Mitigation – Assessment and Recommendations**
W.O. E1908261 **BOE-GED File No. 17-200**

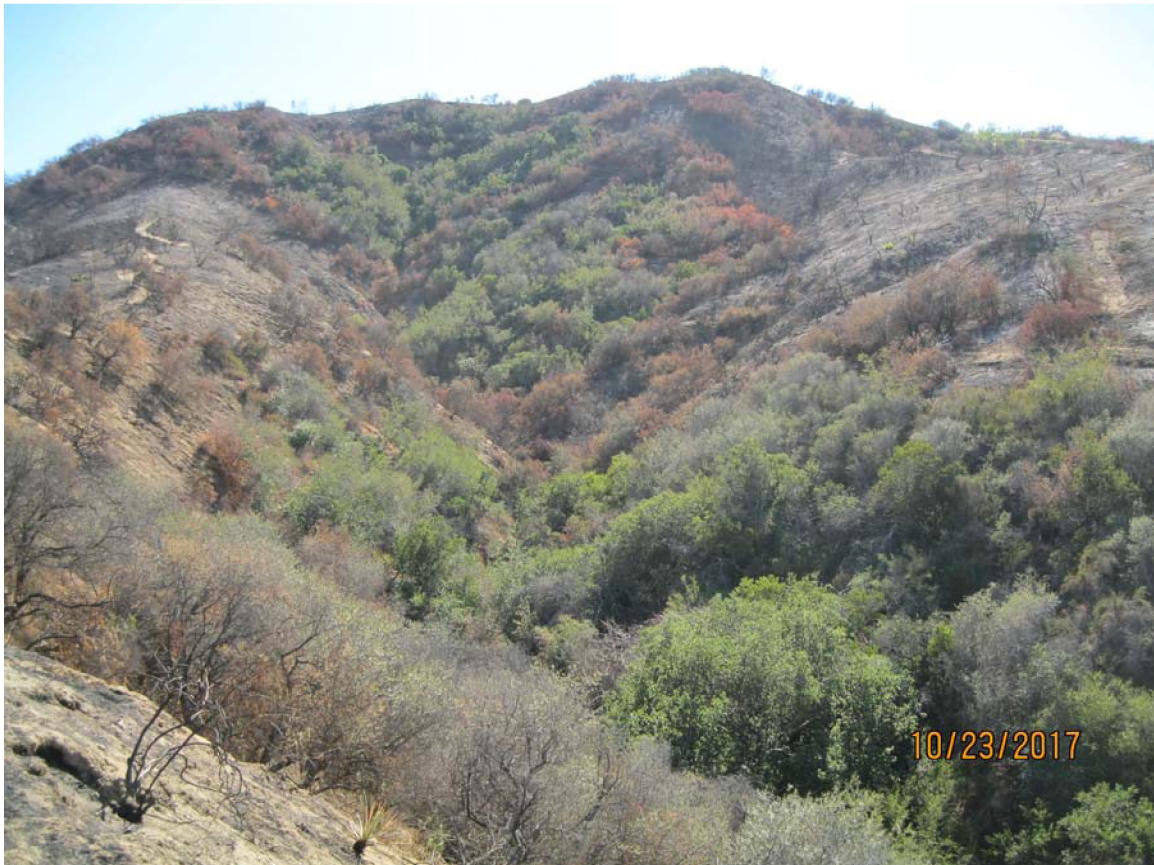
| Site No. | Location | Description | Recommendation |
|---|--|--|--|
| 14 | 10007 N. Moy Lane | Runoff from drainages on private property is directed towards Moy Lane. Substantial portions of the drainages were unburned. Where the drainages were burned, the fire burned with low to moderate intensity. Additionally, the drainage channels have relatively long and gently sloping runouts on private property. | It is BOE-GED's opinion that debris would be contained on private property. No action is required. |

Site 14: Looking south towards one of two drainages above Moy Lane. Substantial portions of this drainage were unburned.

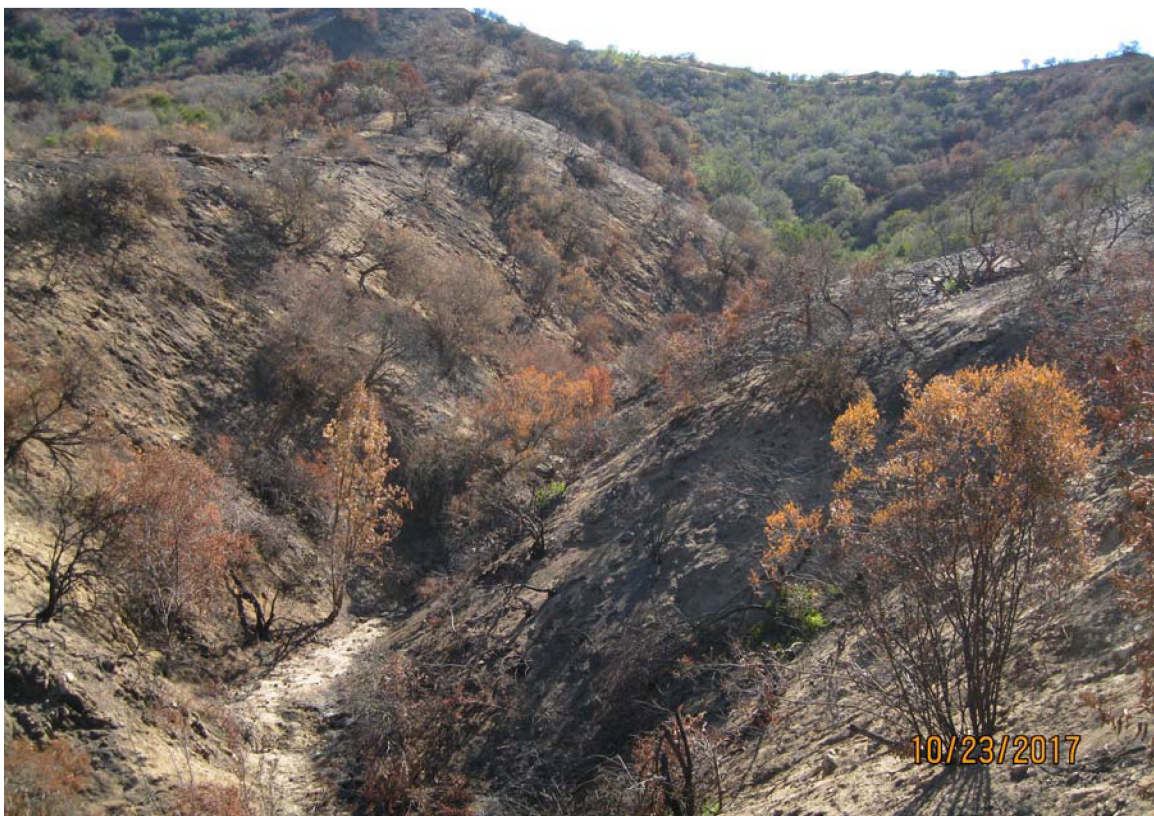
Site 14: Looking south towards the second of two drainages above Moy Lane. Note the low to moderate intensity of the burn. Also note the relatively gently sloping nature of the drainage channel.

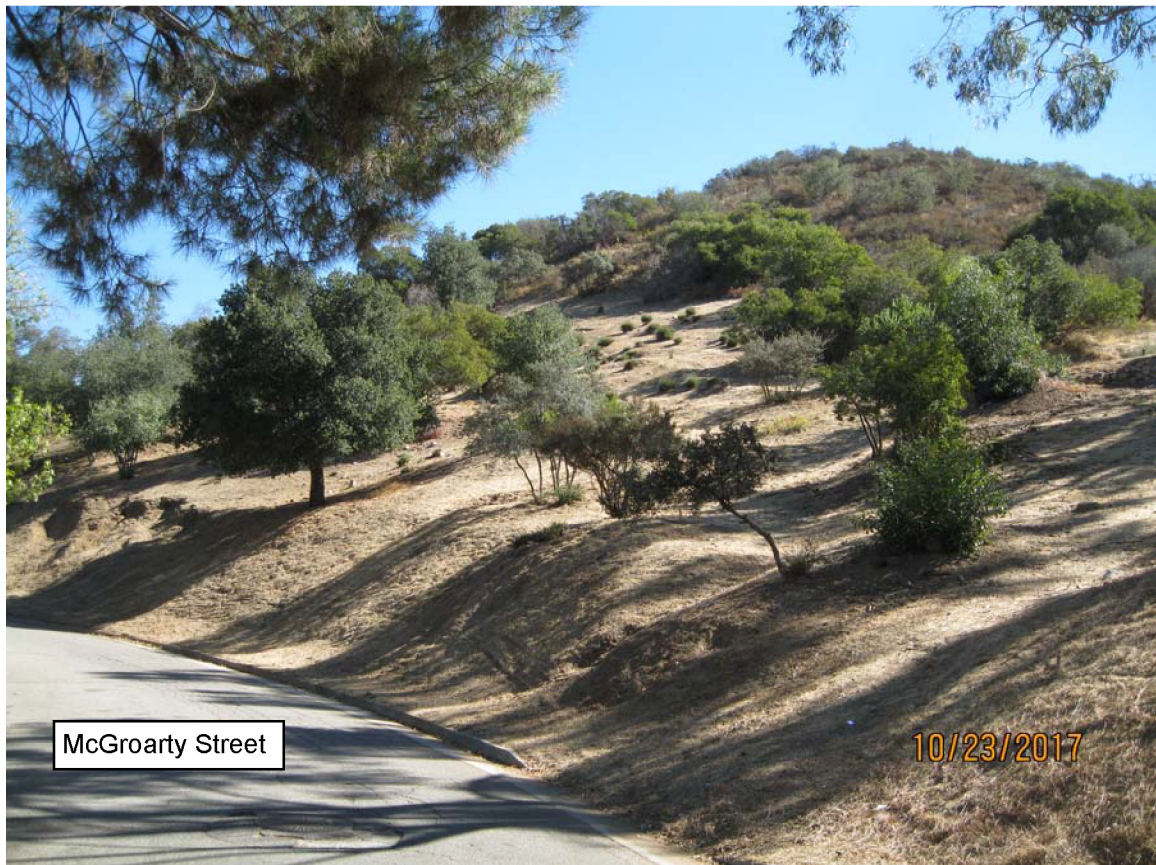
| Site No. | Location | Description | Recommendation |
|---|--|--|--|
| 15 | 7700 W. McGroarty Street | Moderately steep and undeveloped slopes on private property descend directly to a City street. The slopes were unburned. | No action is required. |

Site 15: Looking southeast towards the slope that descends directly to McGroarty Street. Note, the slope is unburned.

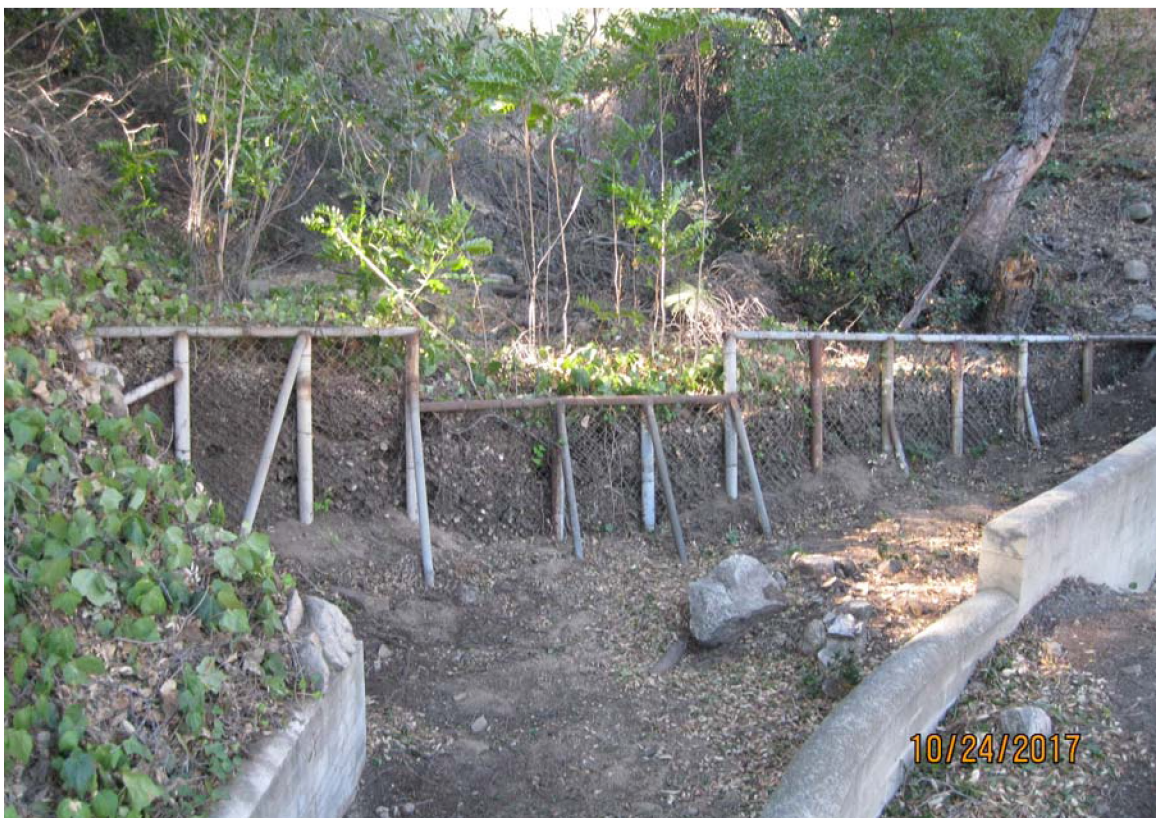
| Site No. | Location | Description | Recommendation |
|---|--|--|--|
| 16 | 7570 W. McGroarty Terrace | Multiple north-south trending drainages are located on Rec. & Park property and drain towards a City street and park. The western drainages are largely unburned and debris is contained behind a debris fence located west of the McGroarty Cultural Center Building. The east drainage is partially burned, represents a moderate debris flow hazard, and empties towards a stacked cobble and mortar-filled catch basin and energy dissipator located east of the McGroarty Cultural Center Building. | Remove the soil and debris accumulations behind the existing debris fence west of the McGroarty Cultural Center Building. To increase capacity, remove soil and debris accumulations from the catch basin east of the McGroarty Cultural Center Building. Also, install a 40' (L) x 4' (H) debris fence behind the stacked cobble and mortar-filled wall to increase capacity and prevent the catch basin from becoming clogged. |

Site 16: Looking southwest towards the debris fence that is located west of the McGroarty Cultural Center Building. Note, the accumulations of soil and debris behind the debris fence.

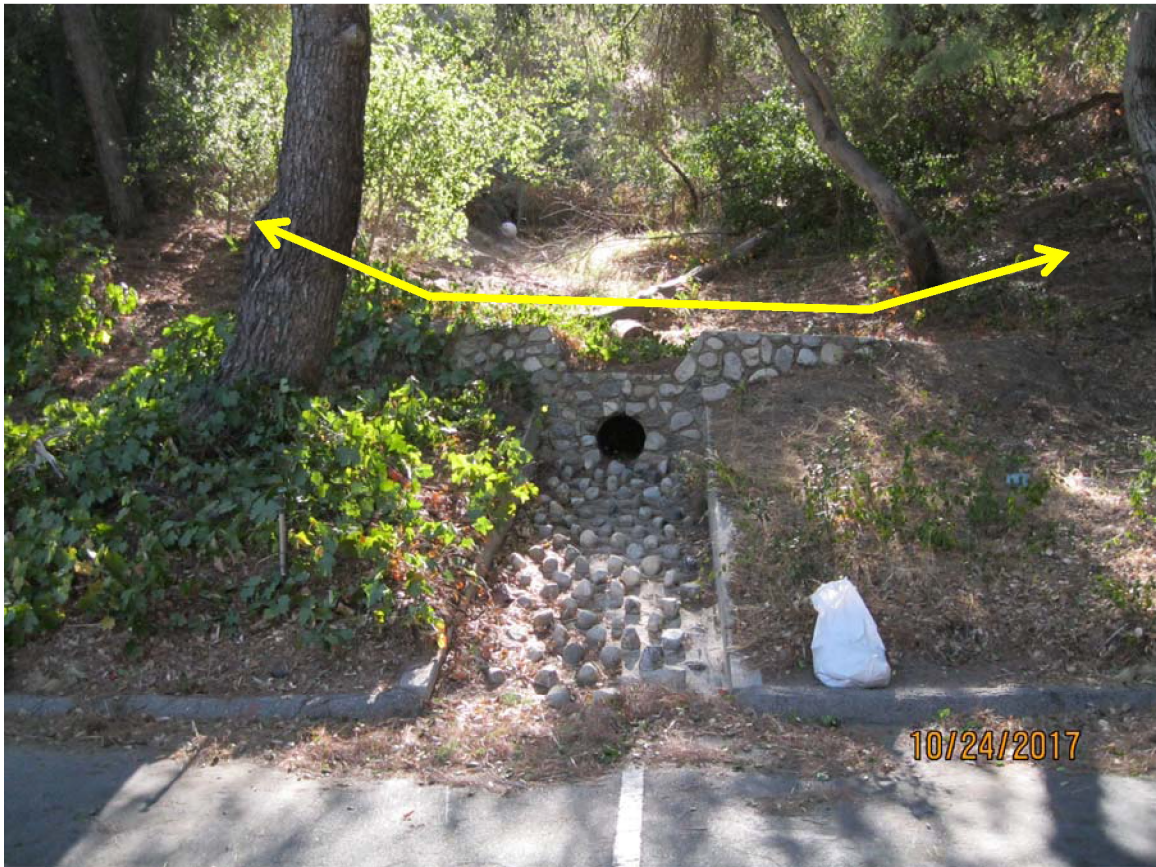
Site 16: Looking south towards the stacked cobble and mortar-filled catch basin. The double yellow arrow points out where a 40' (L) and 4' (H) debris fence has been recommended to increase debris storage capacity and prevent the catch basin from clogging.

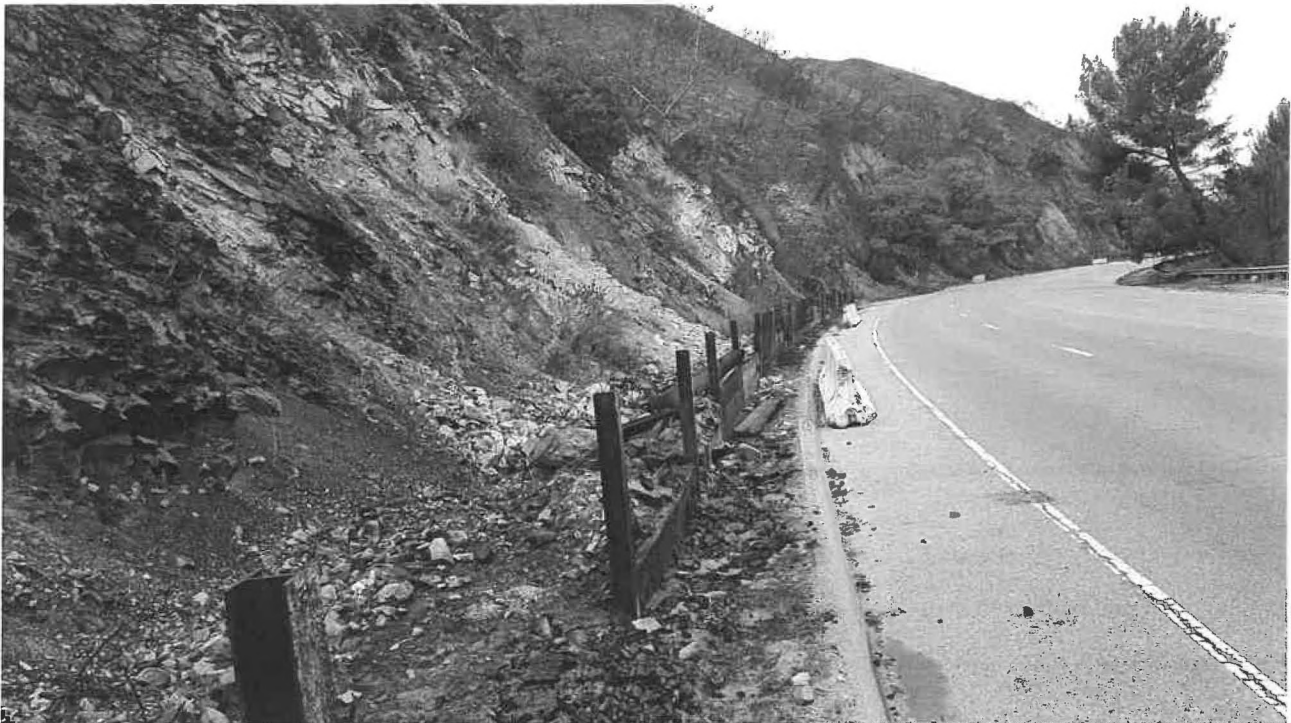
Photo 1: View west along the south side of La Tuna Canyon Road. Note the sections of lagging that are completely burnt out as well some sections that are relatively intact. Also note the debris piles behind the slough wall.

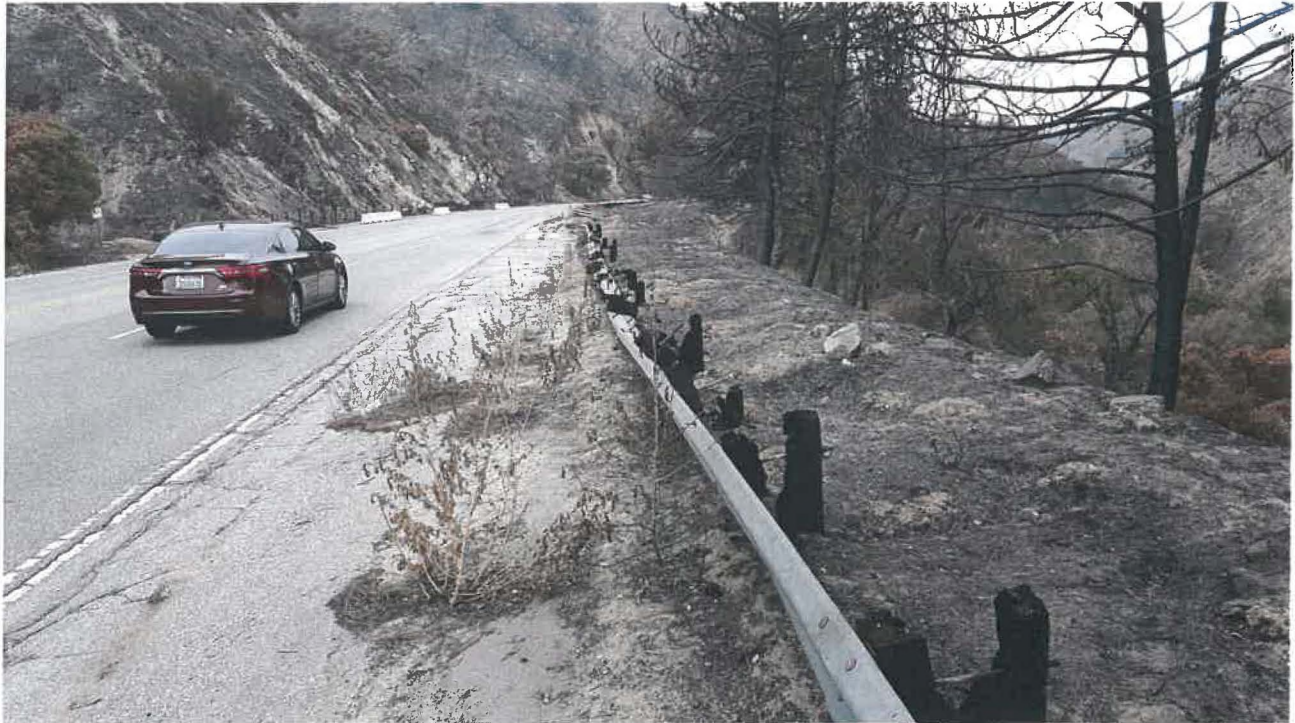
Photo 2: View west along the north side of La Tuna Canyon Road. Note the burnt-out wood support posts for the guard rail.

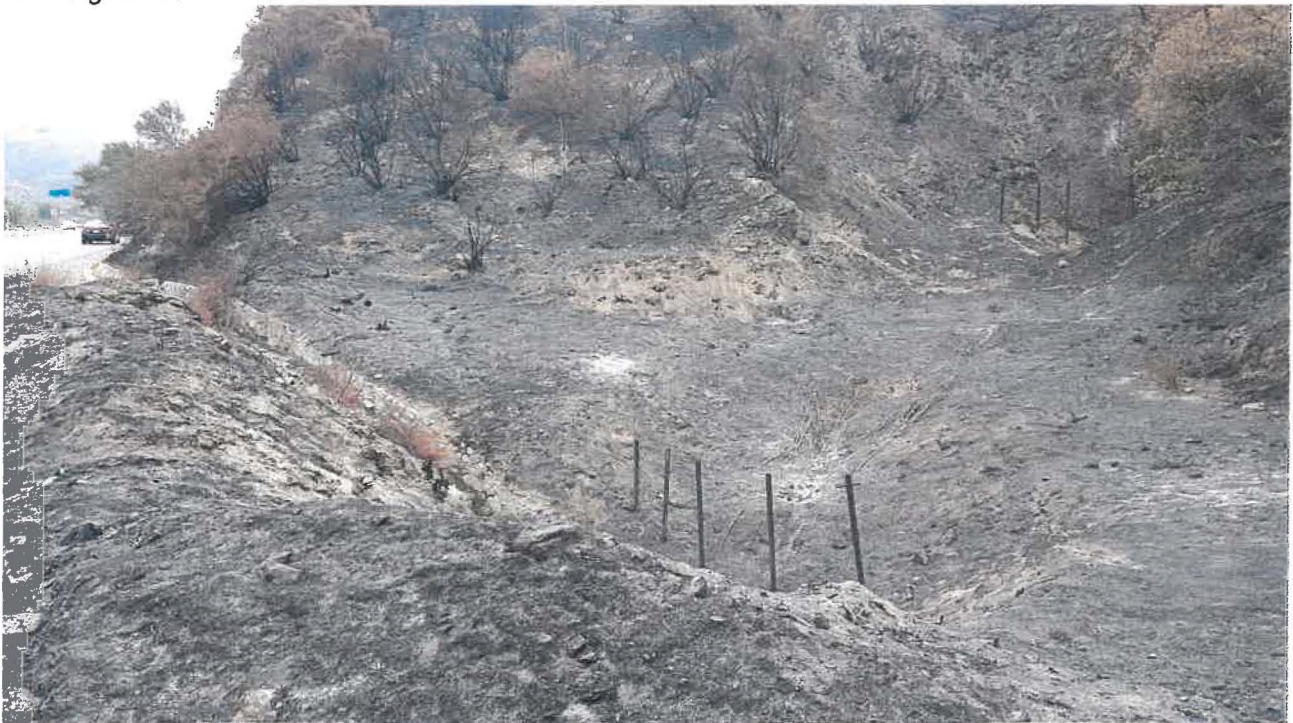
Photo 3: View east from the shoulder area next to a culvert along the south side of La Tuna Canyon Road. Note the two debris fences.

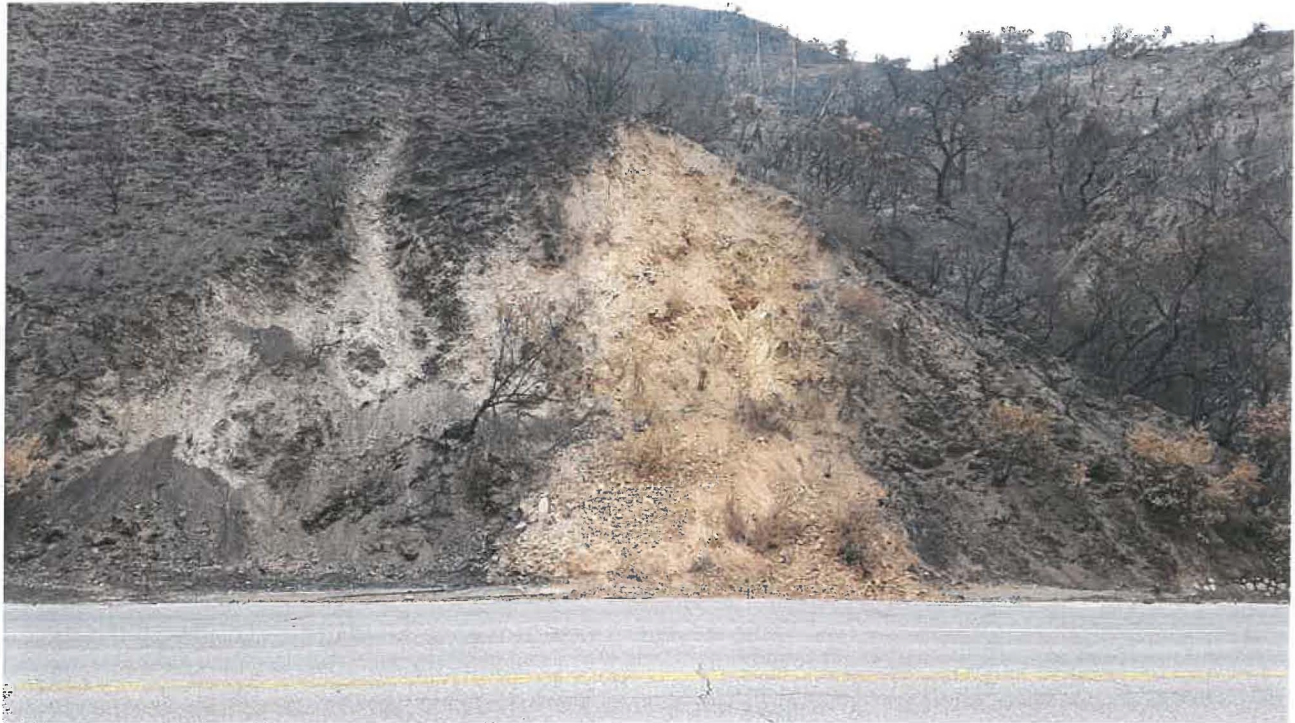
Photo 4: View south towards an active debris apron.

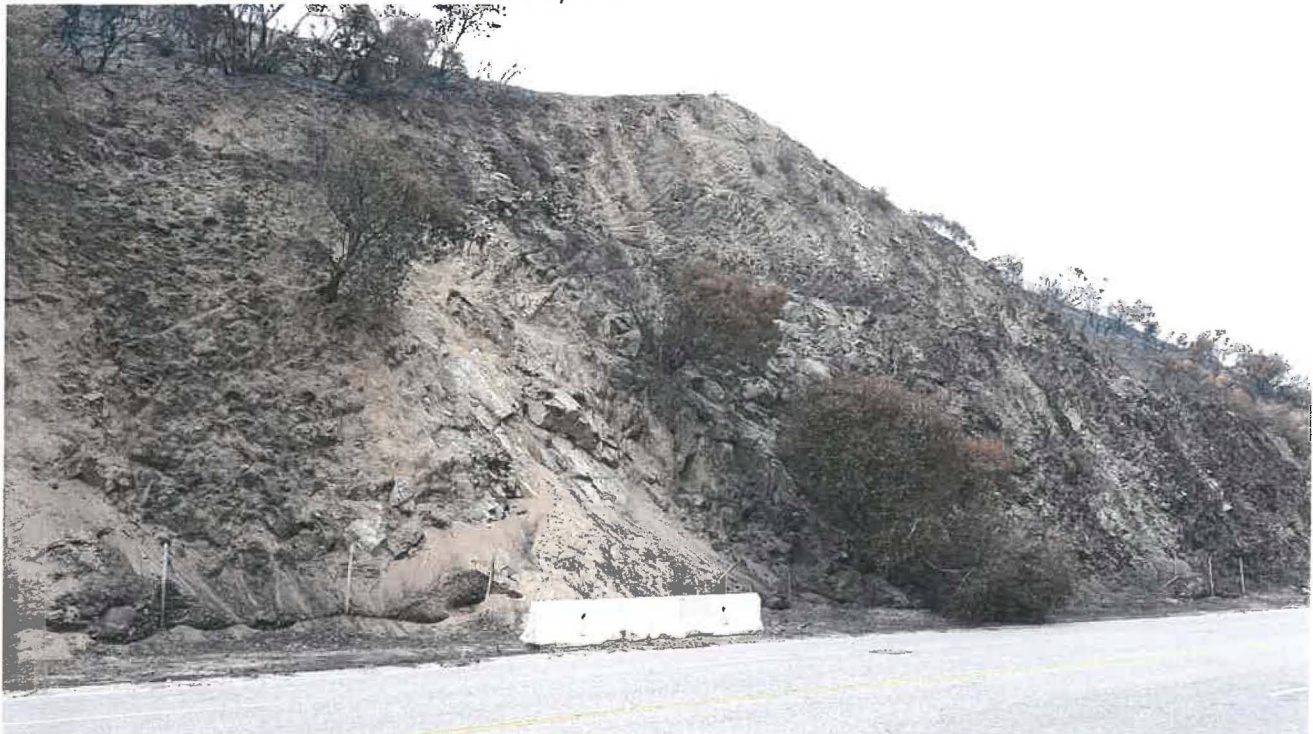
Photo 5: View south towards an active debris and rubble apron that has overwhelmed a 'debris fence' that consists of standard chain link.

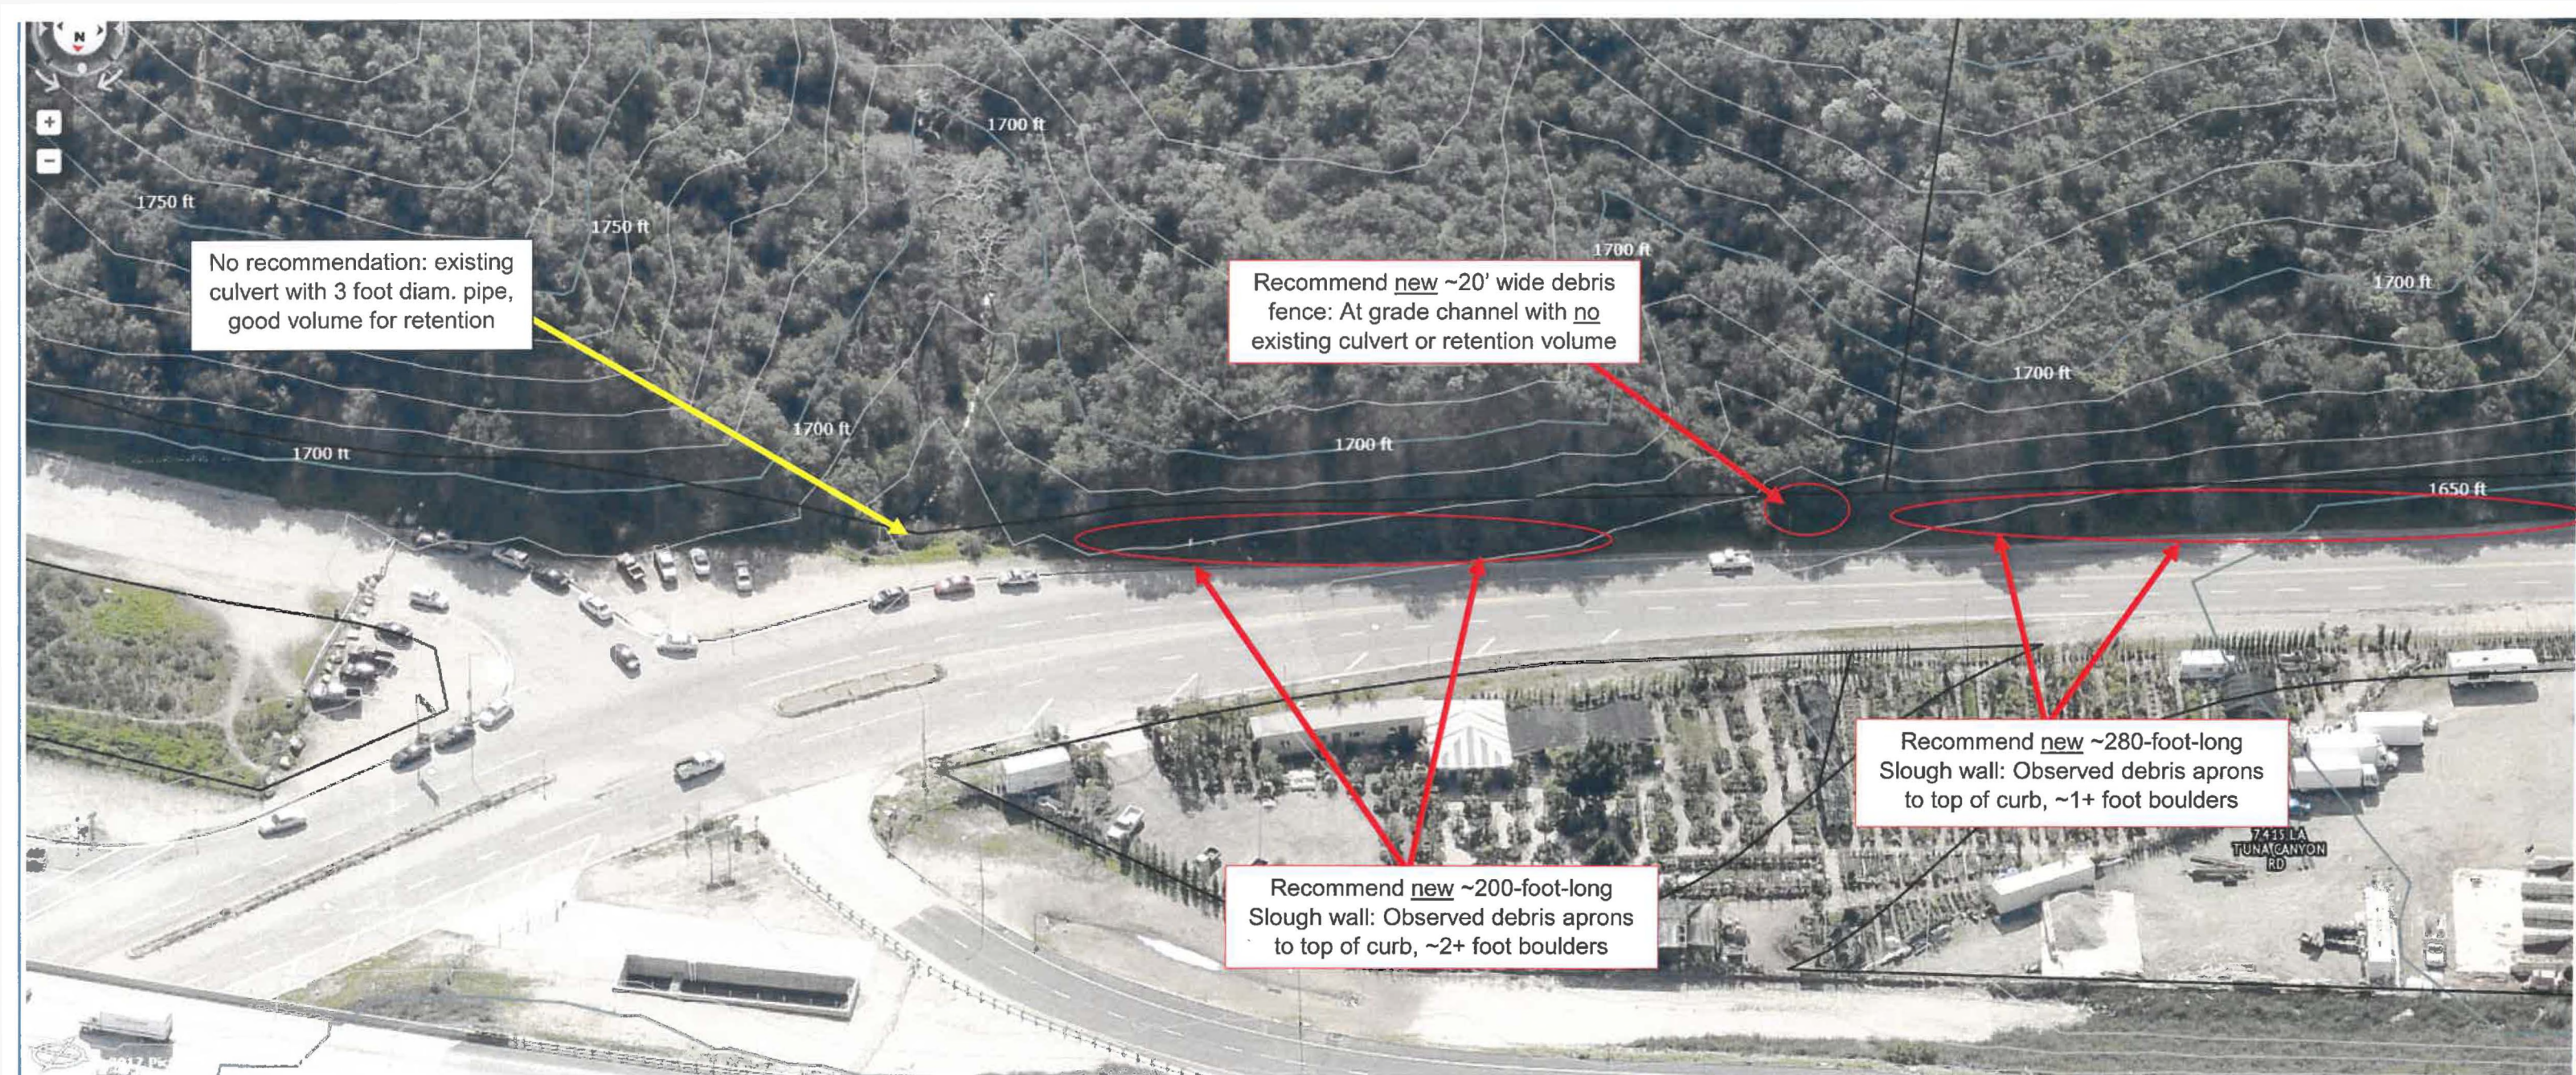
Plate 1: Looking south towards La Tuna Canyon Road adjacent to the 210 Freeway. Note the annotations regarding observations and recommendations. Oblique aerial image showing parcel boundaries in solid black lines (Pictometry). The following Plates are overlapped by approximately 60 feet. Areas with recommendations denoted in red, no action in yellow.

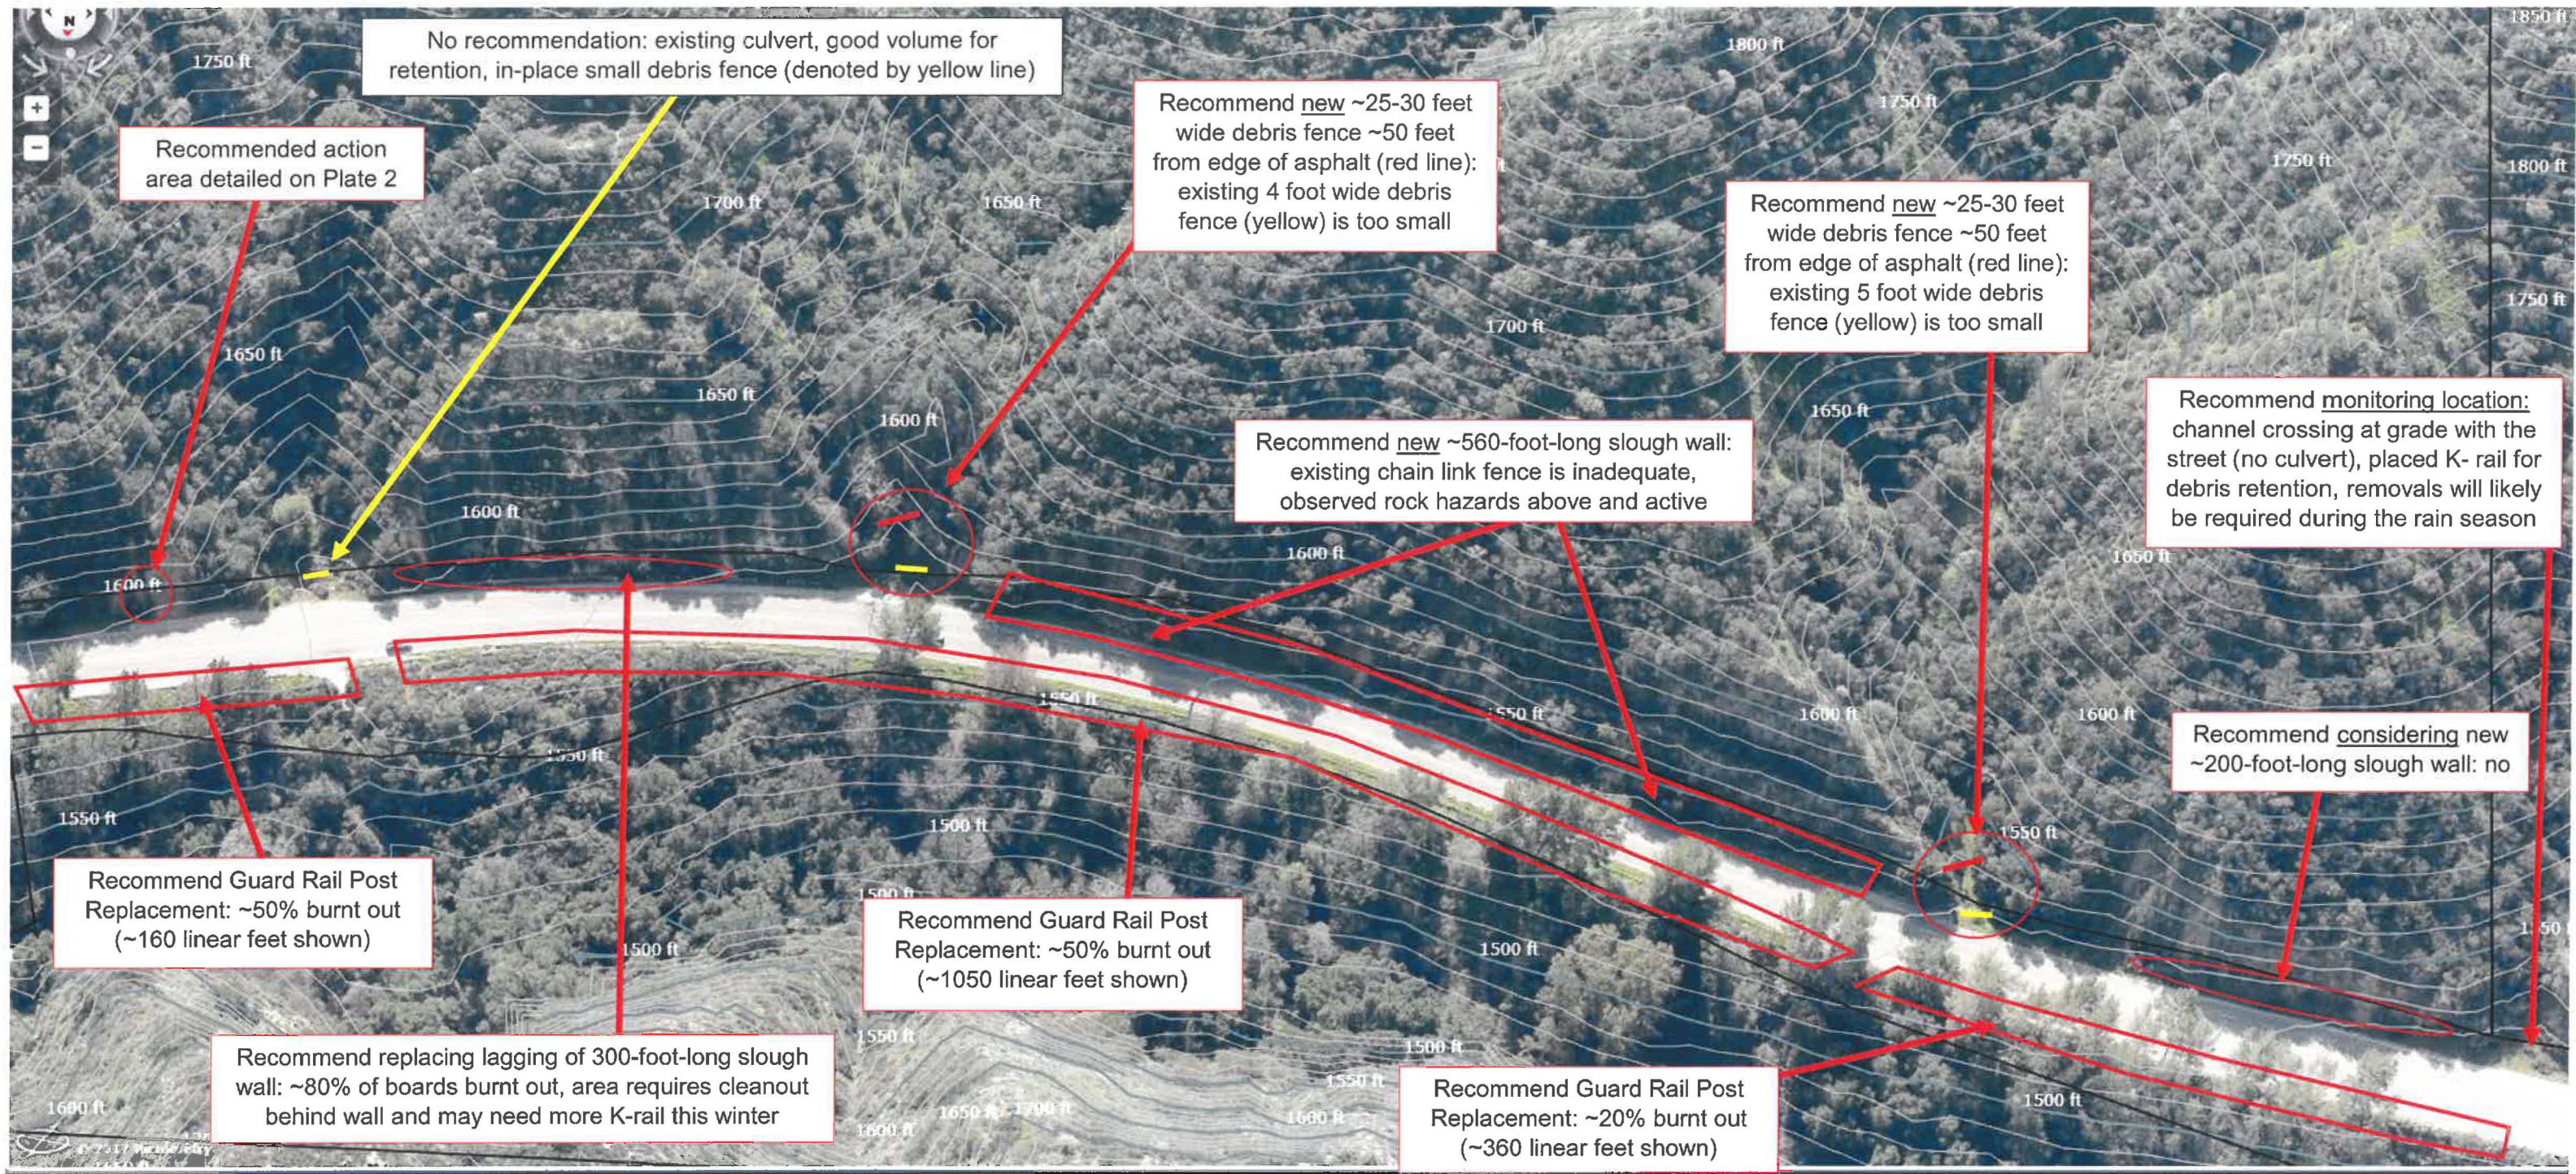
Plate 3: Looking south, ~500 feet west of 7415 La Tuna Canyon Road (on the left side of the photo.) Note the annotations regarding observations and recommendations. Oblique aerial image showing parcel boundaries in solid black lines (Pictometry). Areas with recommendations denoted in red, no action in yellow.

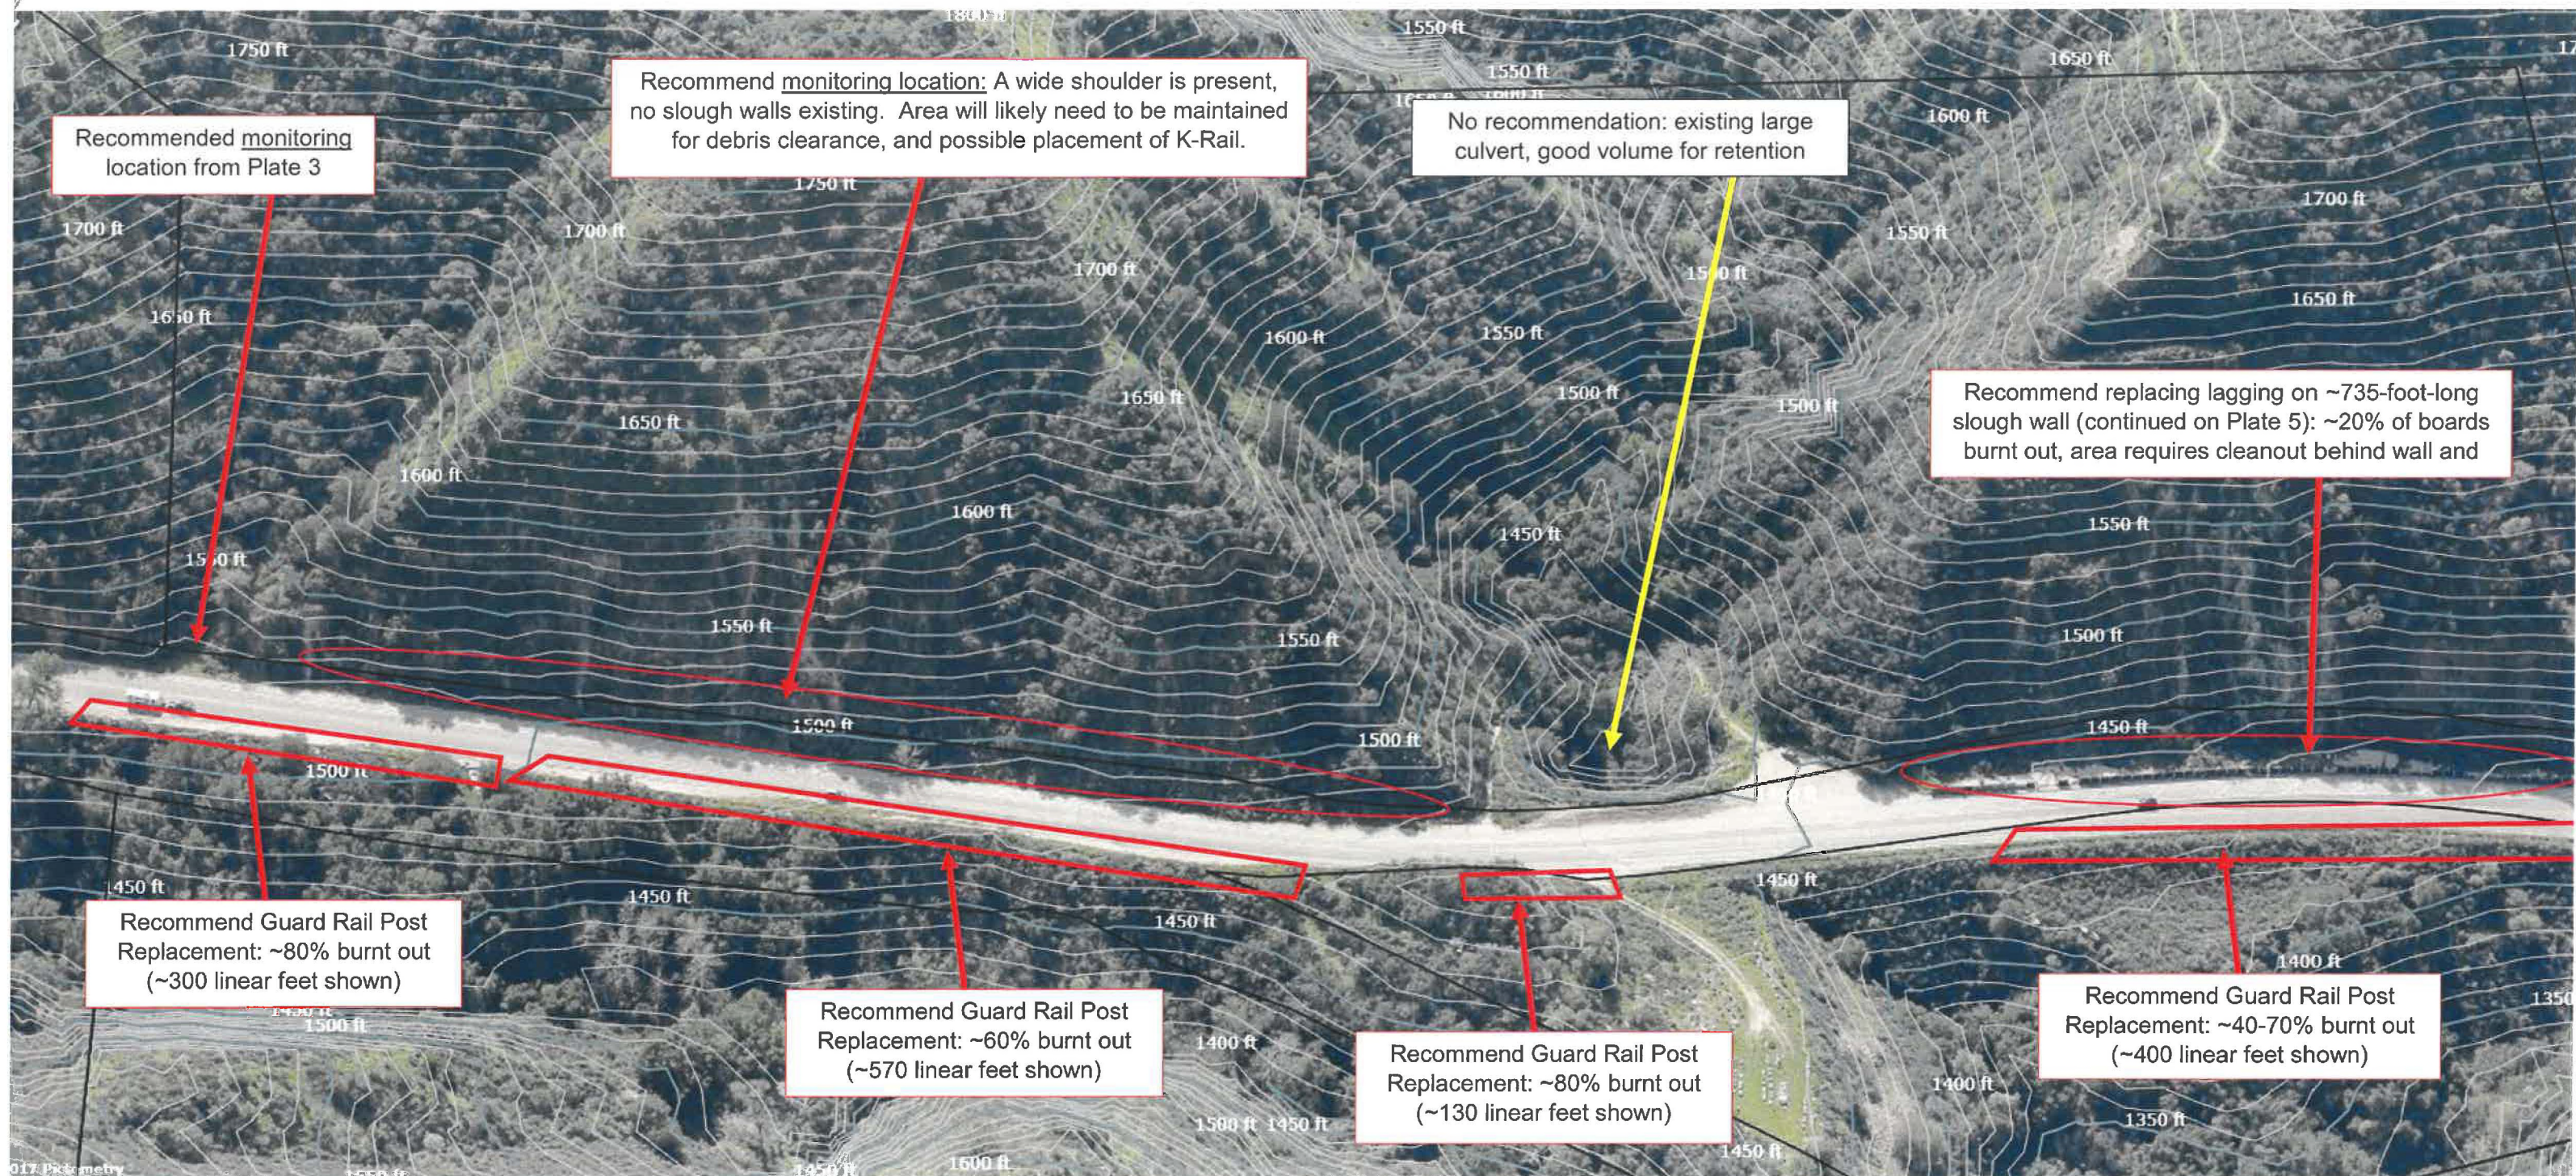
Plate 4: Looking south, ~2100 feet along the roadway west of 7415 La Tuna Canyon Road (on the left side of the photo.) Note the annotations regarding observations and recommendations. Oblique aerial image showing parcel boundaries in solid black lines (Pictometry). Areas with recommendations denoted in red, no action in yellow.

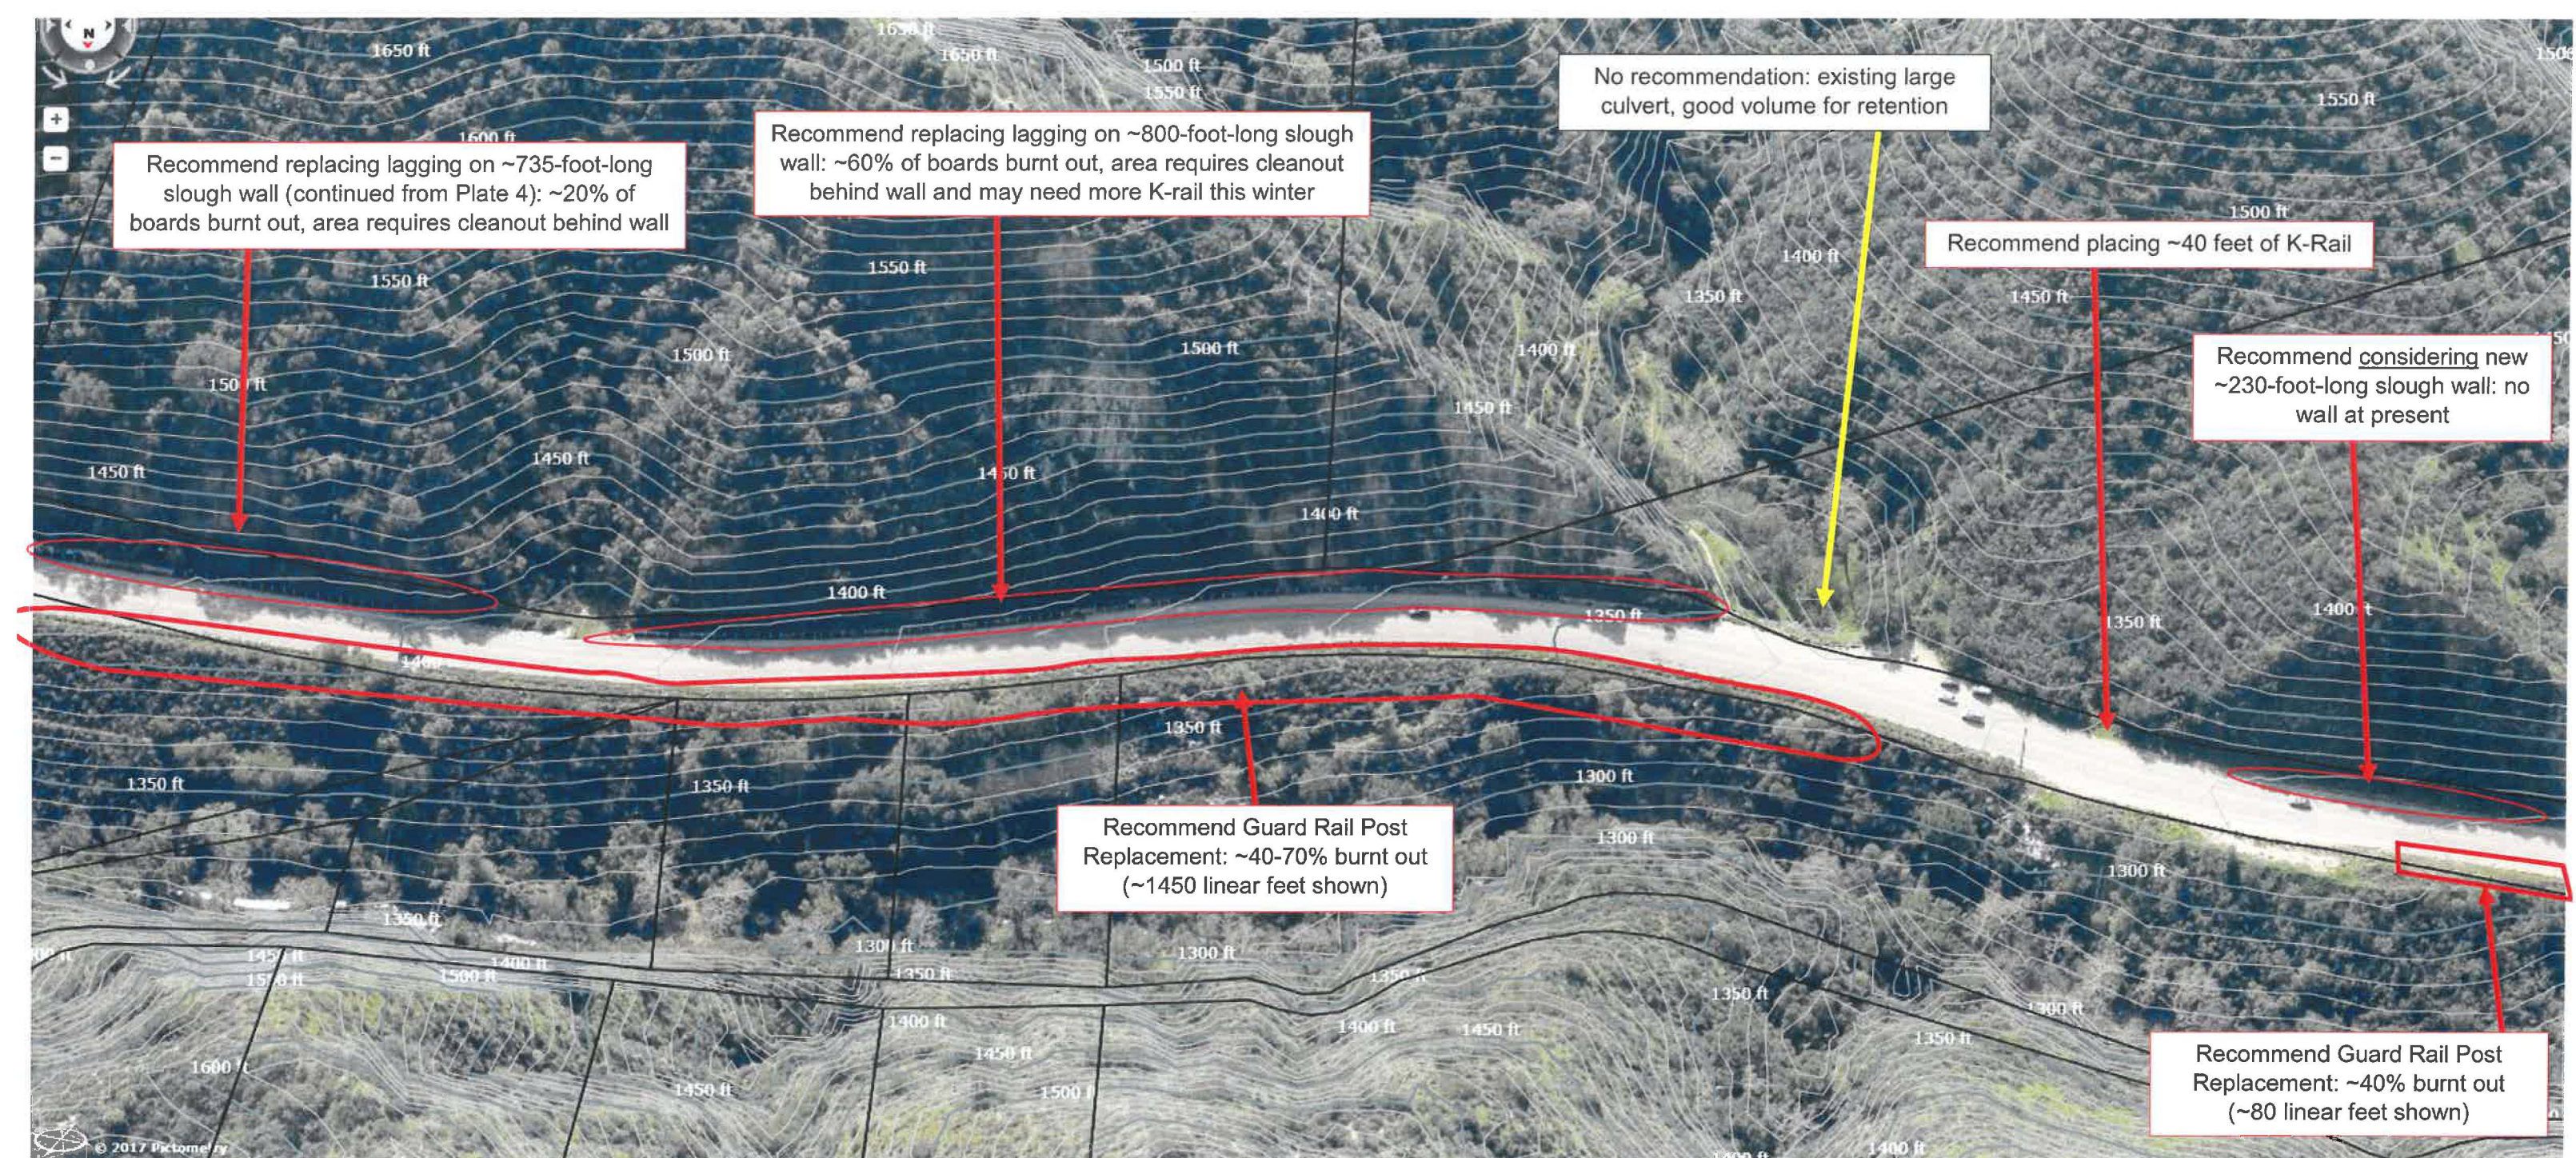
Plate 5: Looking south, ~3800 feet along the roadway west of 7415 La Tuna Canyon Road (on the left side of the photo.) Note the annotations regarding observations and recommendations. Oblique aerial image showing parcel boundaries in solid black lines (Pictometry). Areas with recommendations denoted in red, no action in yellow.
