RE: **LA TUNA FIRE RESPONSE AND RECOVERY SUMMARY REPORT**

BOE La Tuna Fire Burn Area Mitigation – Assessment and Recommendations W.O.
E1908261

SUBJECT: **La Tuna Fire Burn Area Mitigation – Assessment and Recommendations**
W.O. E1908261 **BOE-GED File No. 17-200**

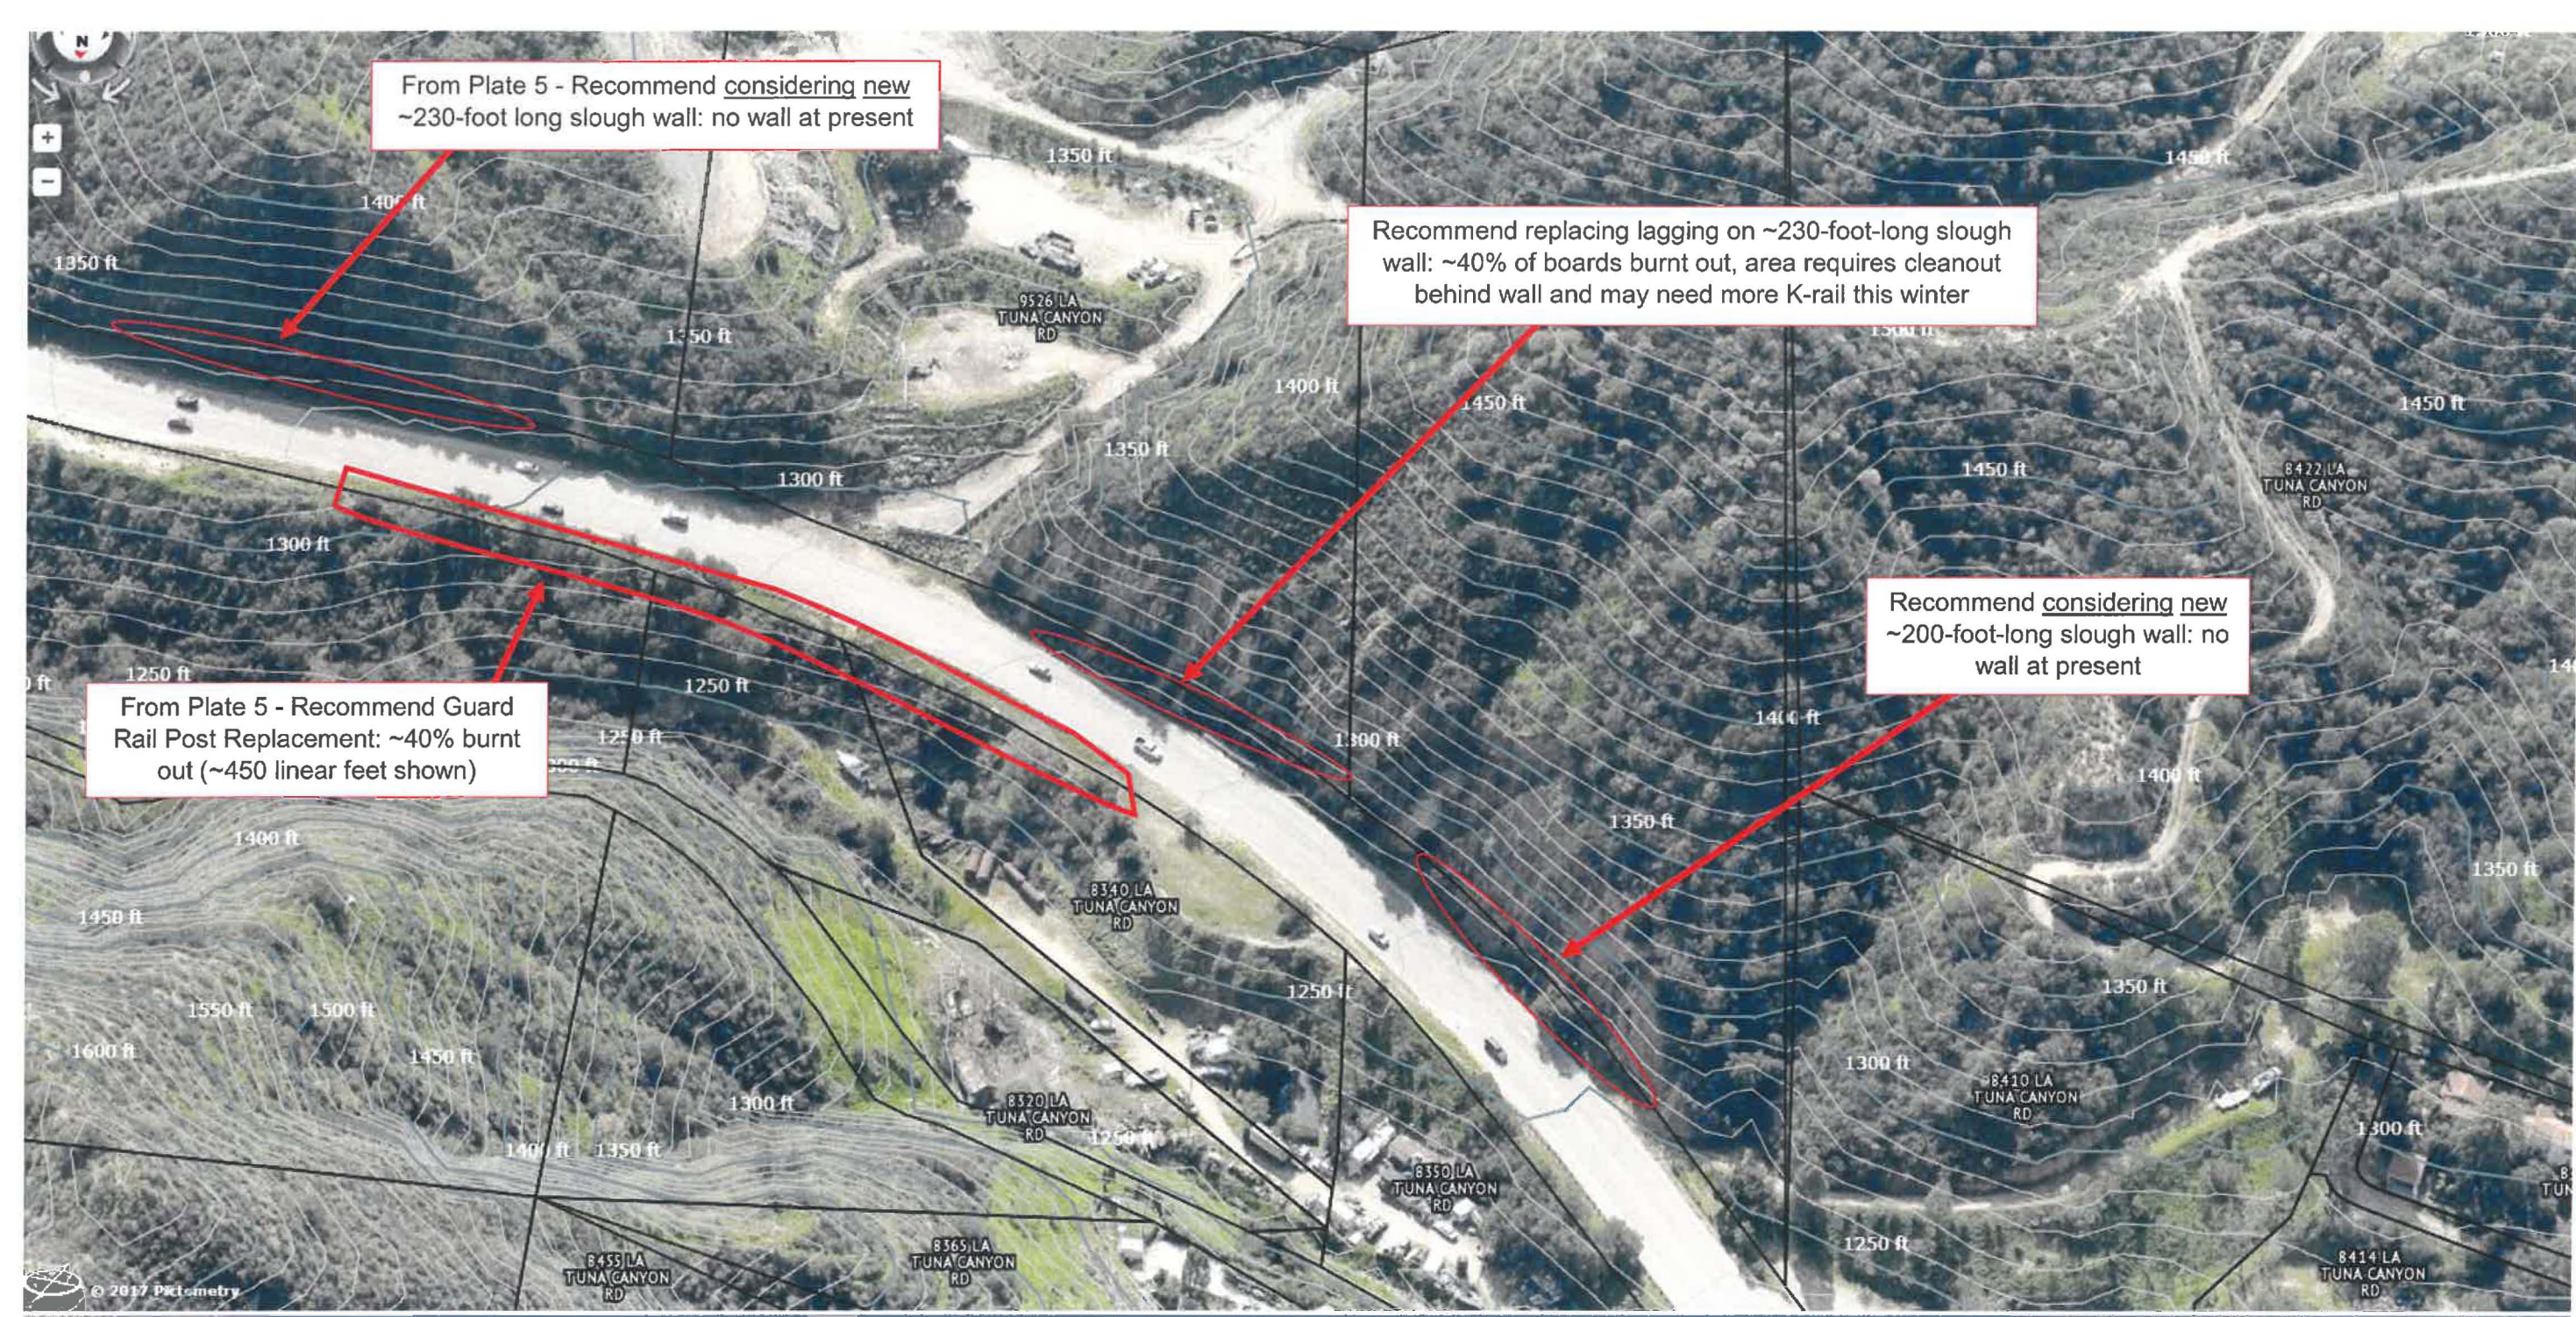
Plate 6: Looking south, ~5300 feet west of 7415 La Tuna Canyon Road (on the left side of the photo.) Note the annotations regarding observations and recommendations. Oblique aerial image showing parcel boundaries in solid black lines (Pictometry). Areas with recommendations denoted in red, no action in yellow.

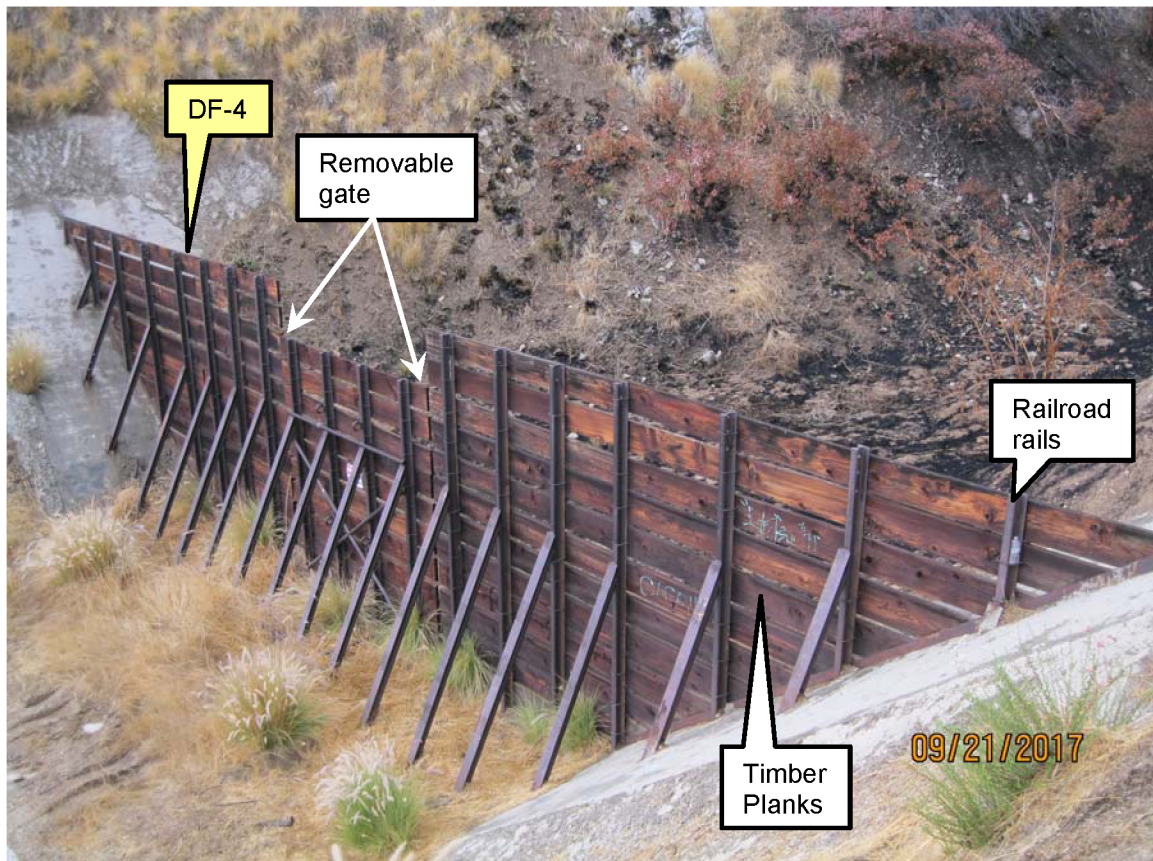
Photo 1: Standing downstream and looking toward DF-4 and the typical debris fence construction consisting of concrete-embedded steel railroad rails and creosote-treated timber planks. Note the vertical spacing between the planks, and the removable gate in the center of the fence.

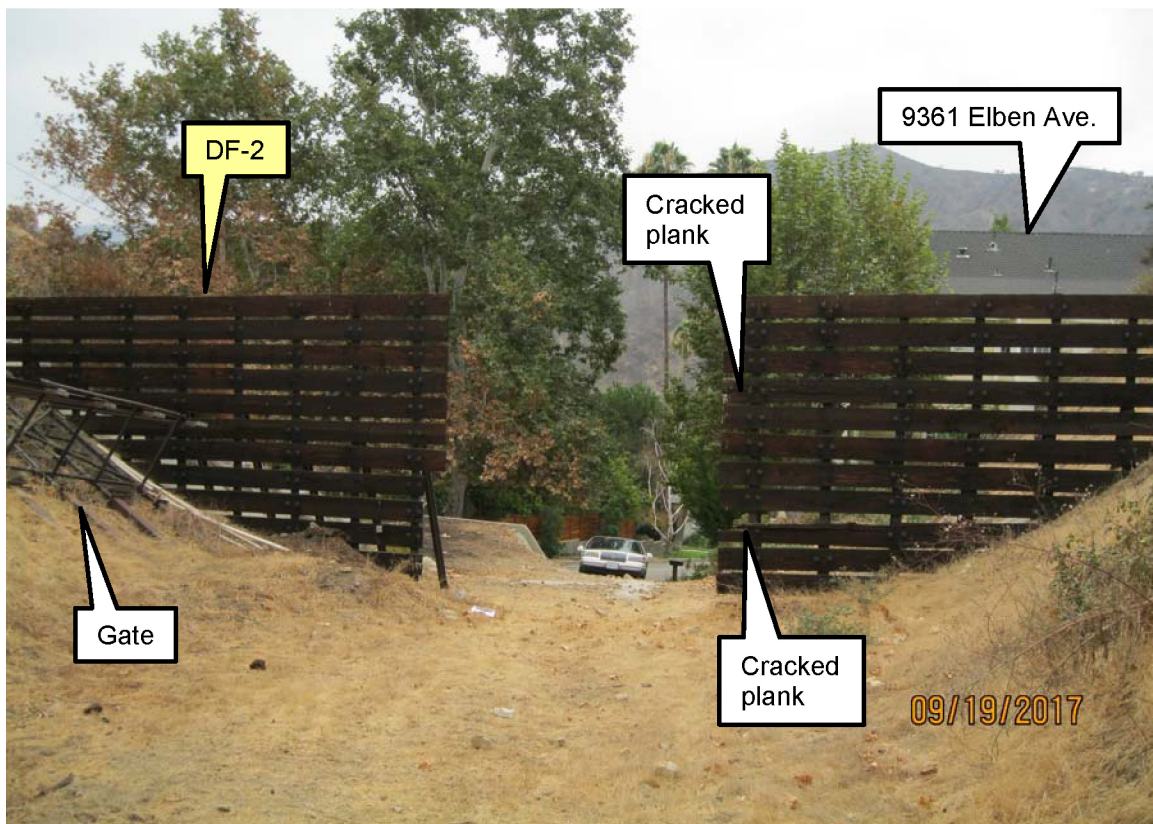
Photo 2: Standing upstream and looking toward DF-2 which is currently open. Note the gate leaning on the slope upstream of the fence. DF-2 was observed in good condition, with no fire damage and only a few cracked planks.

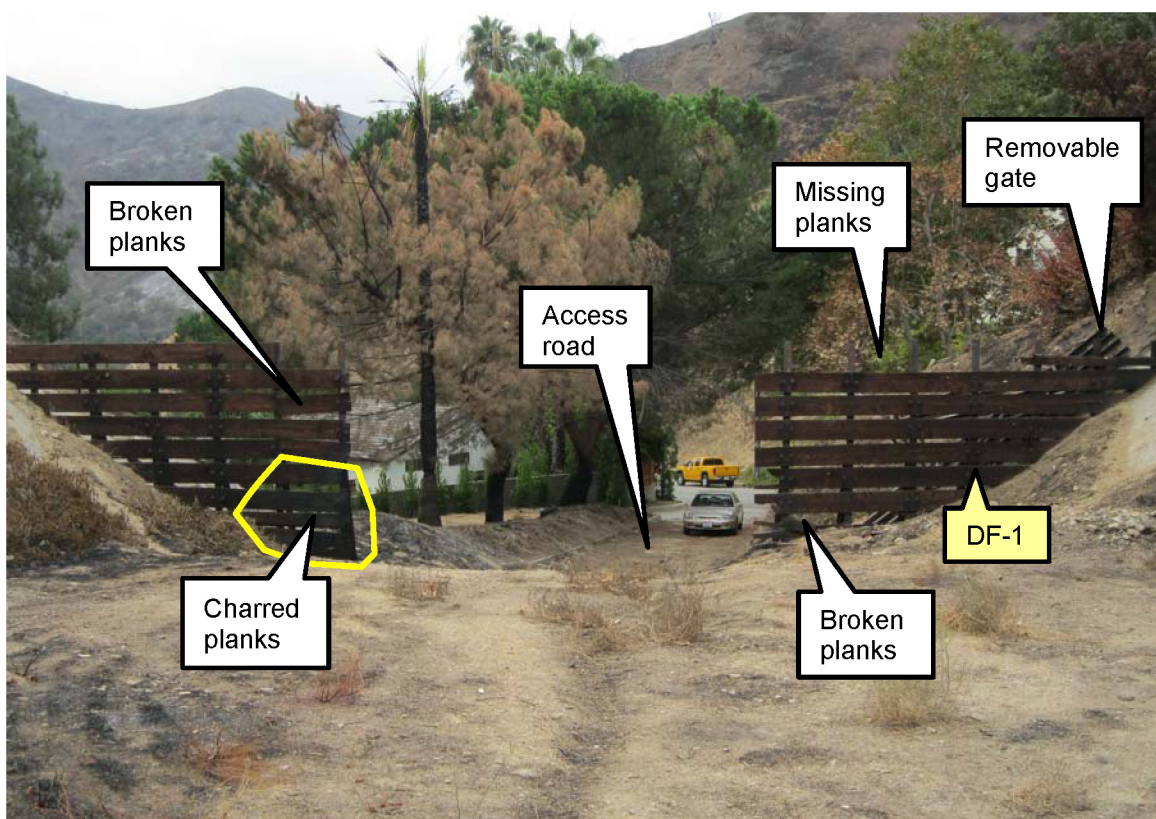
Photo 3: Standing upstream and looking toward DF-1 and the PCC access road downstream. Note the area where the planks are lightly charred, and the areas where planks are broken or missing. Also note the gate which is leaning on the slope, downstream of the fence.

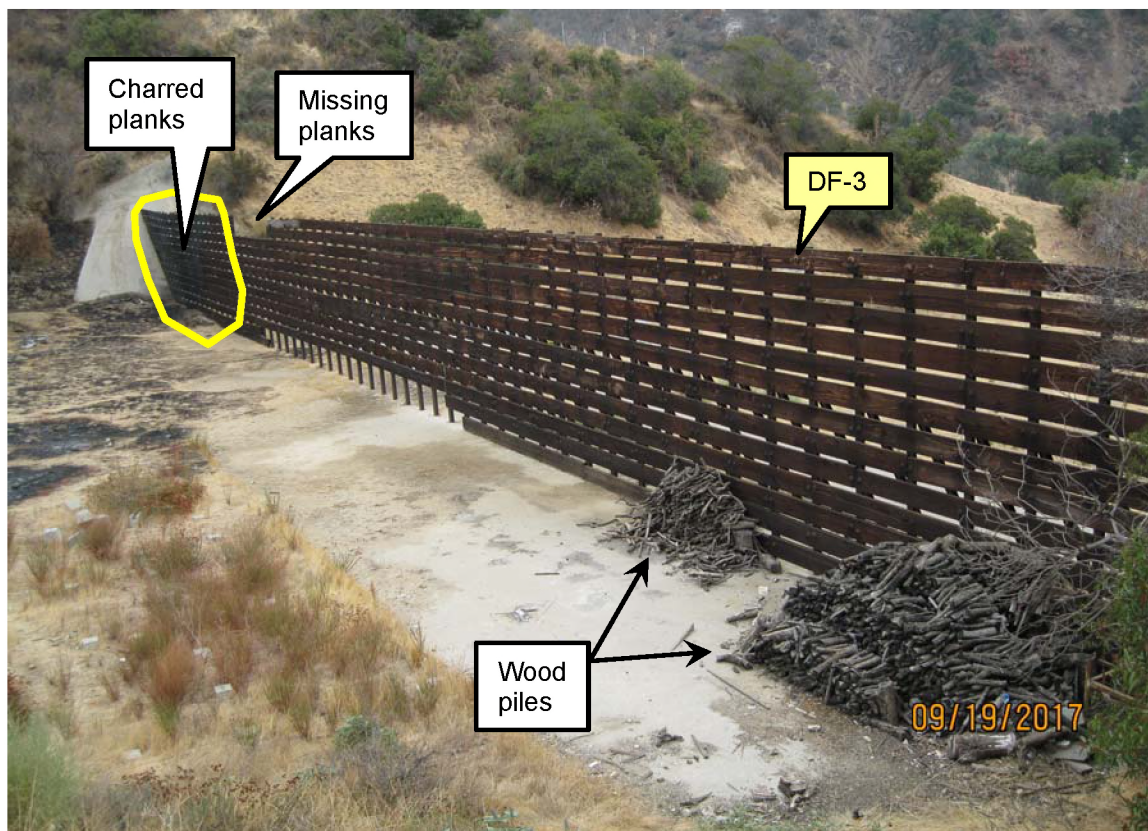
Photo 4: Standing upstream and looking toward DF-3. Note the location of the lightly charred timber planks, the wood piles, and the missing planks near the top of the fence.

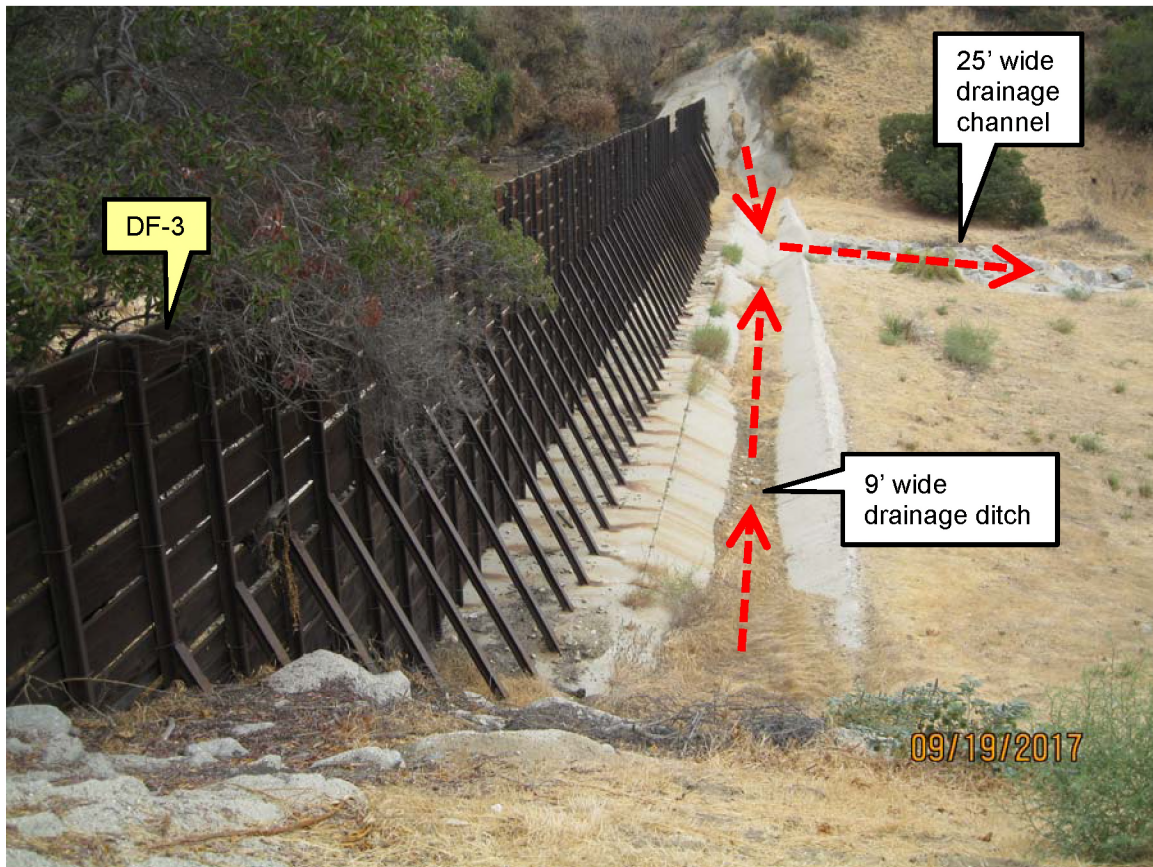
Photo 5: Standing downstream and looking toward DF-3 and the 9-foot wide PCC drainage ditch that is partially filled with sediment. Also note the 25-foot wide drainage channel. The red arrows indicate direction of stormwater flow.
