**PROTECTED TREE REPORT
for
Property
at
2239 Laurel Canyon Blvd.
Los Angeles, CA 90046**

January 11, 2016

Arsen Margossian, Consulting Arborist
Bardez Landscape Services, Inc.
Member, American Society of Consulting Arborists
ISA Certified Arborist # WE-7233A
ISA TRAQ
California Licensed Pest Control Adviser #071429
3512 Rosemary Avenue
Glendale, CA 91208
818 669 6469
arsenm@pacbell.net

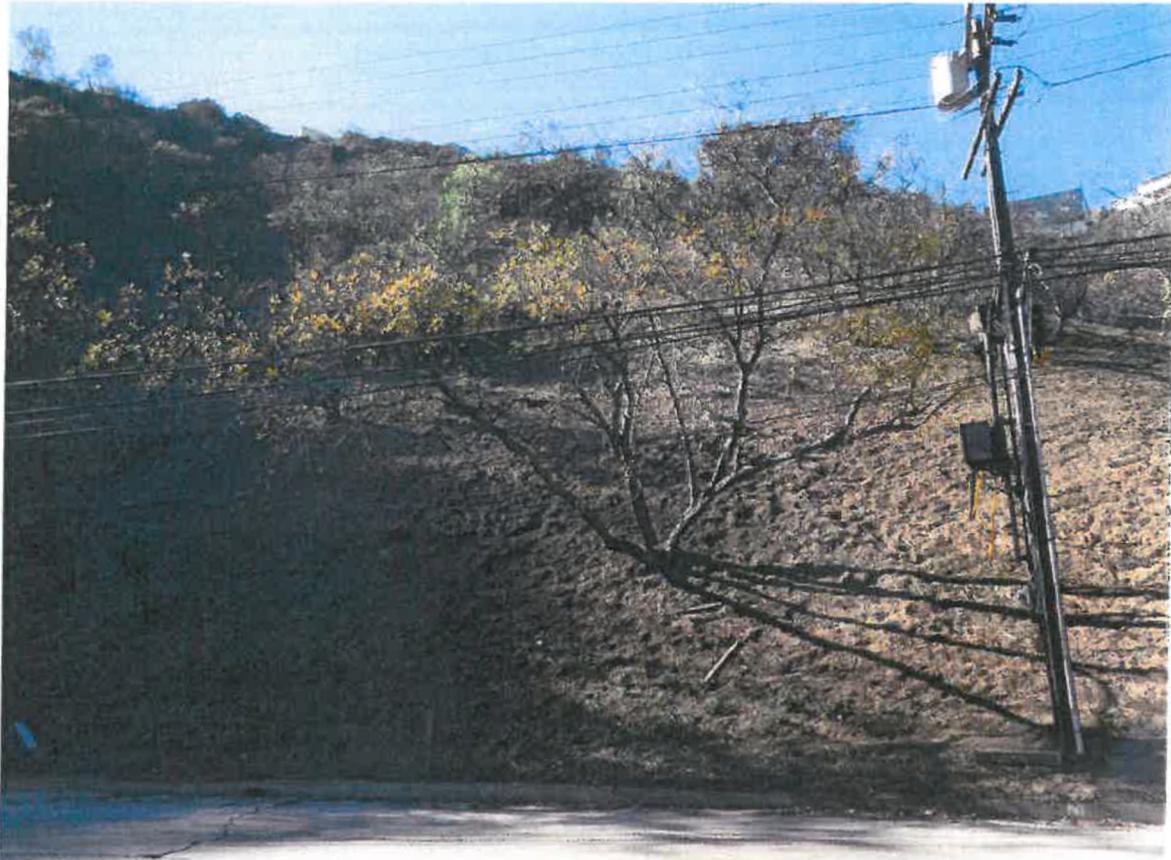
View of the vacant lot as seen from the street.

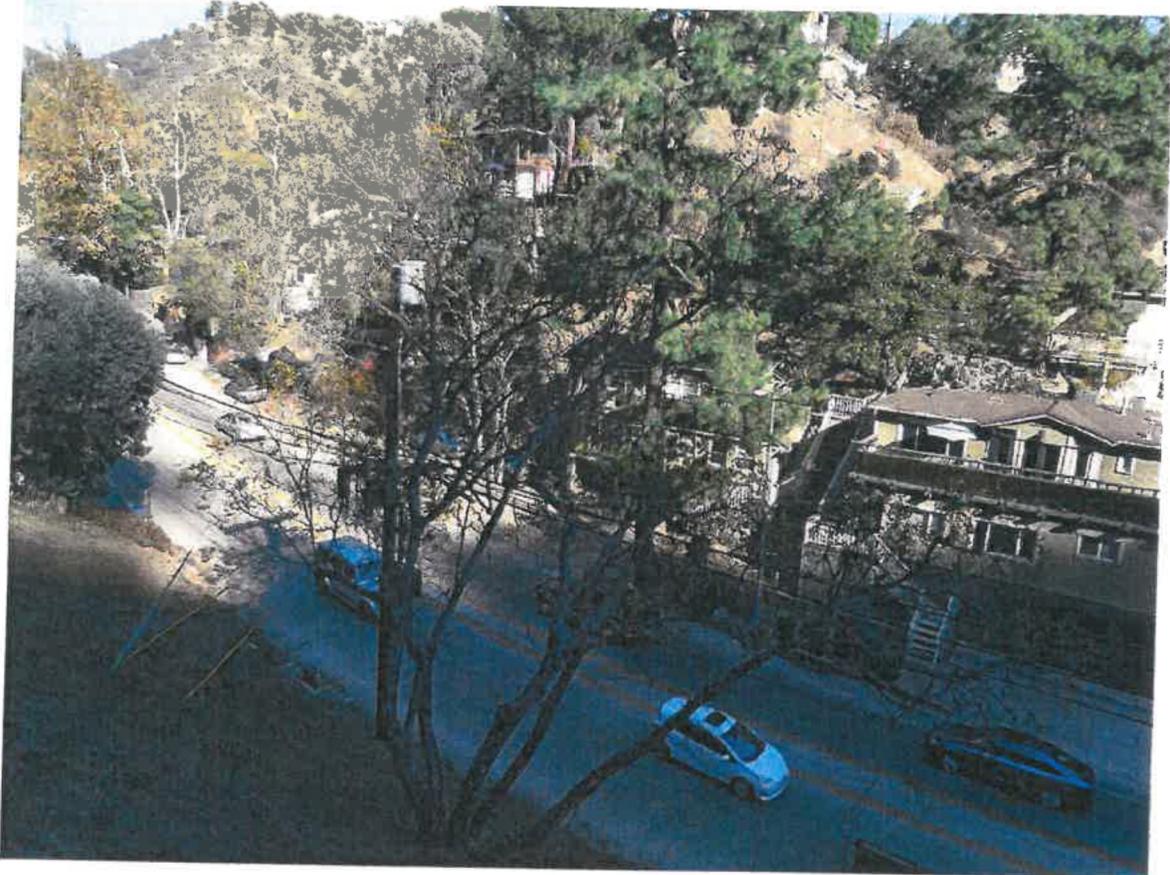
Because these trees are deciduous, very little **foliage** is left on the tree at this time of the year. Accordingly, one cannot determine if the tree has any disease symptoms. However, the tree has substantial **deadwood** and **dieback**, as a result of the recent dry weather and a probable disease, Thousand Cankers disease, caused by a fungus introduced by a beetle when it lays its eggs in the tree branches and trunks.

On a 0 to 5 scale (0 being dead and 5 being excellent), the **condition rating** for this tree is 3 (Average).

Tree #311 as seen from the west side.

Because this tree is located within the **footprint of the proposed dwelling**, it has to be removed.

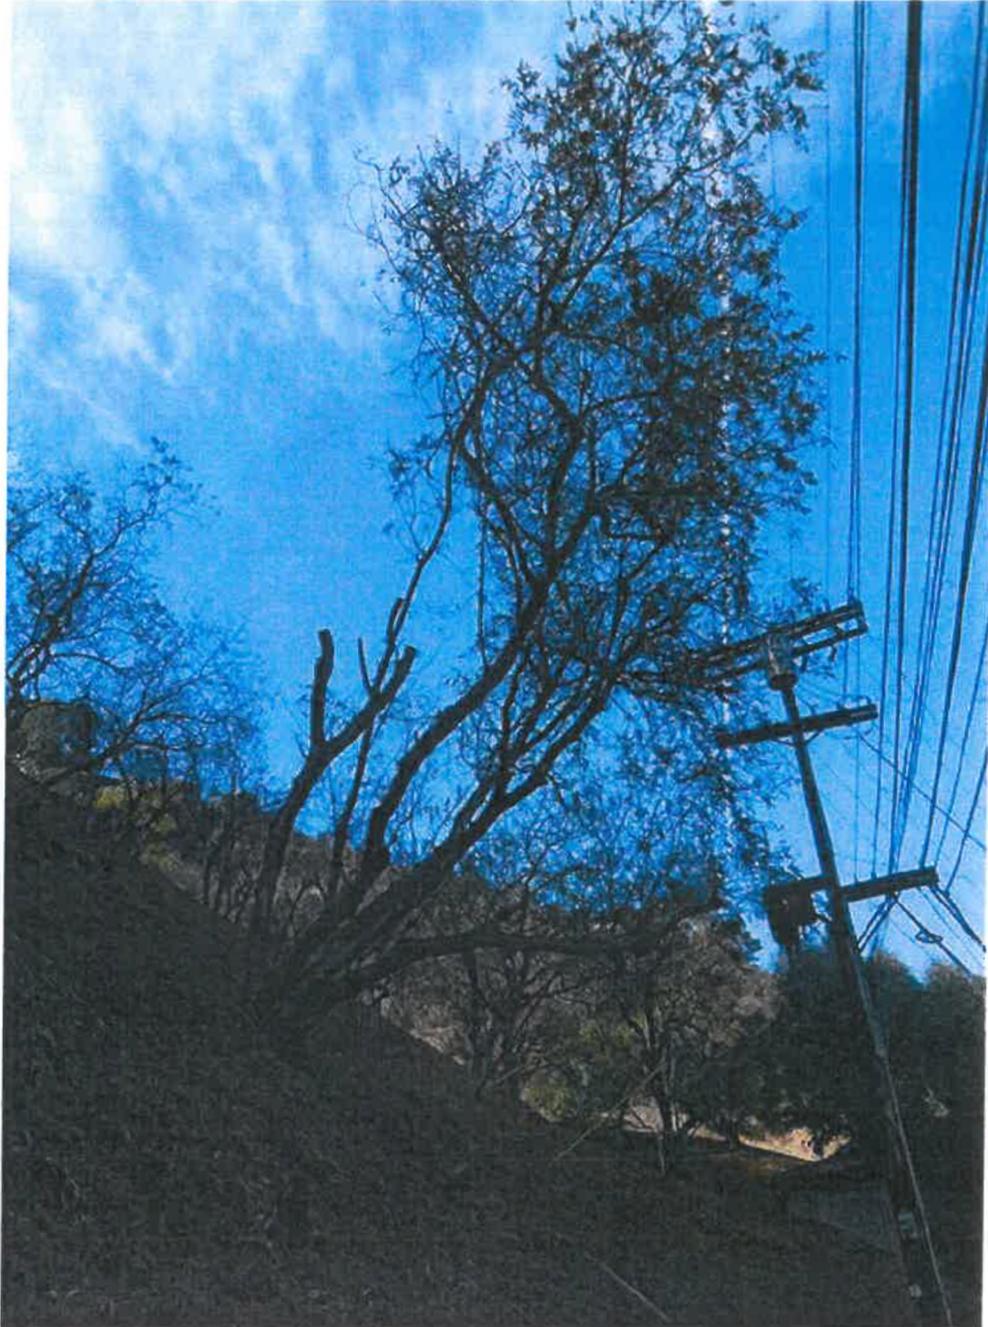
The **canopy** of the tree is unevenly spread, with almost no branches on the uphill side, while the main **scaffold branches** extend downhill almost up to 30 feet.

Tree # 311 as seen from the south side.

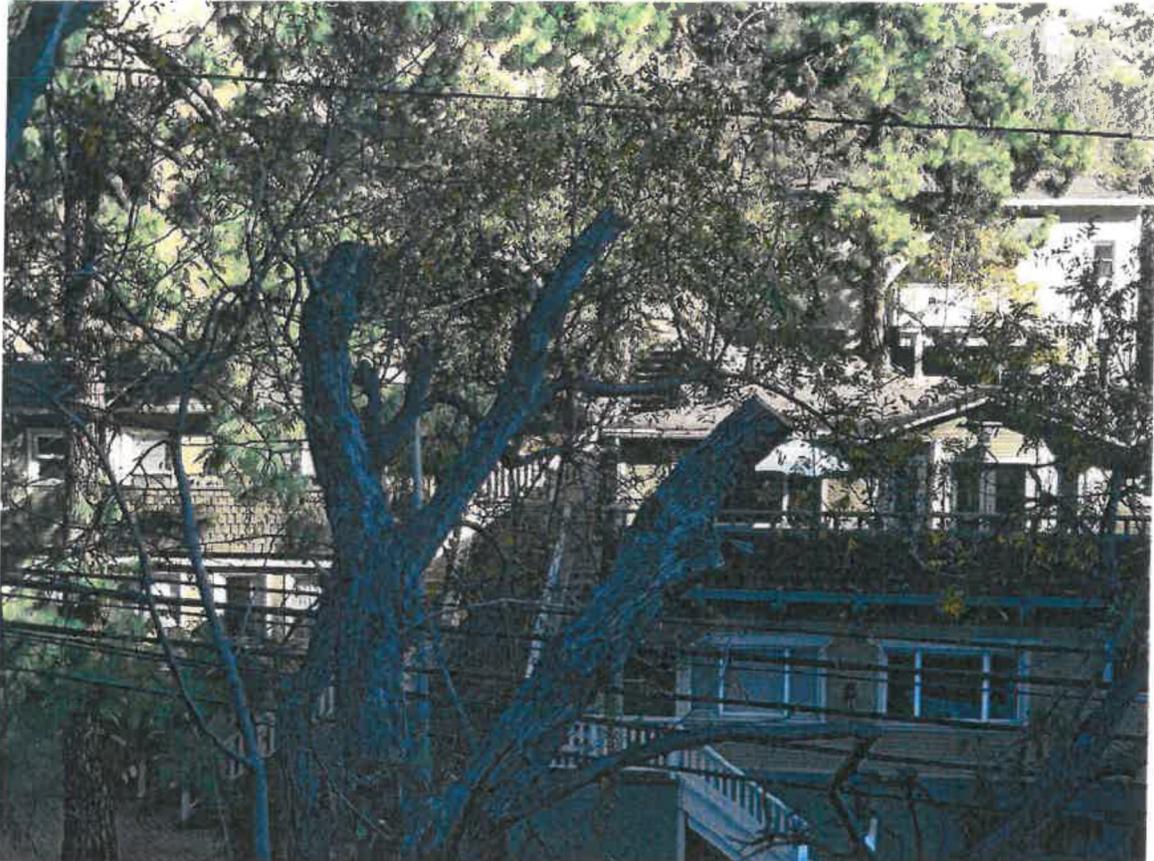
Three of the main scaffold branches have been cut back not long time ago, most probably because of failure.

Cut scaffold branches on Tree #311.

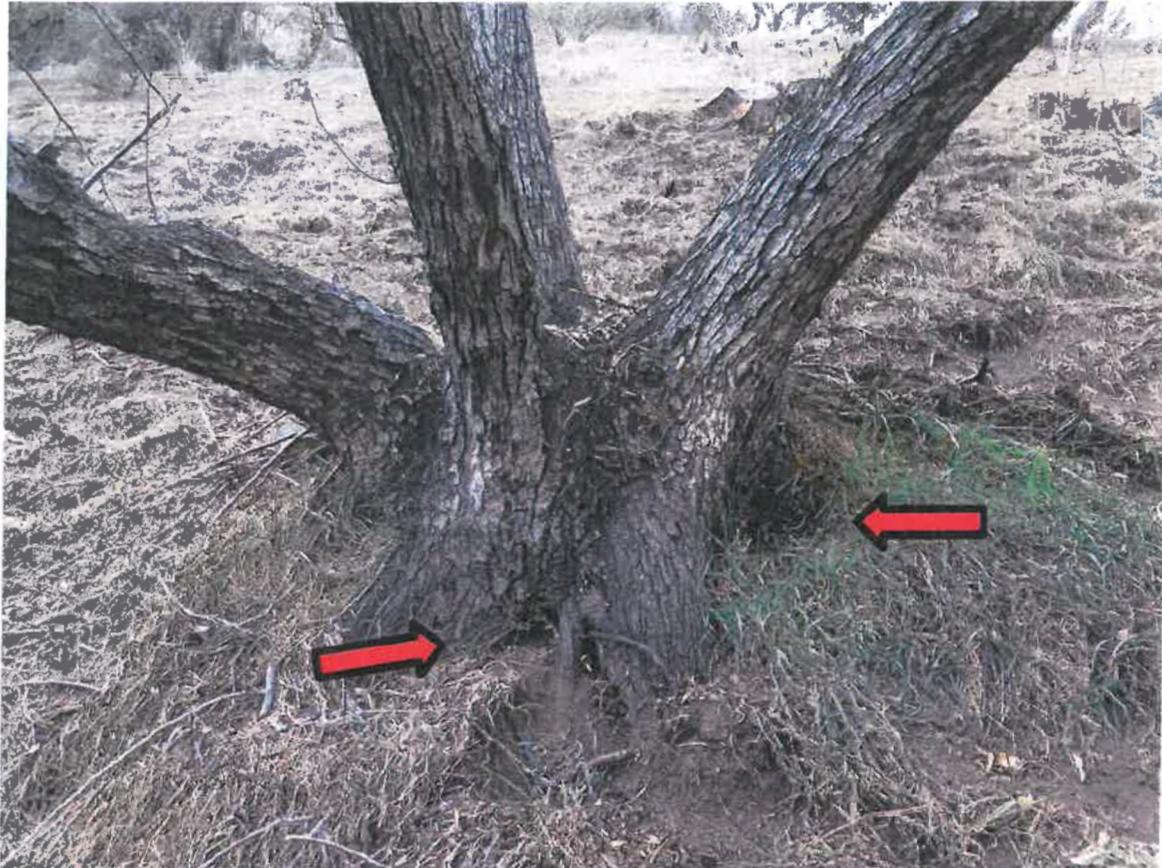
The tree has some visible **buttress roots**, and there are **cavities** at the base of the trunks, most probably due to soil erosion.

Base of Tree #311 trunks. Arrows indicate cavities.

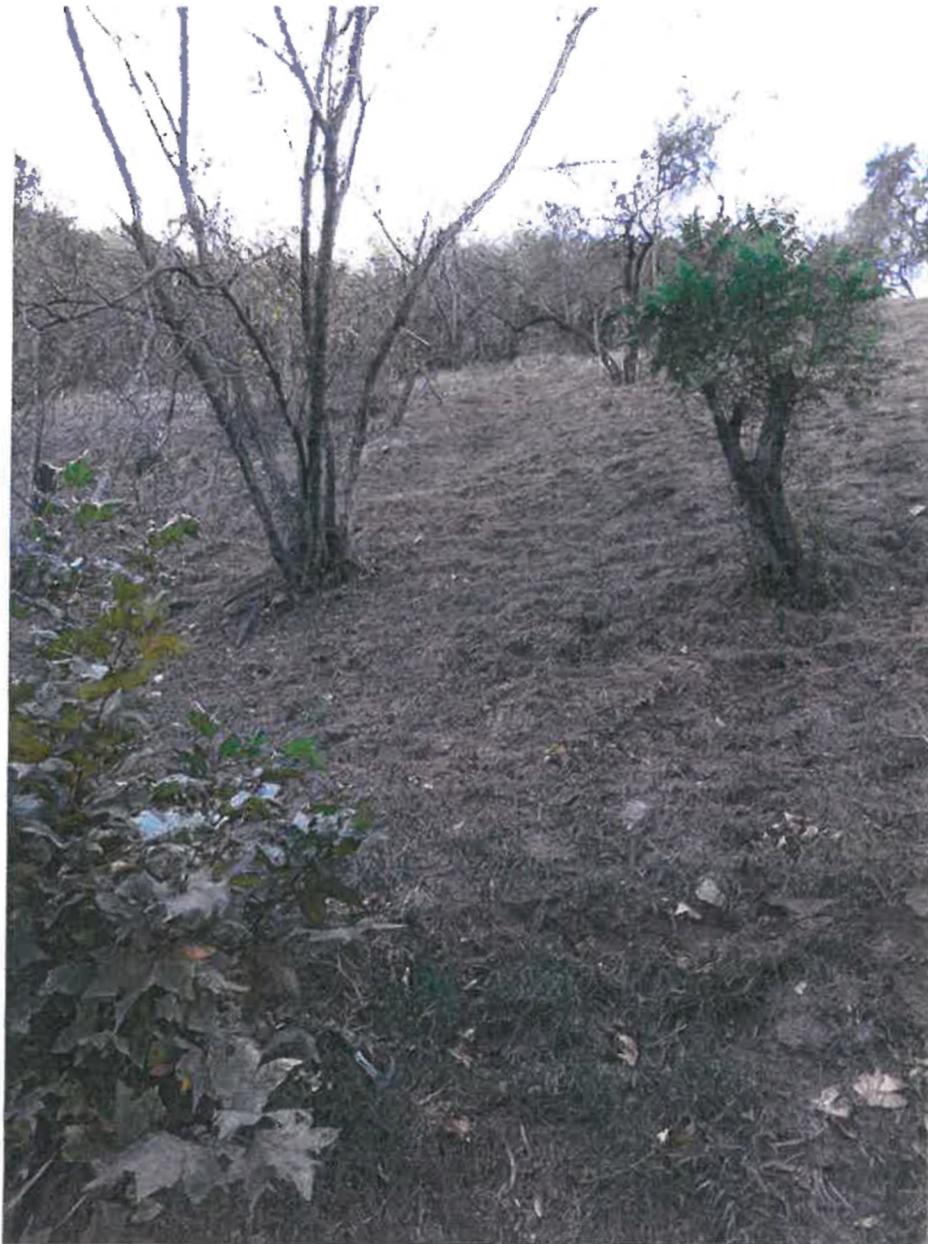
The main trunk has been injured and a vertical cavity has developed almost along the entire length of the main trunk, and as a result, this tree will eventually fail.

On a 0 to 5 scale (0 being dead and 5 being excellent), the condition rating for this tree is 1 (Poor).

Tree #312 (to the right) and off-site tree.

Because this tree is located within the footprint of the proposed dwelling, it has to be removed.

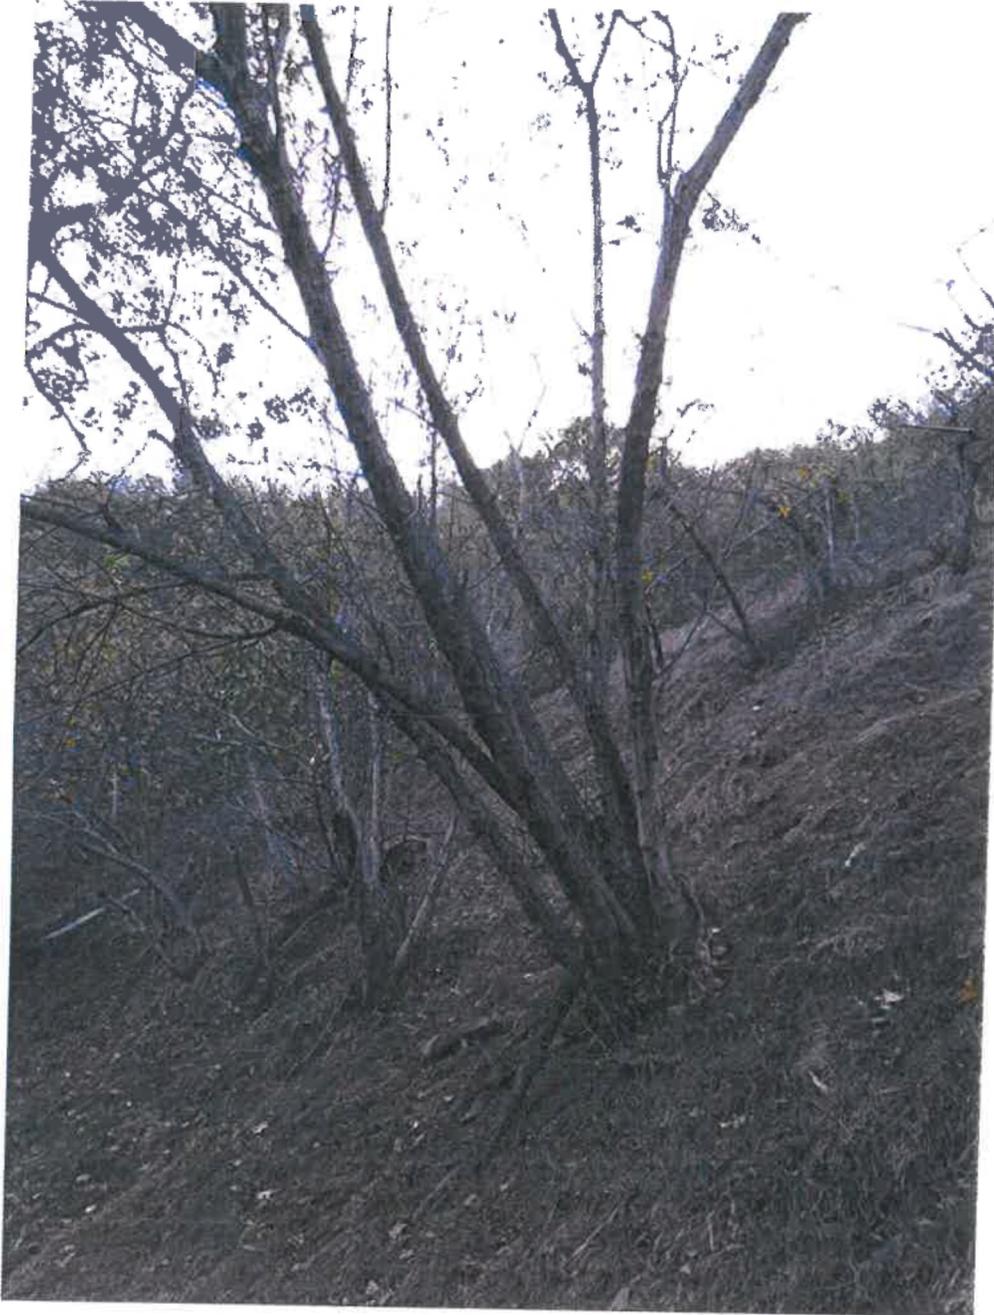
There is one black walnut tree about fifteen feet to the southwest of Tree #12 on the adjacent property. It has seven trunks, each ranging from two to three inches dsh.

The base of the trunks has a cavity and an eight trunk has already failed.

Off-site tree.

Because of its size and its location, it shouldn't be impacted by the construction activity. However, attention should be paid so that the tree is preserved in place.
