Re: Board File 170118  
10830 Chalon Road, Bel Air  
Appeal of Building Permits  
*Hearing date: March 6, 2018; Agenda Item 10*

**Re: 10830 Chalon Road**

# Exhibit B

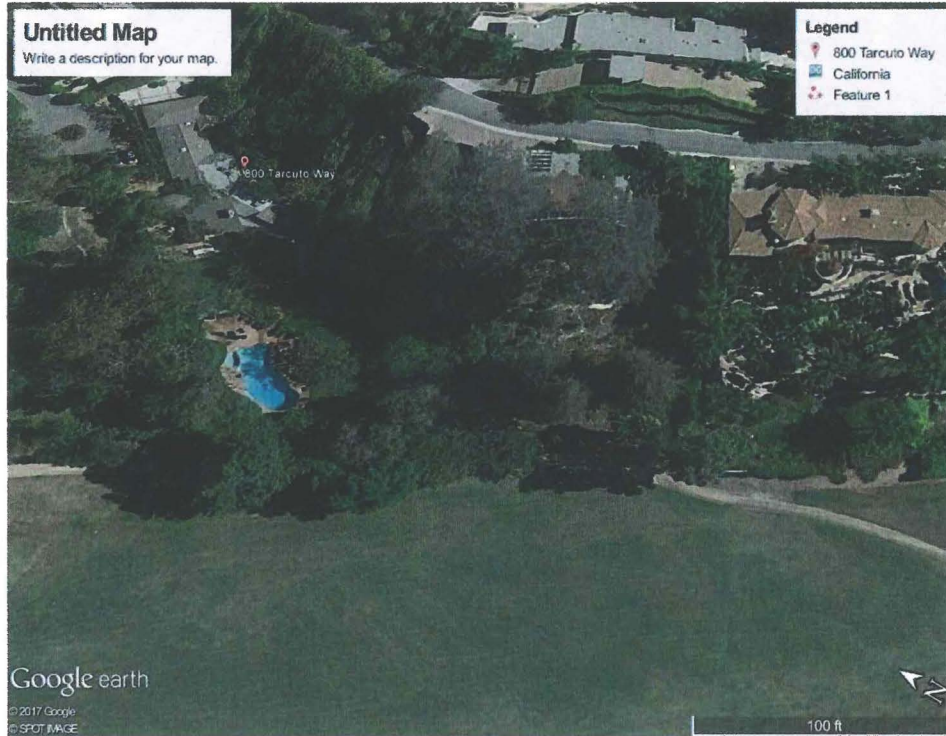
- There were two large trees laying on the side of the hill that measured approximately 3 feet in diameter. Based on early photographs of these trees, I would estimate them to be at least 100 feet tall. The calculated volume of these trees would produce approximately 56 cubic yards of material.**
- I observed 8 trees with cumulative diameter of 2 feet and approximately 70 feet tall, which would produce approximately 92 cubic yards of material.**

**Photograph 1:** Oblique aerial view of the Property, showing the dense vegetation and two large Canary Island pines, prior to their felling.

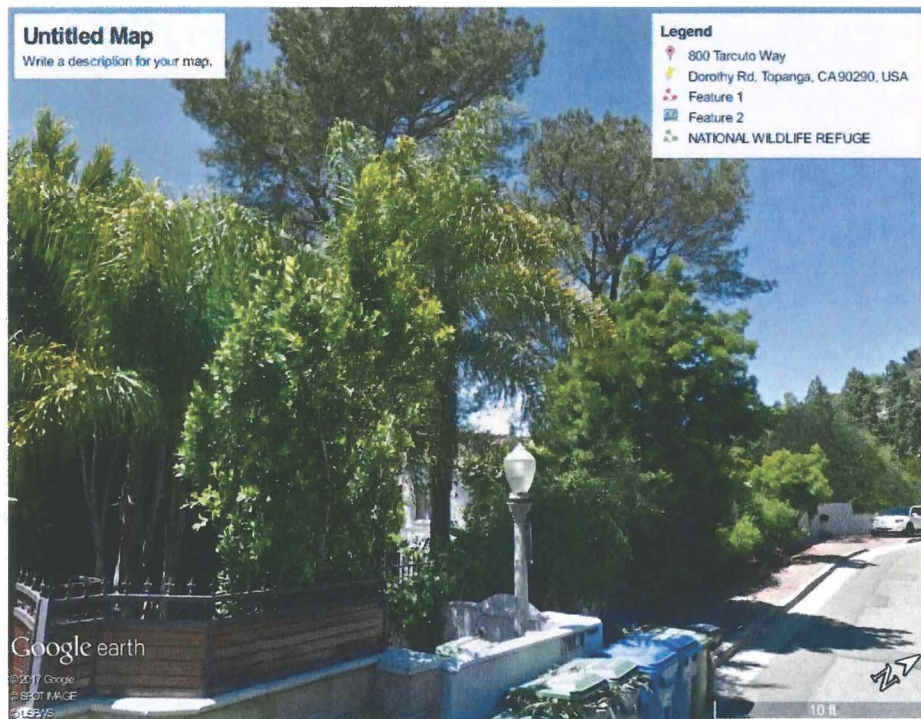
**Photograph 2:** Alternate view of the large Canary Island Pine trees.

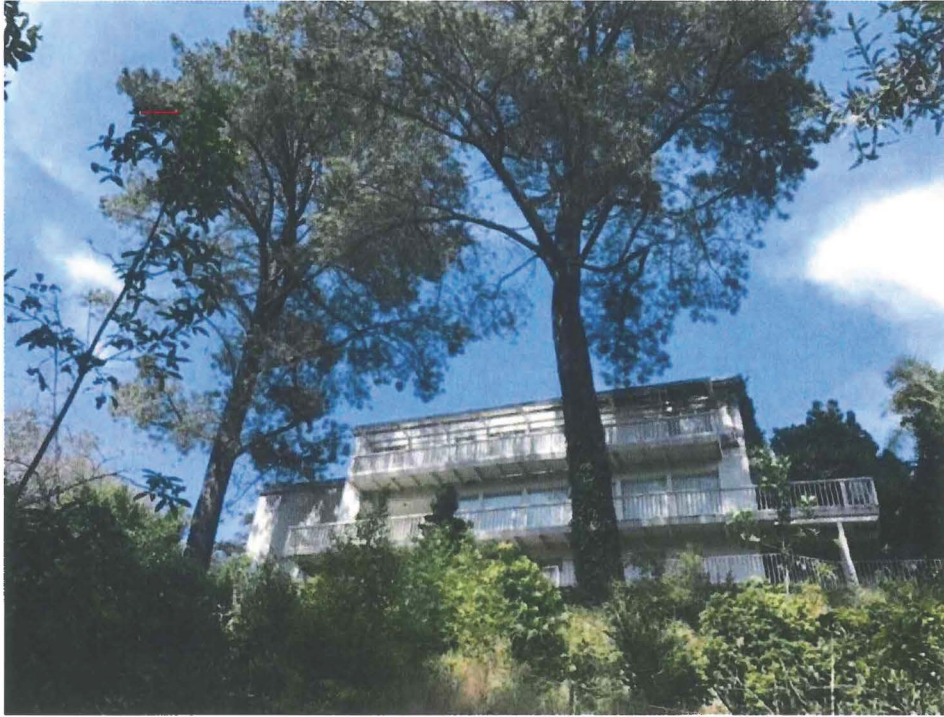
**Photograph 3:** Alternate view of the large Canary Island Pine trees, prior to felling.

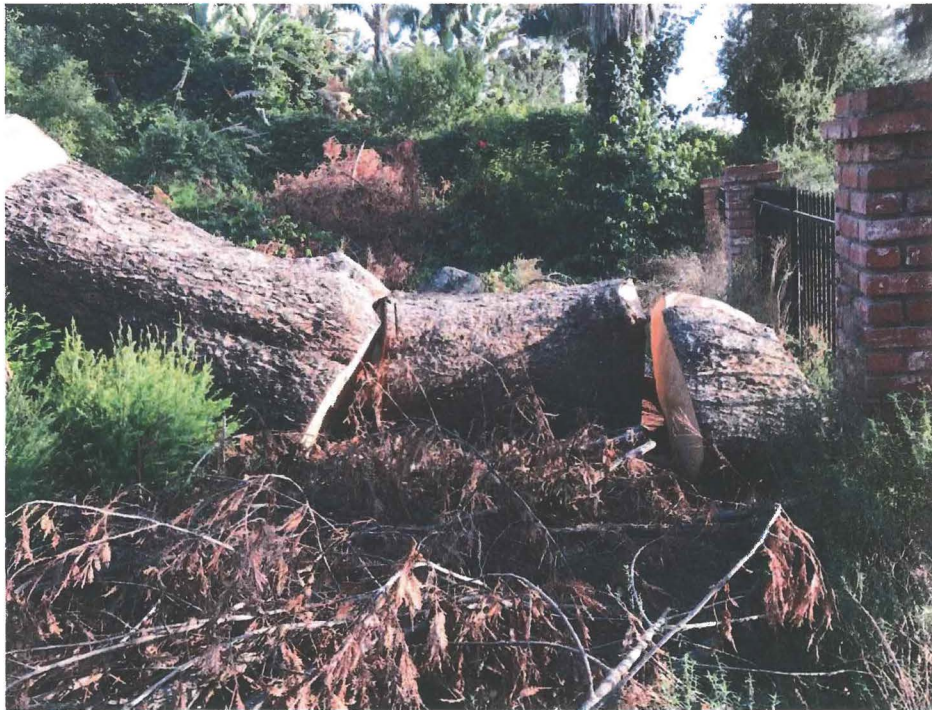
**Photograph 4:** Close-up of one of Canary Island pines after felling. Note the diameter of the trunk relative to the fence height.

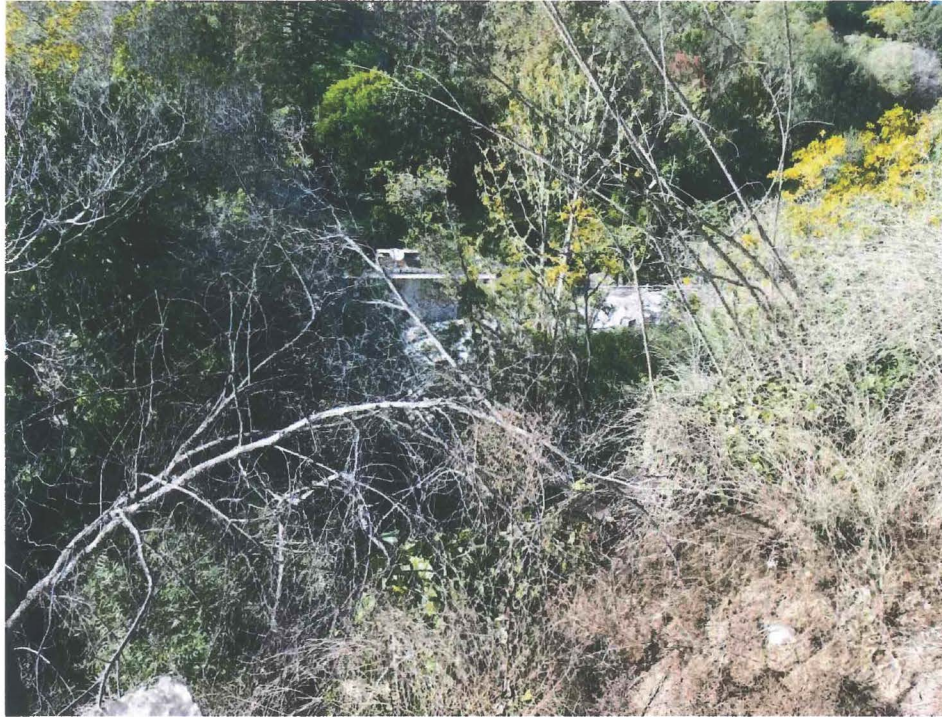
- I observed 15 smaller trees with a cumulative diameter of 1 foot, approximately 50 feet tall which would produce approximately 87 cubic yards of material.
- The property is over 23,000 square feet and contains a home with a relatively small footprint. Conservatively I would say there is at least 10,000 square feet of thick brush and smaller trees in addition to the above. If this brush and smaller trees were ground it would add approximately 6 inches of similar material over the 10,000 square feet, which would equal 185 cubic yards of material.
- This would be the total of brush and similar material of 420 cubic yards.

**Photograph 5:** Other trees and dense vegetation on the Property, all of which will require removal and hauling.

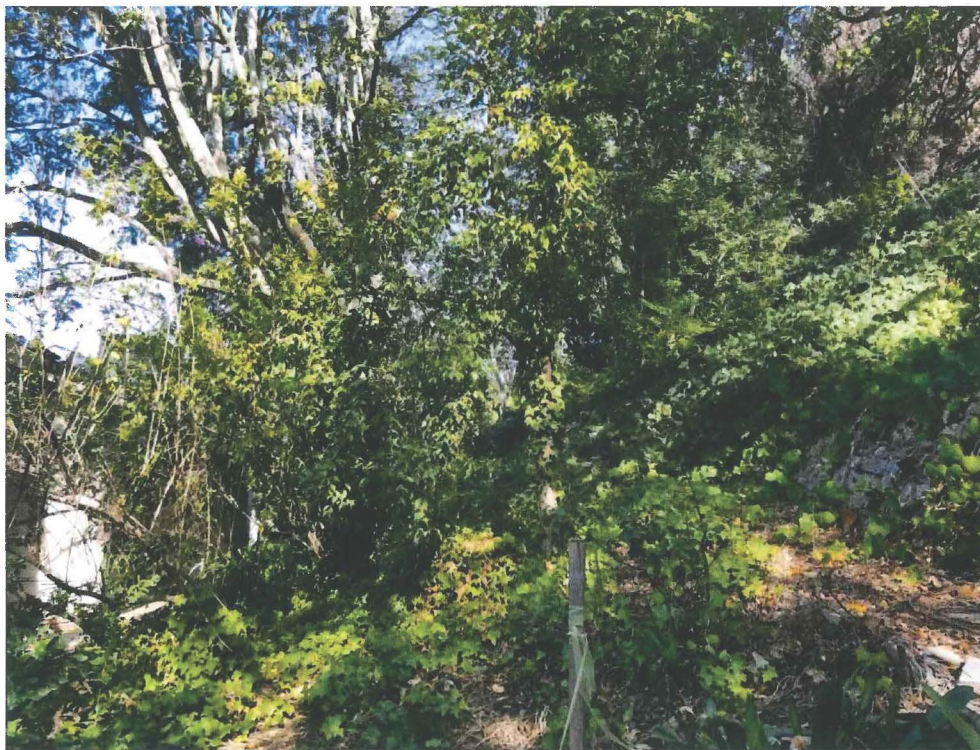
**Photograph 6:** Dense vegetation, brush, and one of the garden walls on the Property, all of which will require removal and hauling.

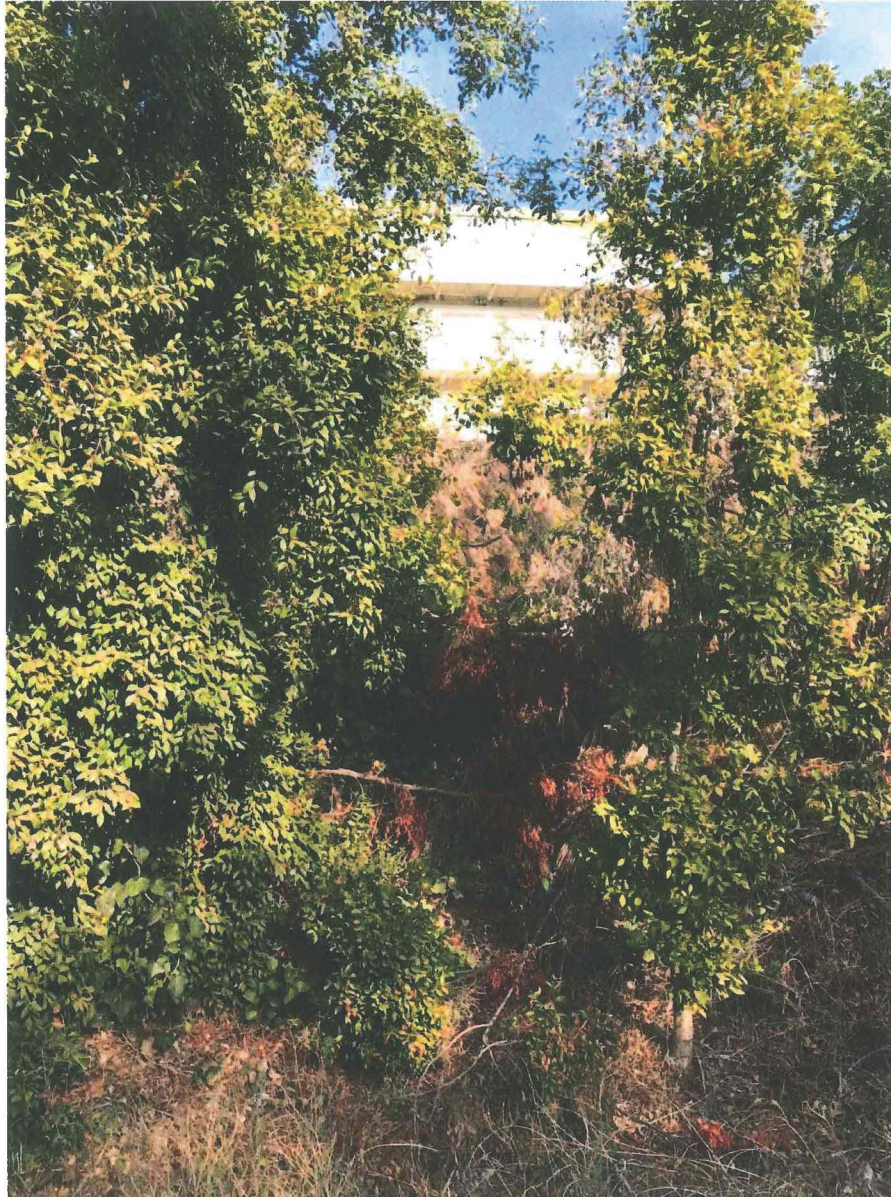
**Photograph 7:** Dense vegetation on the Property, all of which will require removal and hauling.
