**Re: Partial Appeal of VTT-74478-1A and CPC-2016-3174-ZC (ENV 2016-3175-MND)
Council File 19-0870-S1**

SUMMARY	3
ASSIGNMENT	4
LIMIT OF ASSIGNMENT	4
TREE CHARACTERISTICS AND SITE CONDITIONS	4
IMPACT ANALYSIS AND SPECIFIC RECOMMENDATIONS	5
APPENDIX A –TREE LOCATION MAP	7
APPENDIX B - PHOTOGRAPHS	8
APPENDIX C – SUMMARY OF FIELD INSPECTION	19
APPENDIX D – SUMMARY OF DATA	23
GENERAL RECOMMENDATIONS	24
WORKING WITHIN THE PROTECTED ZONE	24
PLANTING WITHIN THE PROTECTED ZONE	26
NEW TREE PLANTING	27
TREE MAINTENANCE AND PRUNING	29
DISEASES AND INSECTS	31
GRADE CHANGES	31
INSPECTION	31
THE TREE RESOURCE - LISA SMITH - BIO	32
ASSUMPTIONS AND LIMITING CONDITIONS	33

APPENDIX B - PHOTOGRAPHS

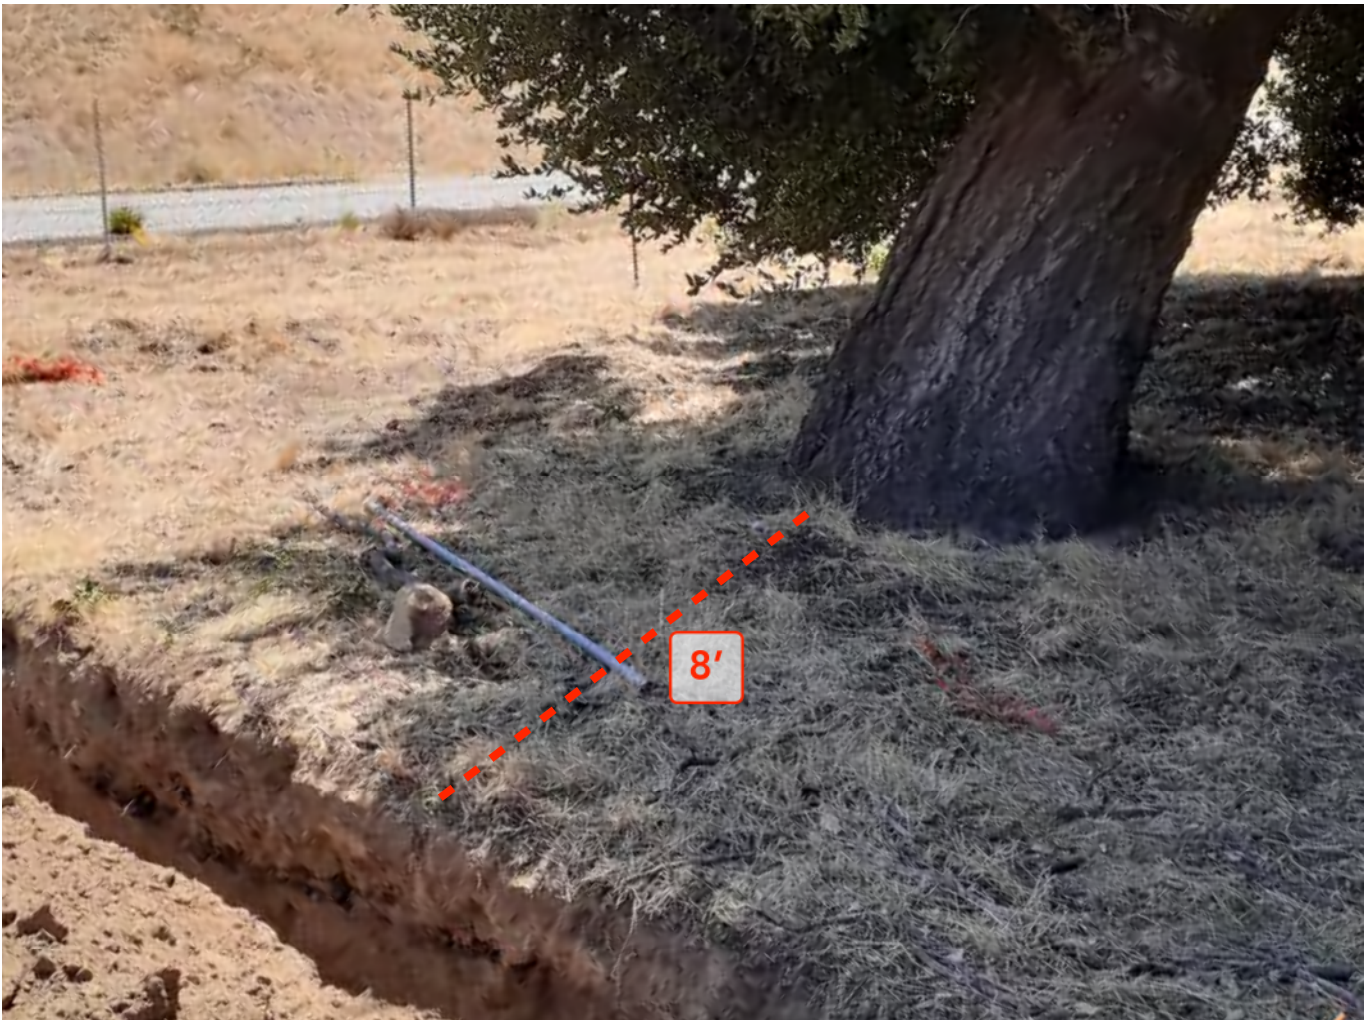
Coast Live Oak (*Quercus agrifolia*) #3: This tree was originally recommended for removal because it lies within a close distance to the proposed house on Lot 9. The concern for this tree was mainly root impact. Because this tree has a 36 inch DBH, industry standards recommend that encroachment stay 9 to 15 feet away from the trunk. In this case, the tree is greater than 9 feet from the proposed construction, and creative solutions, including exploratory trenching, have been utilized to optimize this tree's health. Exploratory trenching revealed only one 2-inch root 8 feet away from the trunk, closer than the edge of impact.

The sump will be the protected (ungraded) area around the tree and will have 2:1 slopes surrounding it, up to the proposed grade. There will be a portion of a deepened footing along the northern edge of the sump exposed as well. Grading will be set back more than 9 feet from the trunk, and the building foundation will be set back 11.4 feet from the trunk. In areas around the tree where extra grading room is available, the grading setback will be at least 15 feet from the trunk. Seeing as these distances fall within industry standard, and only one 2-inch root has been found 8 feet away from the trunk, this tree can be retained.

PHOTO 1 - Exploratory trenching was recently performed 8 feet away from oak tree #3 to evaluate impact at the edge of the building footprint. Trenching revealed minimal roots at this distance, suggesting that construction and root pruning may occur in this area without significantly impacting the tree. All encroachment will occur over 9 feet away from oak tree #3. This tree will remain protected in place throughout construction with protective fencing.

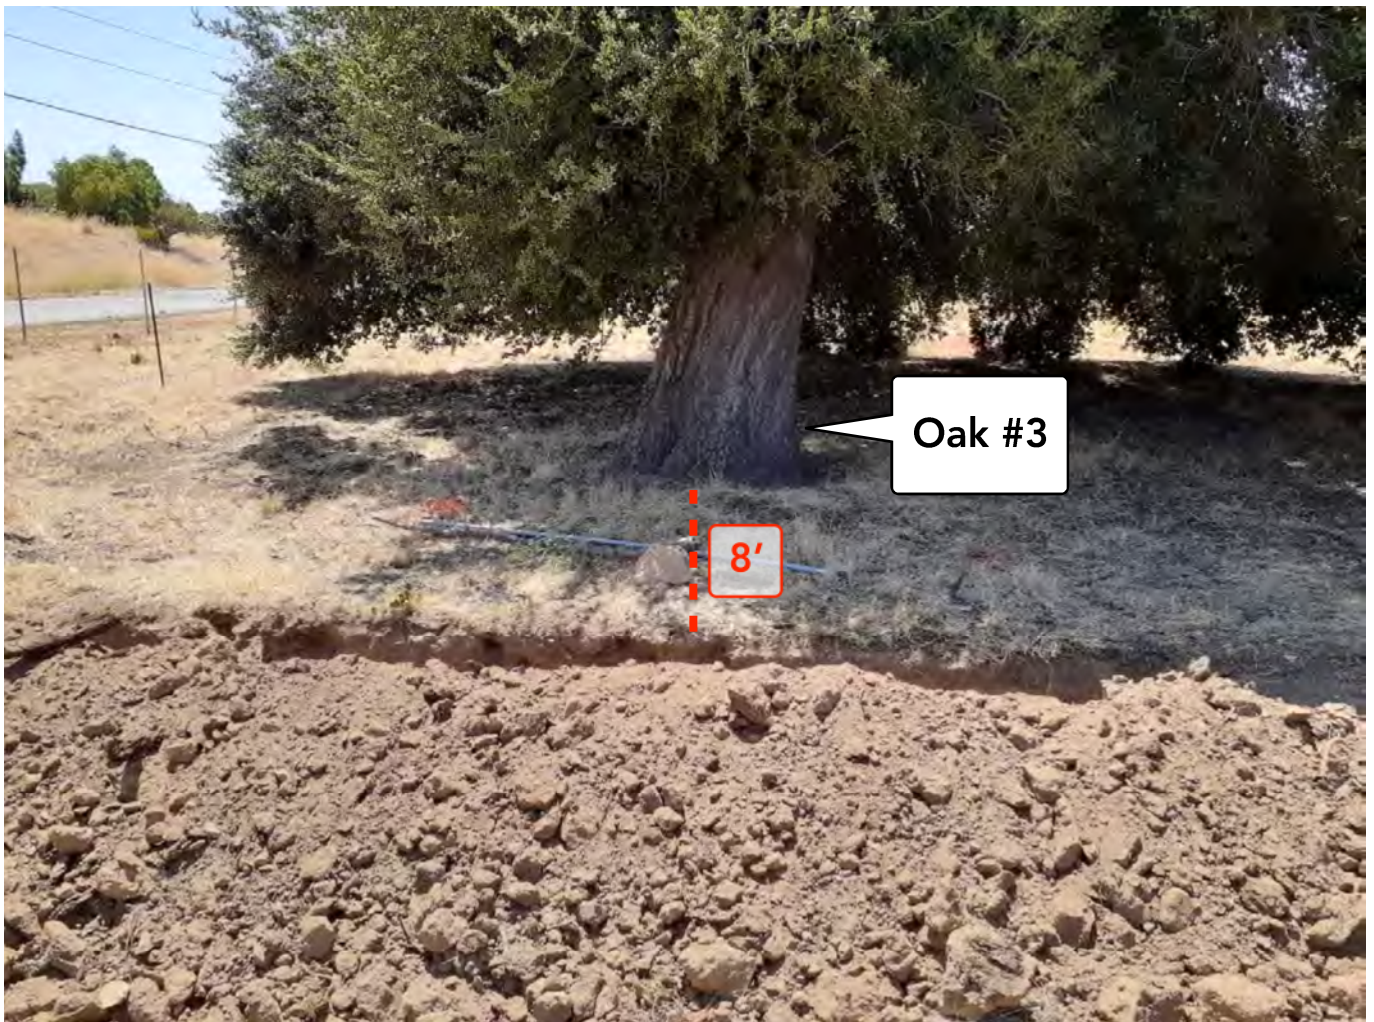
PHOTO 2 - Shows a frontal view of trenching in front of oak #3.

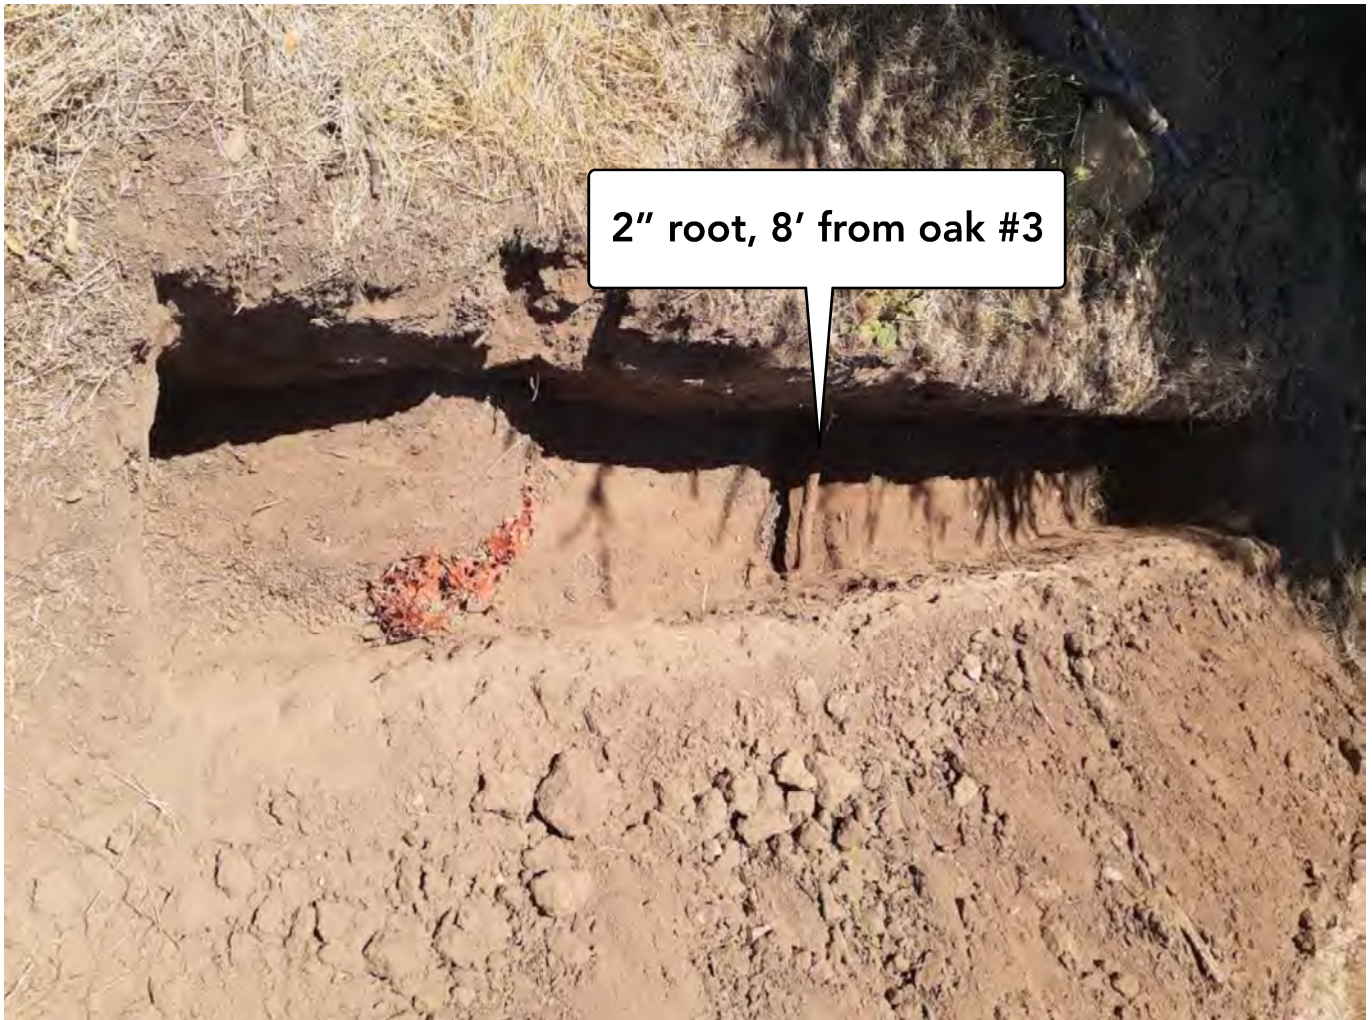
PHOTO 3 - Shows that only one relatively prominent root and very few roots in general were discovered 8 feet away from the trunk of oak tree #3 in this trench. This tree will be minimally impacted by the proposed construction in this area and will be retained.

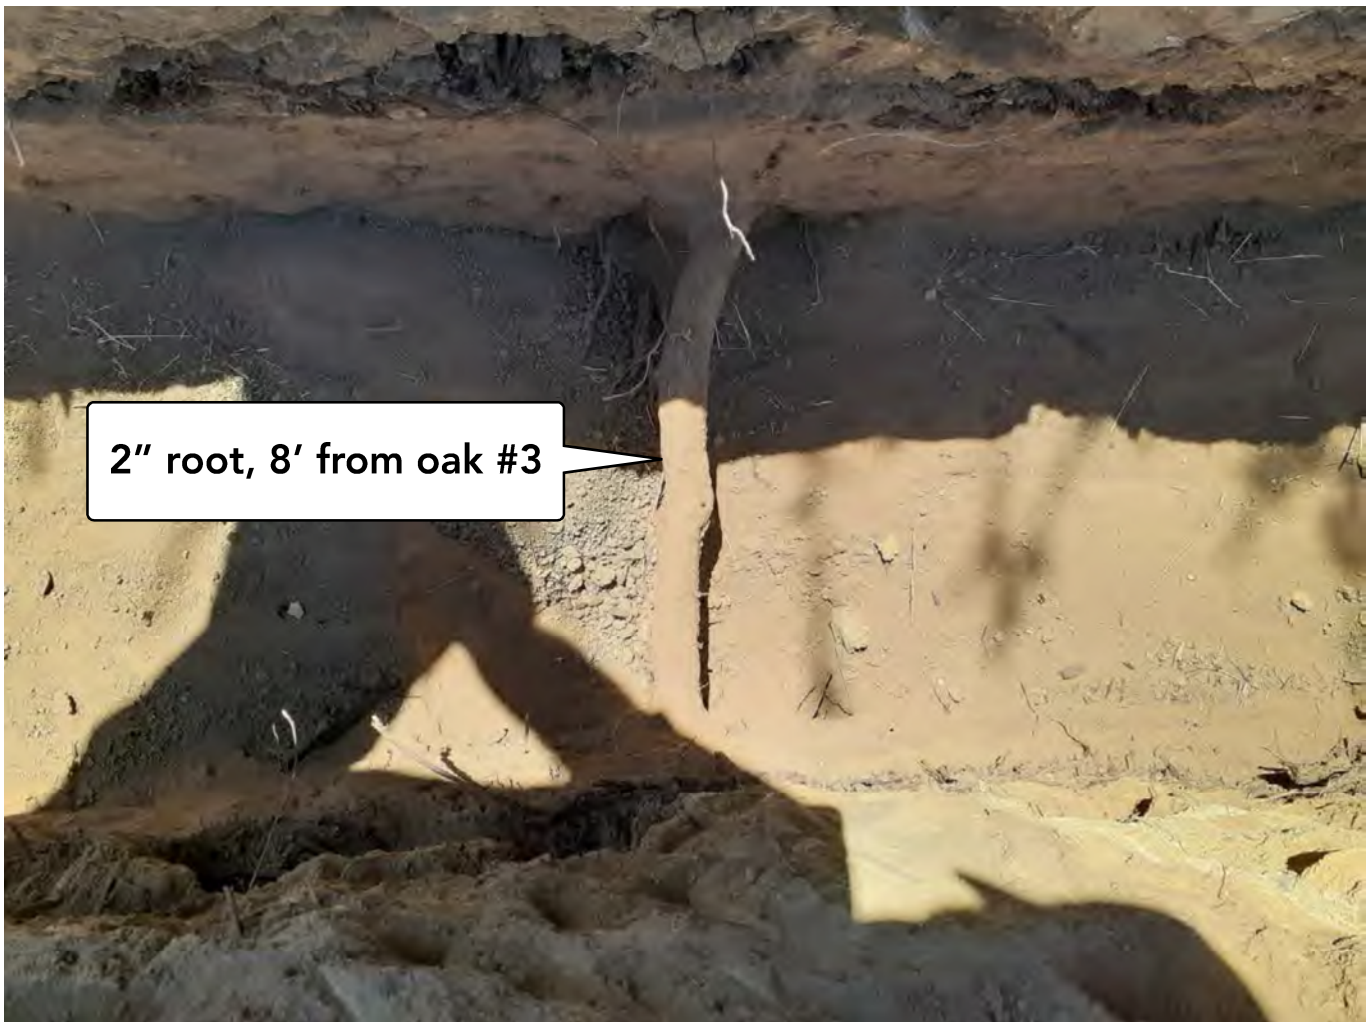
PHOTO 4 - This root is isolated and no more than 2 inches in diameter. Per industry standard, oak tree #3 can be retained if this root is cut at this distance from the trunk, because it is the only root 2 inches or greater in this area. This will allow for the proposed construction to occur while retaining tree #3.

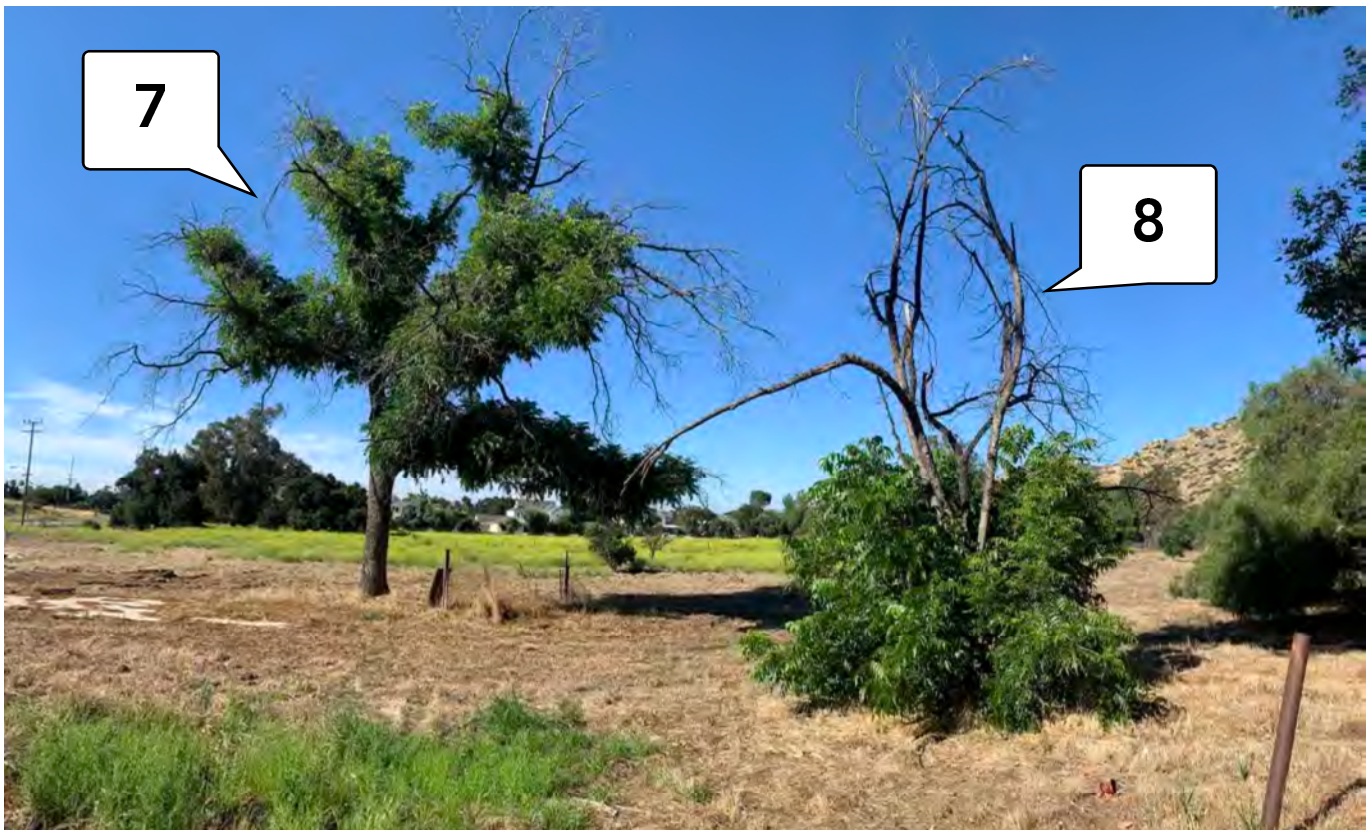
English Walnuts (*Juglans regia*) #7 and #8: These mature trees are approaching the end of their lives, for they have begun senescence. Removing these trees and replacing them with more juvenile trees provides an opportunity to enhance the landscape's longevity. In addition, deadwood falling from these trees may injure residents or cause damage to existing or proposed structures. These trees, especially #8, are falling apart. These trees will be replaced at a 1:1 ratio.

PHOTO 5 - English walnut (*Juglans regia*) trees #7 and #8 are in very poor condition. The green leaves, encouraged by the winter rain, provide a false sense of vitality. The green leaves are all suckers and will not revive the trees. These trees have begun senescence and are falling apart. They should be removed as soon as possible and replaced at a 1:1 ratio to the satisfaction of the Department of City Planning.

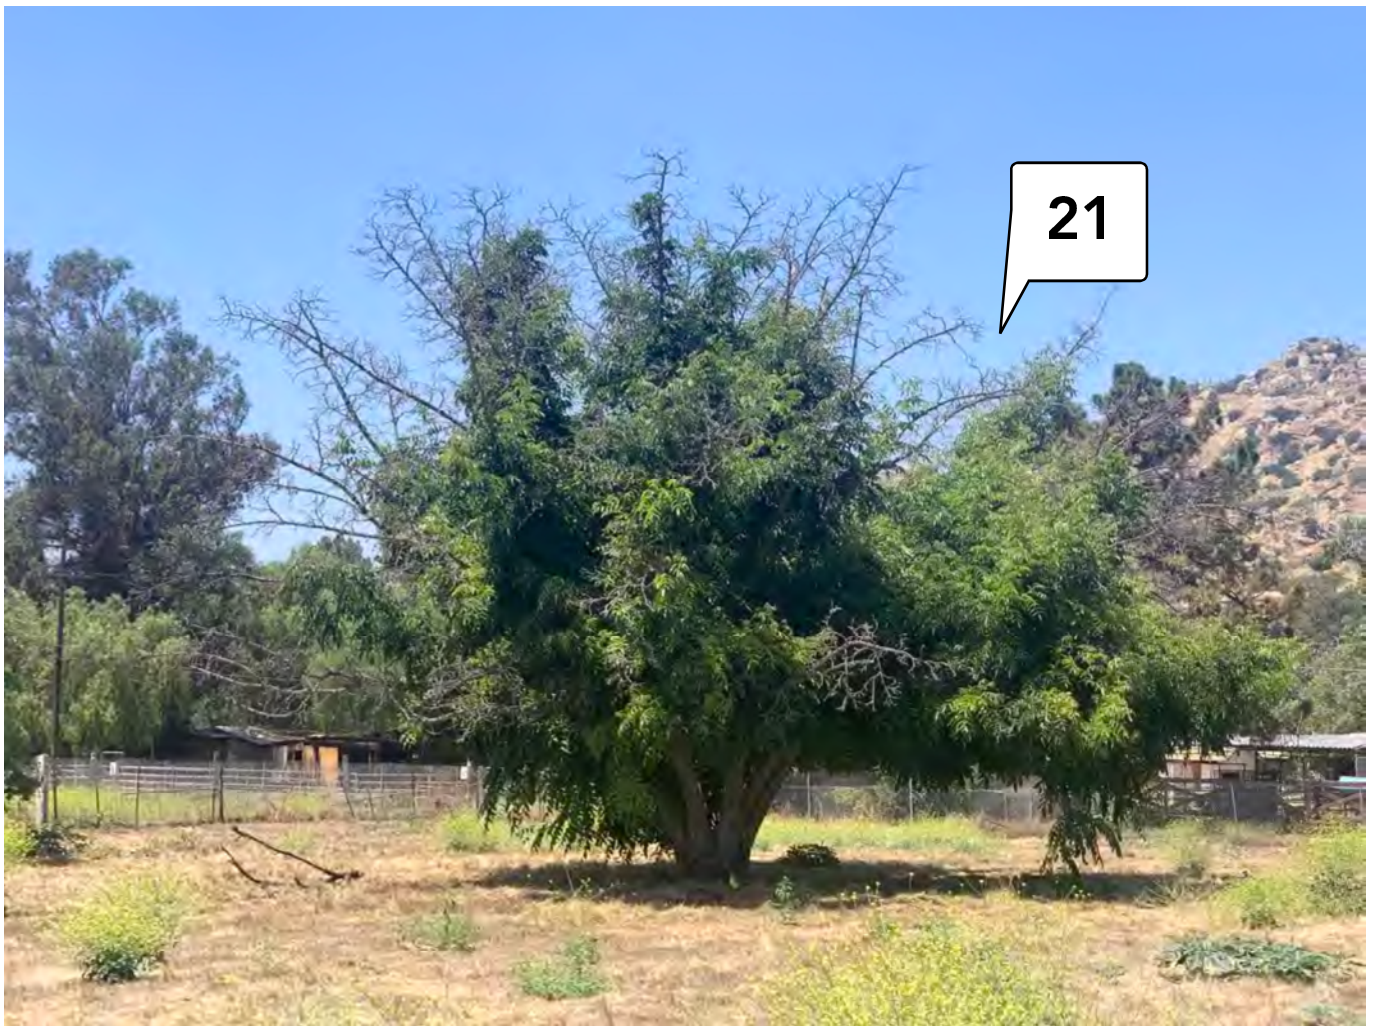
English Walnut (*Juglans regia*) #21: This tree's poor condition as indicated by extensive interior rotting, which will only grow worse. The green leaves, encouraged by the winter rain, provide a false sense of vitality, but the risks associated with this rotting will only increase. This tree is no longer viable. This tree will be replaced at a 1:1 ratio.

PHOTO 6 - English walnut (*Juglans regia*) trees #21 is no longer viable. The green leaves, encouraged by the winter rain, provide a false sense of vitality.

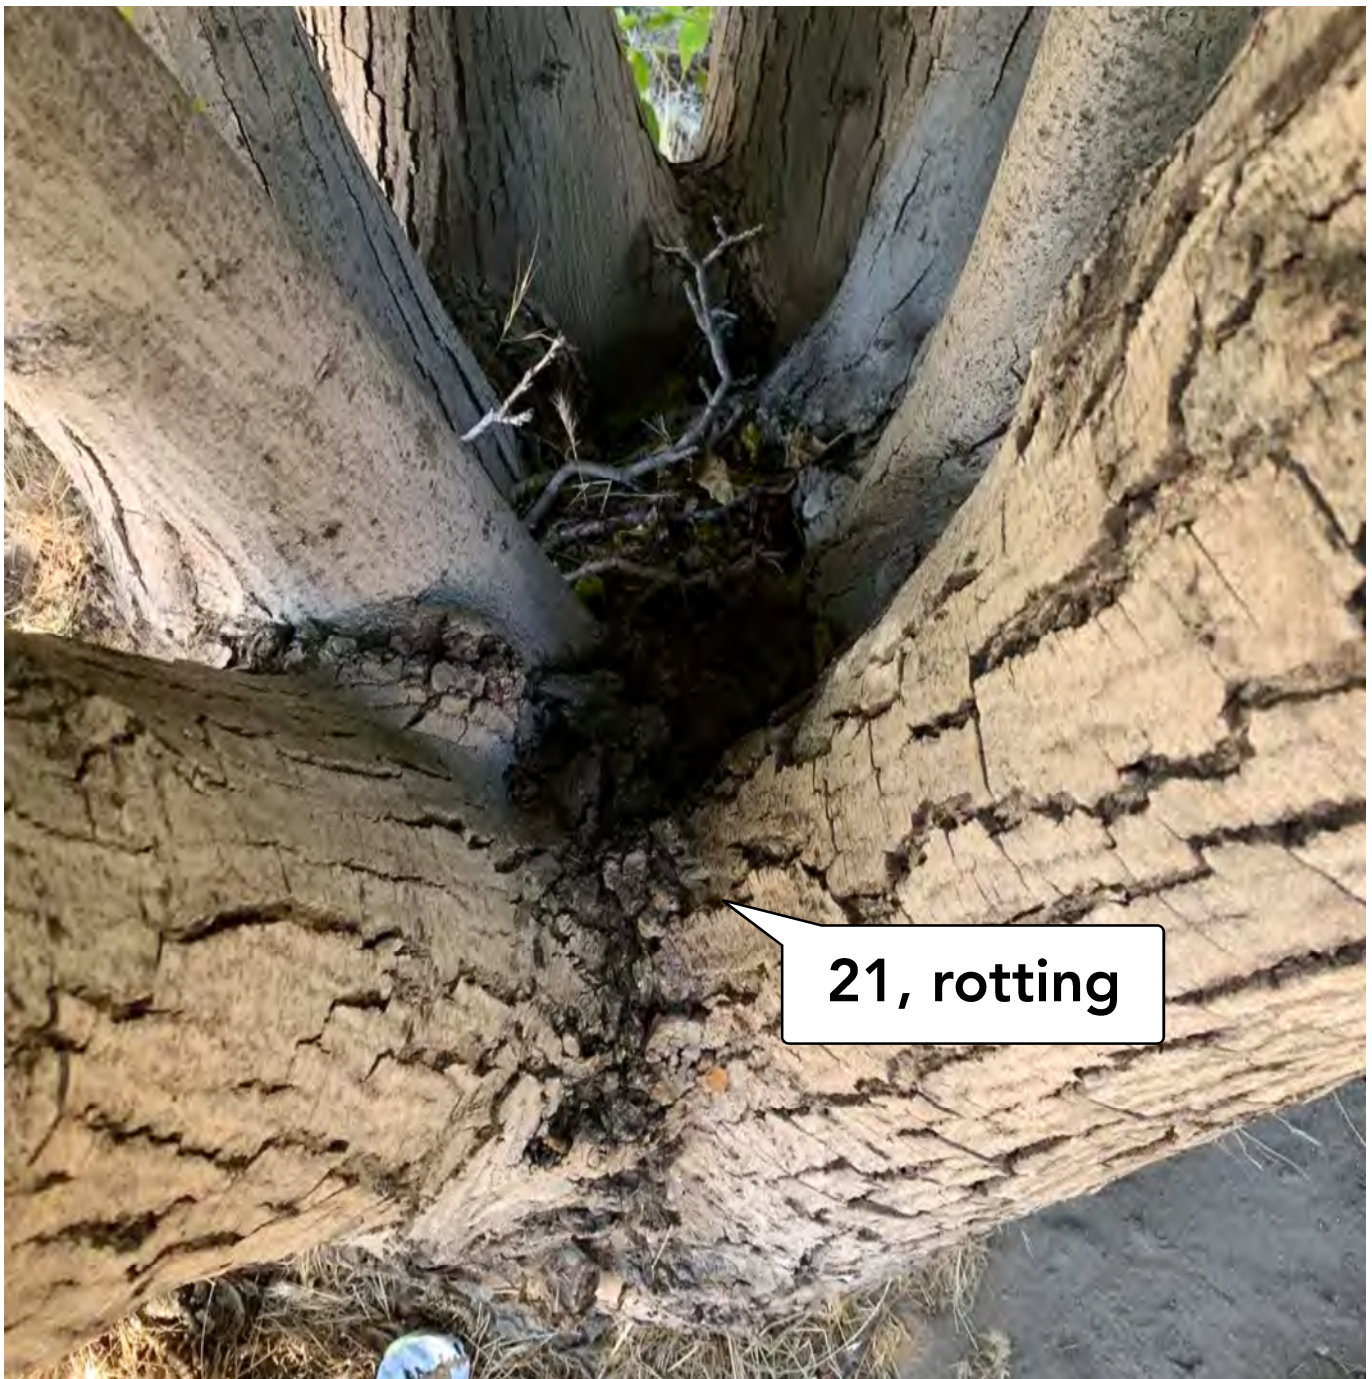
PHOTO 7 - English walnut (*Juglans regia*) trees #21. Note the extensive interior rotting. At this stage, the rotting cannot be effectively managed, and the tree cannot be salvaged. This tree will be removed and replaced at a 1:1 ratio to the satisfaction of the Department of City Planning.

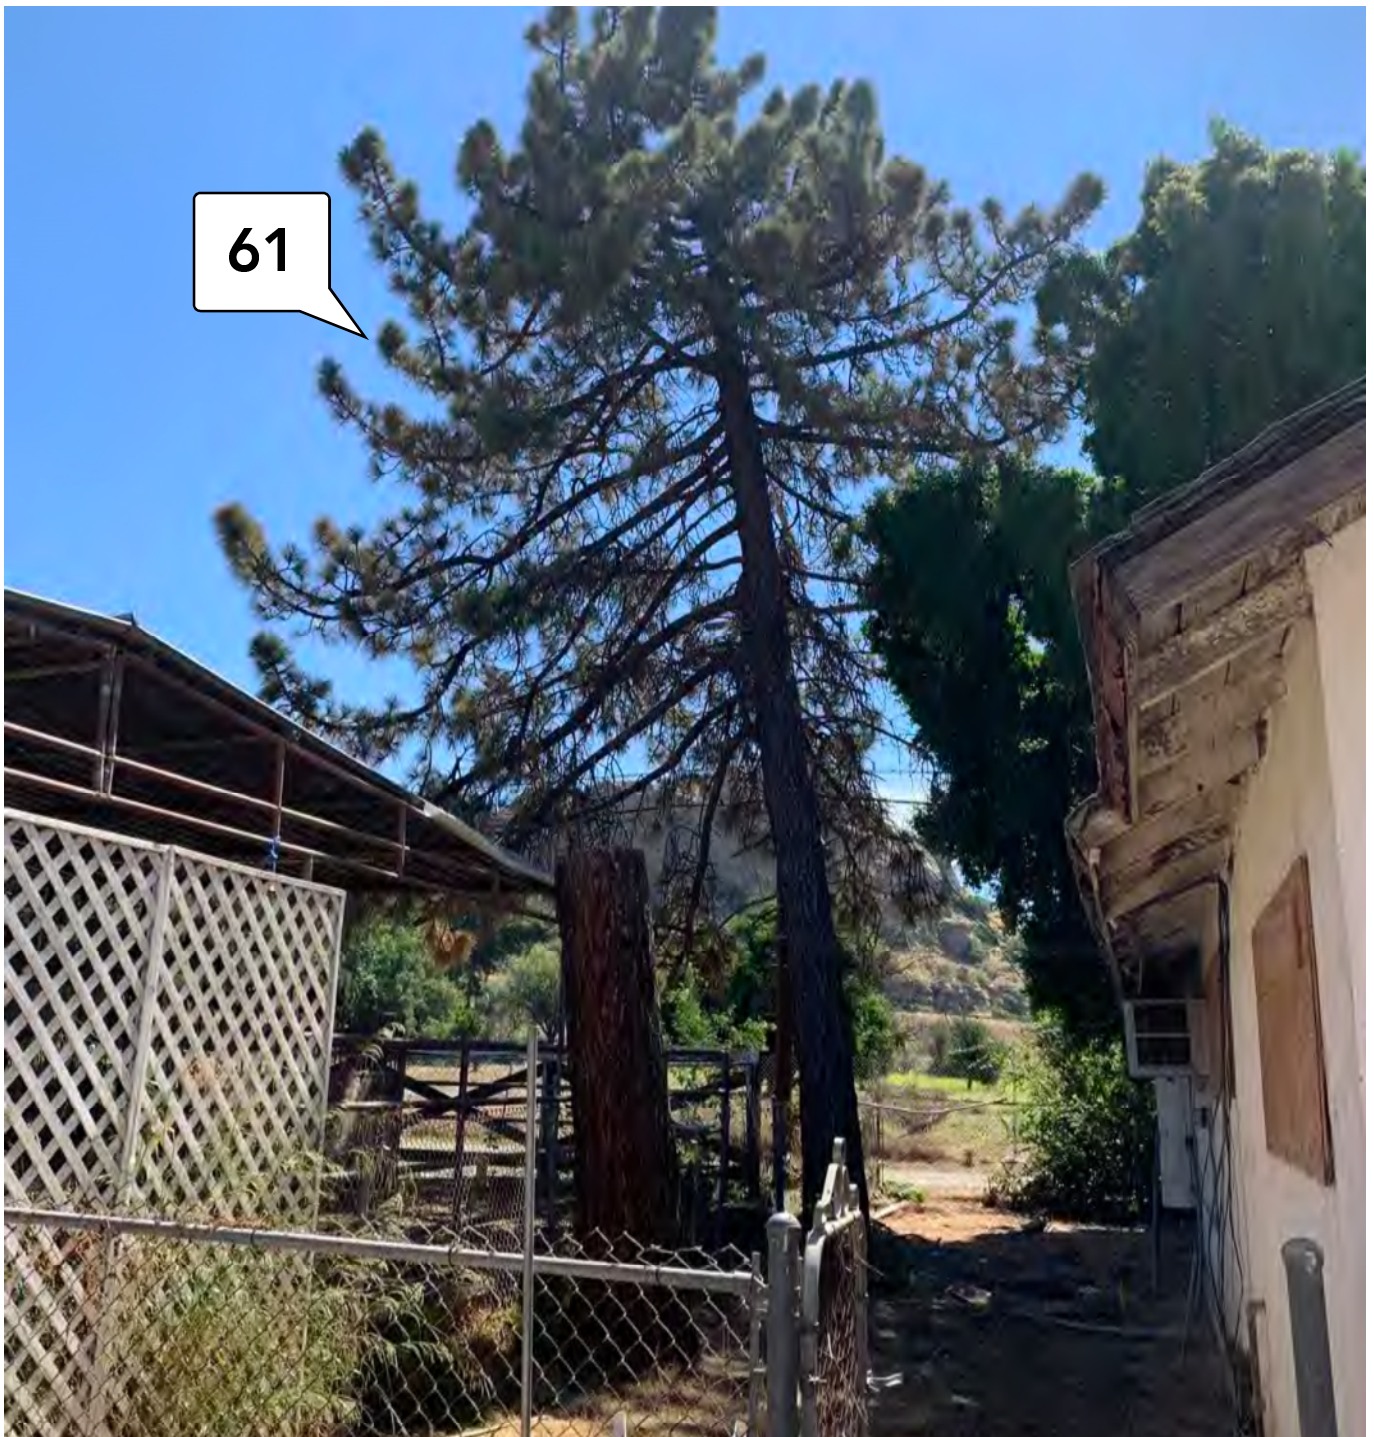
Monterey Pine (*Pinus radiata*) #61: Though this tree (located in a cluster with #62 and #63) is not dead yet, it is not far off. This tree should be removed before it declines even further and becomes hazardous. Because this tree is not yet dead, it will be replaced at a 1:1 ratio.

PHOTO 8 - Monterey pine #61 does not appear to be a good retention candidate because it is in very poor condition and Monterey pines are a bad species for this climate. From this angle, one can note the thinning, dying canopy and lack of vigor. Because this tree is not totally dead yet, it will be removed and replaced at a 1:1 ratio to the satisfaction of the Department of City Planning.

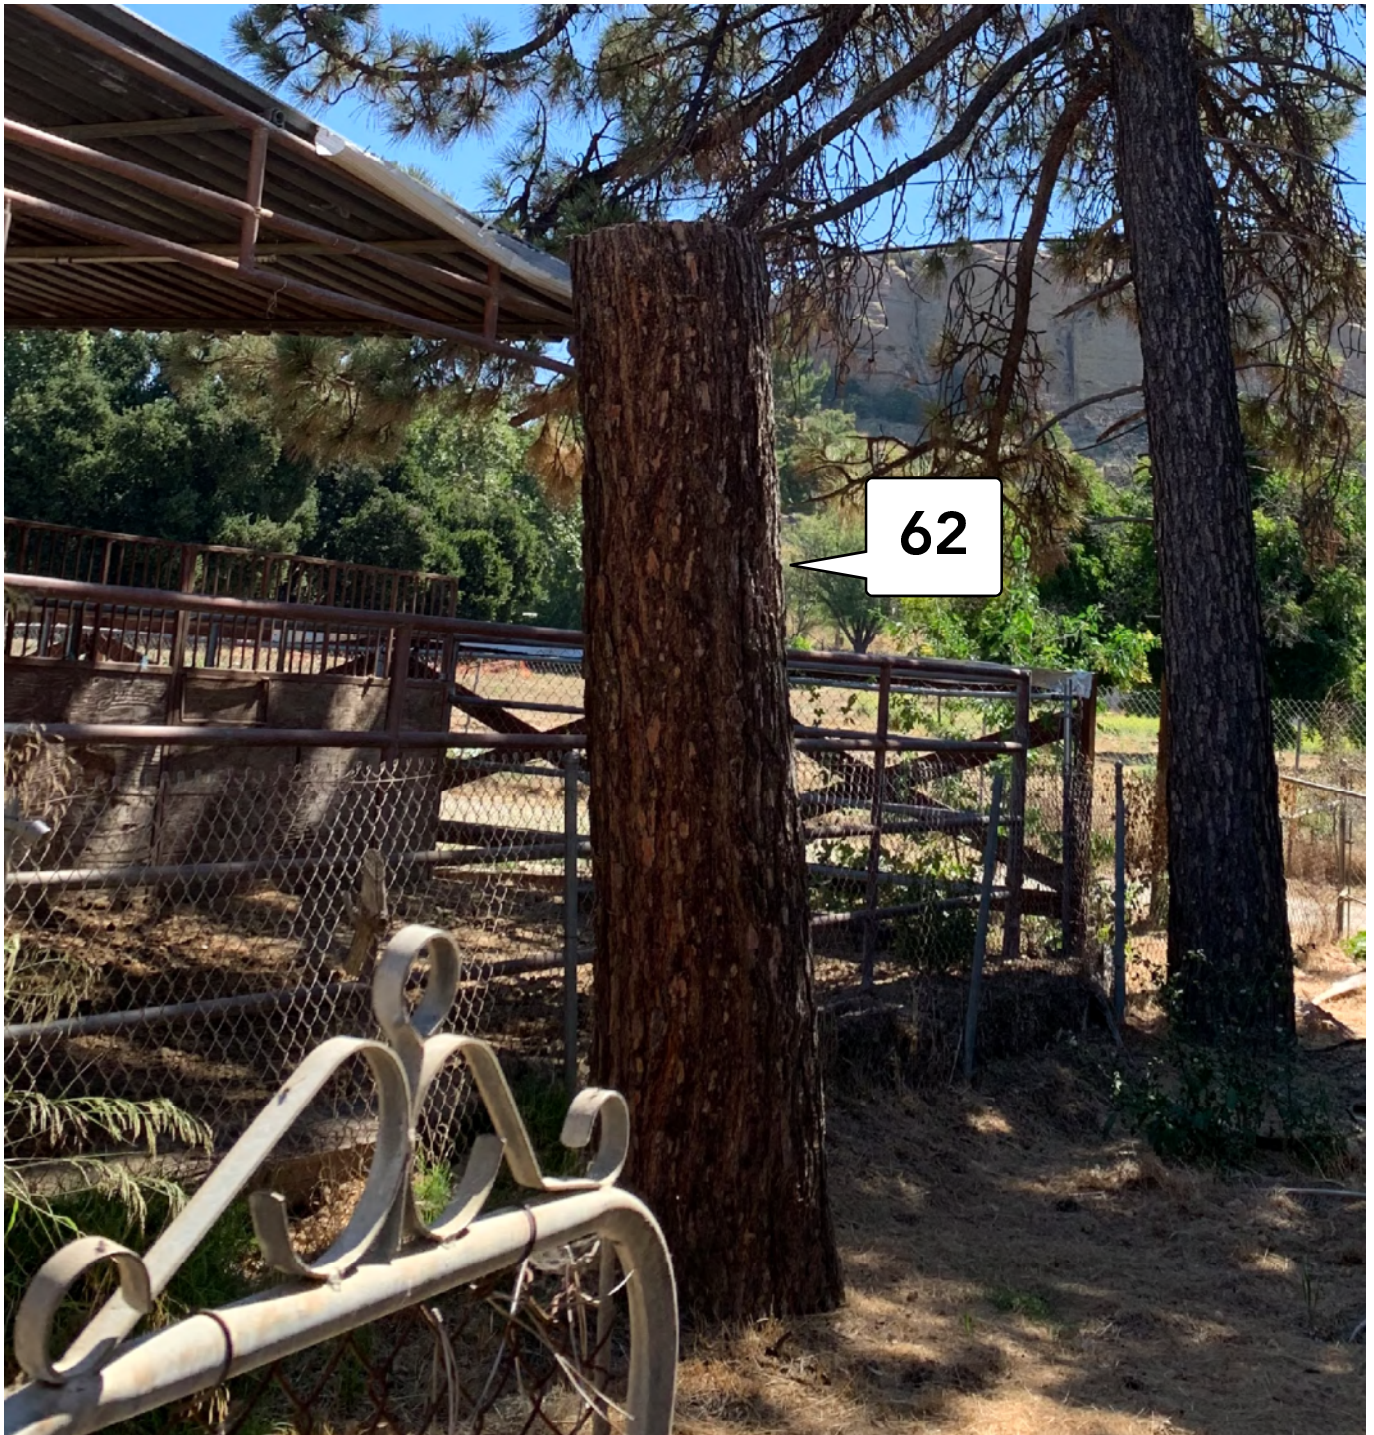
PHOTO 9 - Monterey pine #62 is only a stump at this point with no chance of regeneration. It should be removed without replacement, because it is dead.

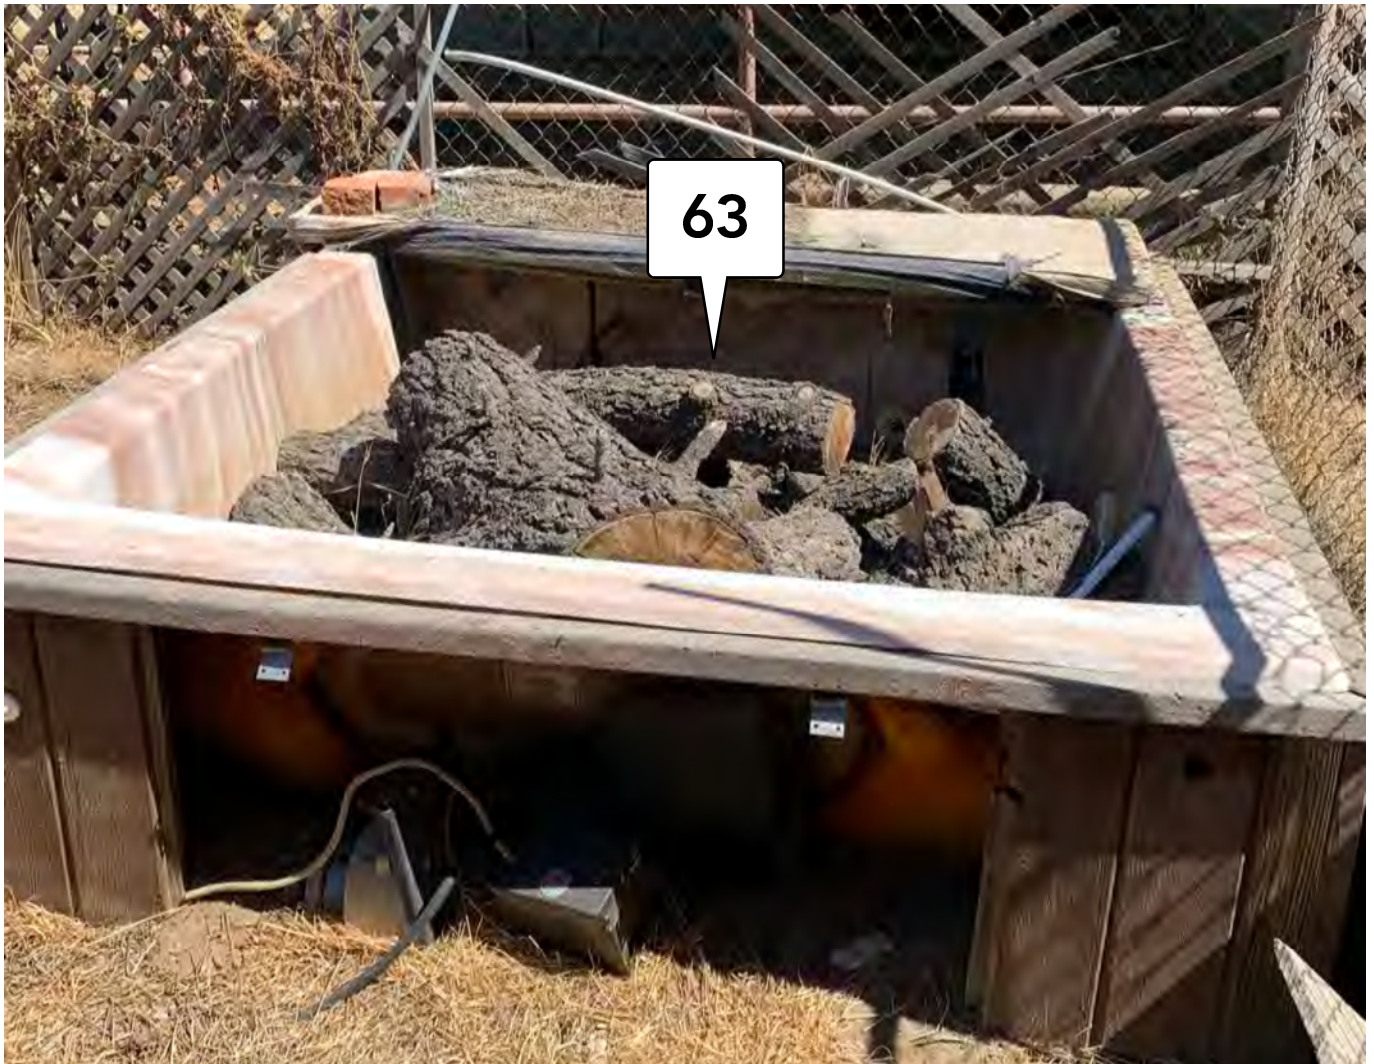
Monterey Pines (*Pinus radiata*) #62 and #63 — DEAD: These trees are dead and should be removed without replacement. Tree #62 is only a stump and #63 is a pile of wood. Both of these trees should be removed regardless of the proposed construction due to the lack of value, including aesthetic, monetary, and environmental, they add to the property.

PHOTO 10 - Monterey pine #63 is only a pile of wood, with no chance of regeneration. Along with tree #62, this tree is taking up space on the property that could otherwise be utilized in a productive or valued way. It should be removed without replacement, because it is dead.

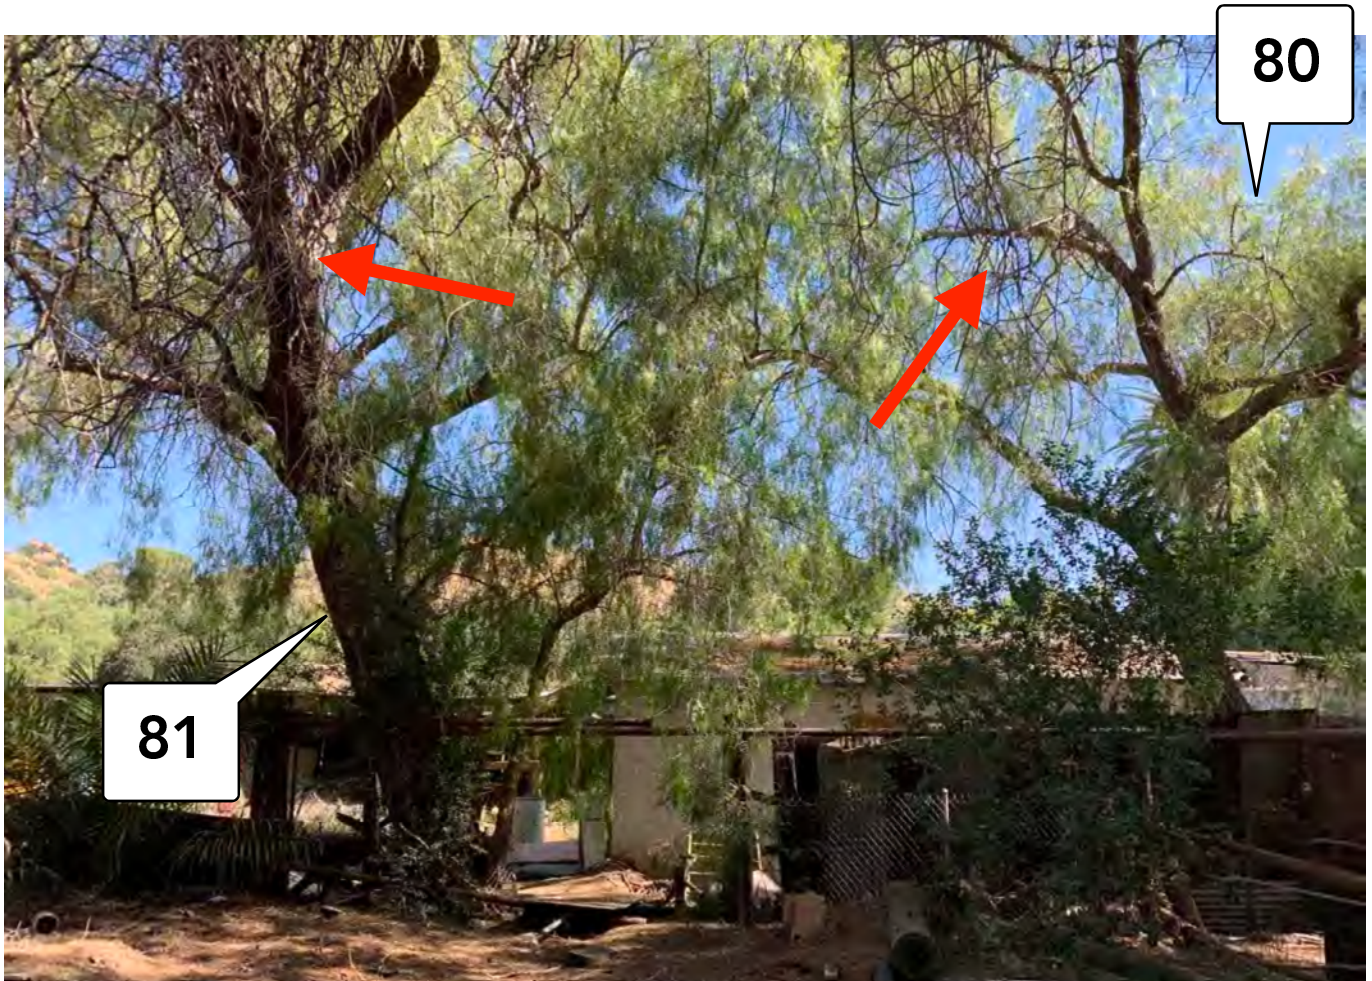
California Peppers (*Schinus molle*) #80 and #81: These trees suffer from multiple structural defects and are entering senescence. Their canopies are dying as evidenced by extensive twig dieback. Removing these trees would allow the installation of healthier juvenile trees. These trees will be replaced at a 1:1 ratio.

PHOTO 11 - California pepper (*Schinus molle*) trees #80 and #81 are in very poor condition. These trees suffer from multiple structural defects and are entering senescence. Their canopies are dying as evidenced by extensive twig dieback (pointed out above). They will be removed and replaced at a 1:1 ratio to the satisfaction of the Department of City Planning.
