23. Four Seasons Apartment Building

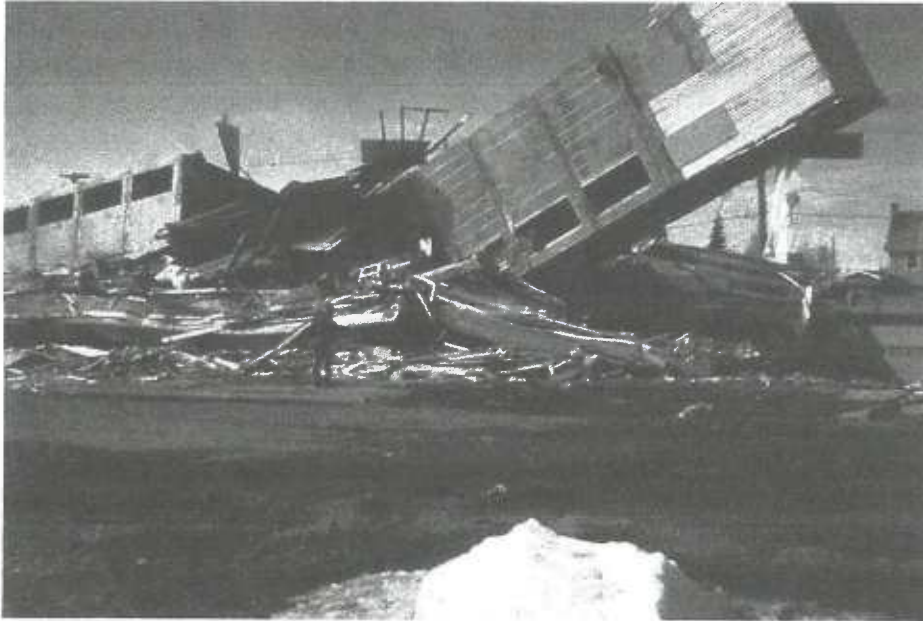
The Four Seasons Apartment Building was a new 6-story lift-slab reinforced concrete building nearing completion in 1964 (fig. 33). It reportedly withstood 2–3 minutes of shaking before collapsing just before the end of the earthquake. The main shear-resistant structural elements of the building, a poured-in-place reinforced concrete stairwell and a combined elevator shaft and stairwell, fractured at the first floor, toppled over, and came to rest on top of building rubble, all the while remaining largely intact (Hansen, 1965, p. A24–A25).

Figure 33. The remains of the Four Seasons Apartment Building, Anchorage, Alaska, 1964. The tilted column on the right was the combined elevator shaft and stairwell. (Photograph from U.S. Geological Survey Photographic Library, ID aeq00026.)
