## OFFICE OF THE CITY ADMINISTRATIVE OFFICER

Subject: **SALE OF SURPLUS PROPERTY – LOCATED AT 8131 SOUTH DELGANY AVENUE IN PLAYA DEL REY**

**Advanced Group Property Inspection Co.**

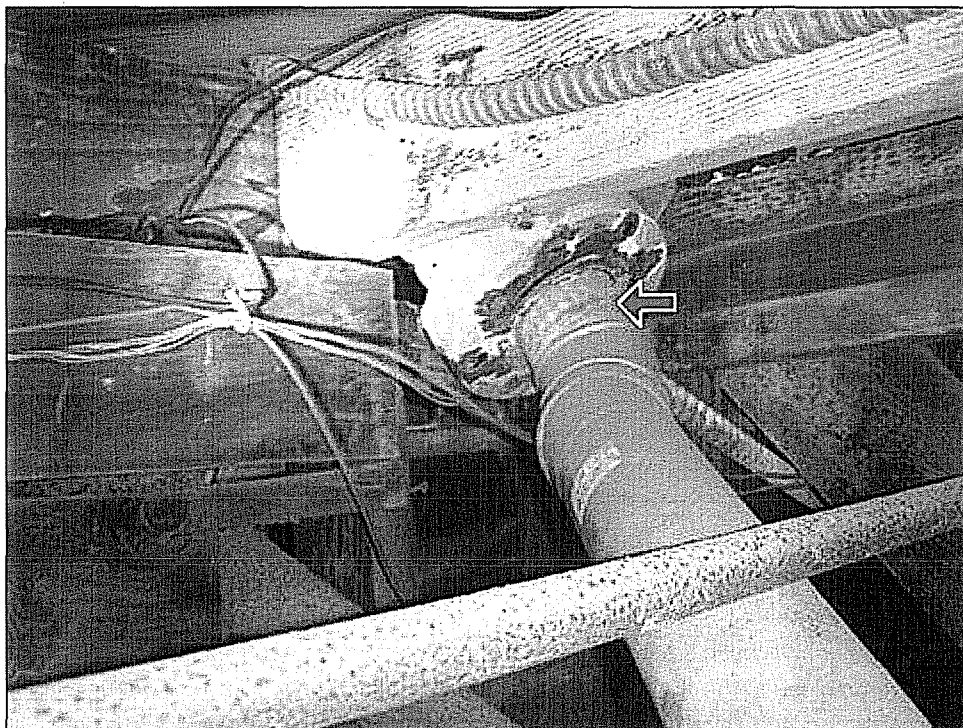
2.3 Picture 2

- Gas line at water heater without drip leg/sediment trap ( this type installation is common for the area/age). Lack of drip leg may void warranties - check with your Home Warranty provider
- The adequacy or efficiency of the hot water heater cannot be determined in a limited time visual inspection. It is not known how hot the water will get or how long it will last ( this is many times a matter of personal preference).
- Vent pipe lack screws, not properly installed - improper. Recommend to correct.

- Gas pipe was loose
- **Furnace/ water heater in the basement noted - Recommend to install carbon monoxide detector/ smoke detector in the basement.**

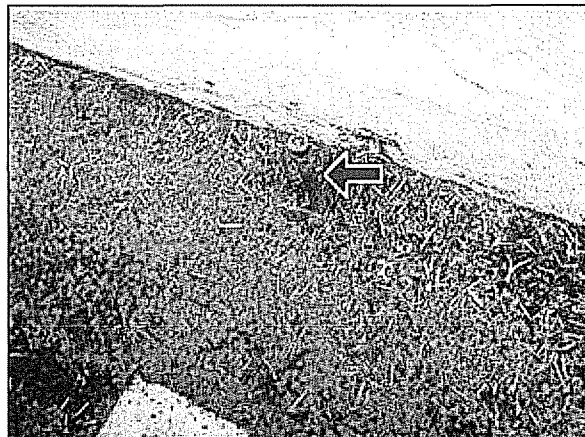
2.5 Picture 2

- Sprinkler systems / automatic timers are not tested and are not a part of this inspection. Check with the seller.
- Sprinklers set too close to the house - keep water/ vegetation away from house/foundation. (Picture 2)

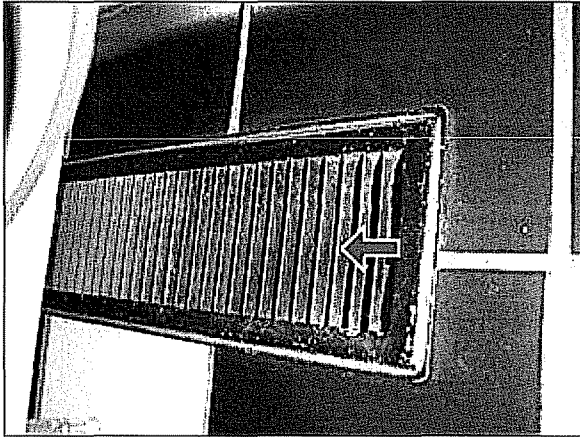
4.3 Picture 1

- Air filters should be changed or cleaned regularly according to Manufacturer's instructions.
- Air flow / balance is not a part of this inspection. Recommend to check with the seller about air comfort/distribution.
- Return air was taken from exterior - improper(Picture 2). Recommend to install return air grill from interior of the house.
- Ducting installed in slab foundations may be subject to mold issues - recommend further evaluation.(Picture 1)

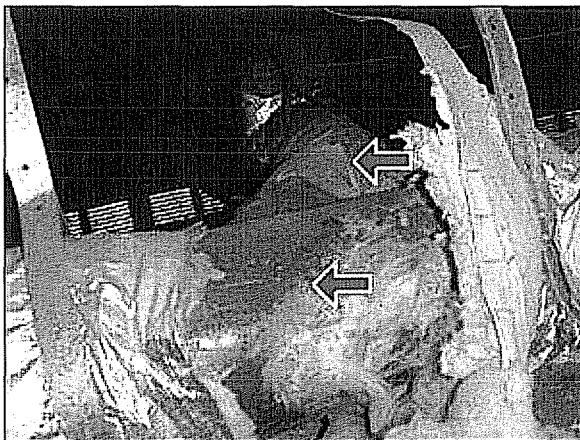
4.3 Picture 5

- Old, rusted ducts found in crawl space (Picture 5)
- Asbestos-like materials were noted on the ducting - further evaluation / testing for abatement / removal is recommended. This is a health concern(Picture 4)

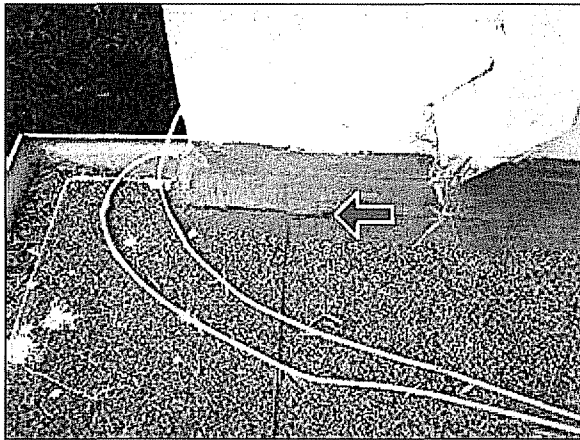
6.1 Picture 2

- Roof to wall flashing not visible/ covered with mastic. Periodic maintenance required to prevent leaks.(Picture 1). Cracked mastic noted - leak hazard. (Picture 2)
- Rusted flashing/ caps noted(Picture 3) - may need replacement.
- Cracked/ worn mastic at flashings noted. Recommend to re-seal to prevent leaks. (Picture 4)

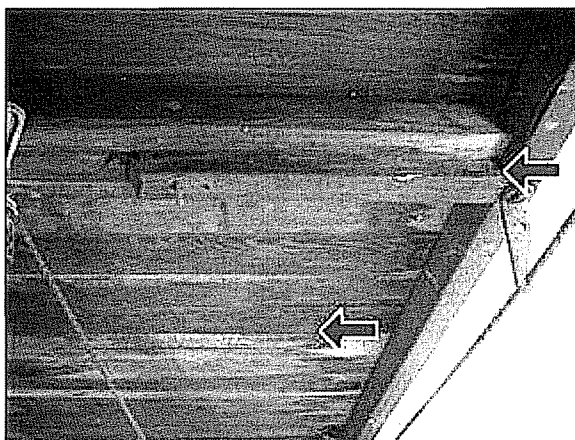
7.0 Picture 2

- Garage vehicle door shows moisture damage, wear, and appears warped - repairs/ replacement by qualified Contractor are recommended.

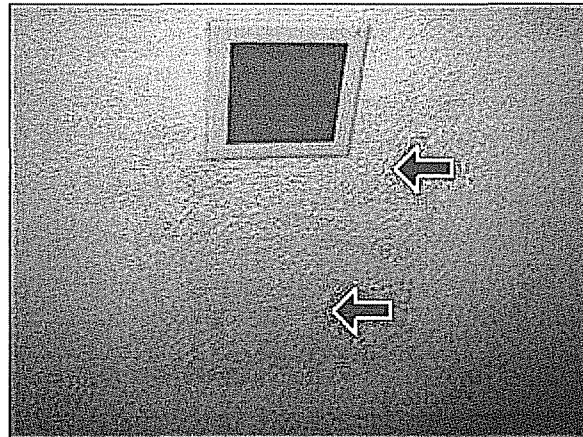
8.0 Picture 2

- Common cracks were noted at the ceilings.
- Acoustic spray at ceilings noted. Acoustic spray may be asbestos containing type - recommend further testing for possible abatement as a safety upgrade.
- Unprofessional patches/ repairs noted at dining rom area ceiling(Picture 2)
- **Water stains, possible MOLD found at Upper Bedroom Closet. In need of further evaluation by a qualified specialist(s).**
- **This is not a Mold or Fungus inspection. it is advised to have a Mold specialist examine the property and structure and do a complete inspection to determine the presence or absence of any Mold that may affect the health or safety of the occupants.**

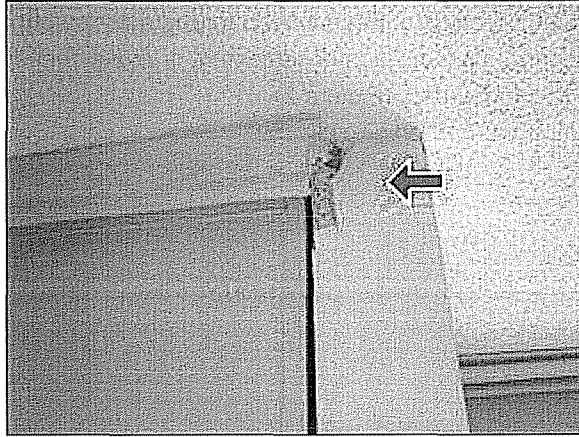
8.1 Picture 1

- Interior walls, ceiling in need of patch/ paint/ repair.

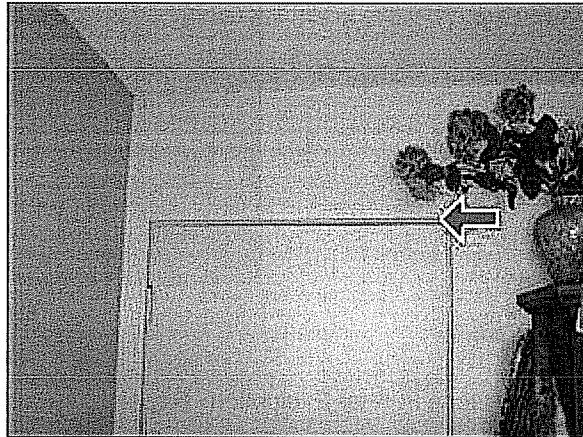
8.3 Picture 2

- Recommend to install door stops to prevent wall damage.
- Sliding doors : glass not tempered type. Recommend to upgrade - safety concern. (Picture 1)
- Door frames were not square - an indication of settlement or movement - further evaluation and corrections by qualified Contractor are recommended. (Picture 2)
- Bathroom area pocket door did not work(Picture 3)

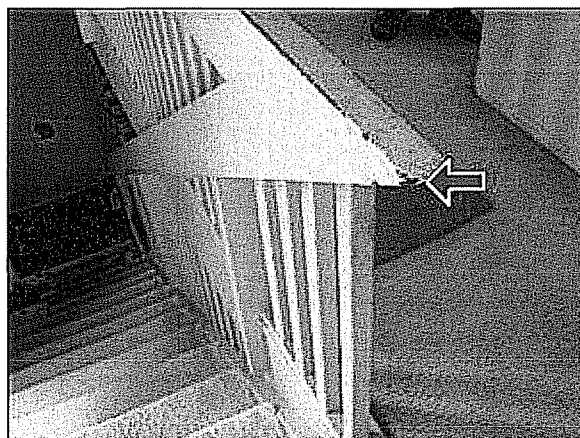
8.5 Picture 5

- Handrails were not today's standards for safety. Were not grippable type. Recommend to upgrade.
- Handrail at interior stairs is not to current safety standards - open end rail noted ( trip hazard) - correction / safety upgrade recommended. (Picture 5)
- Uneven rise was noted at the interior stairs - this condition can present trip hazards.

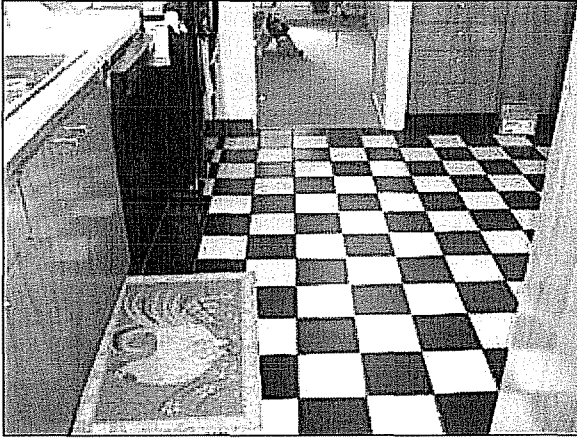
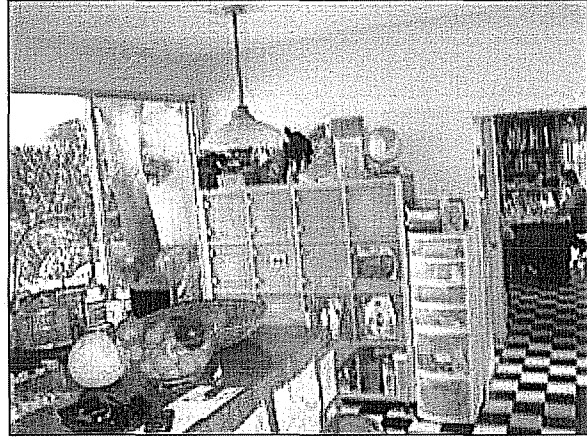
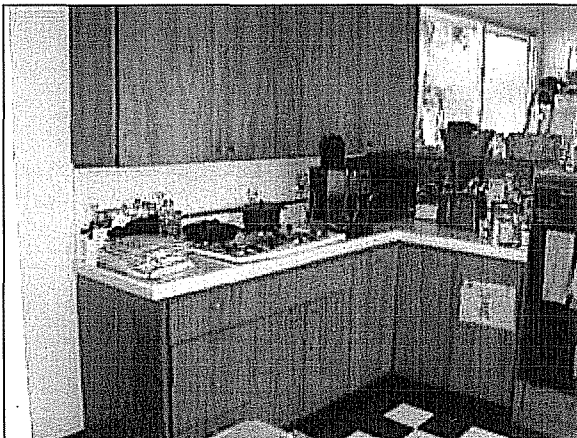
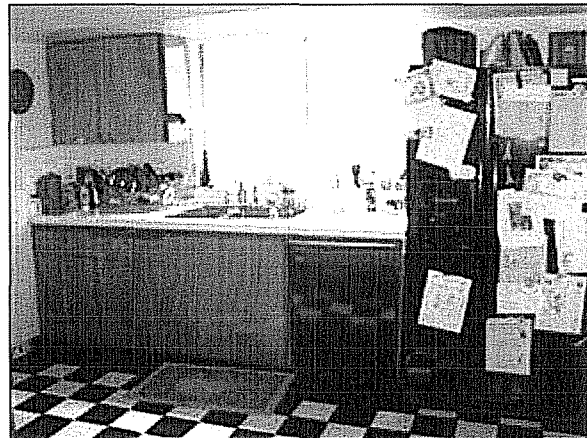
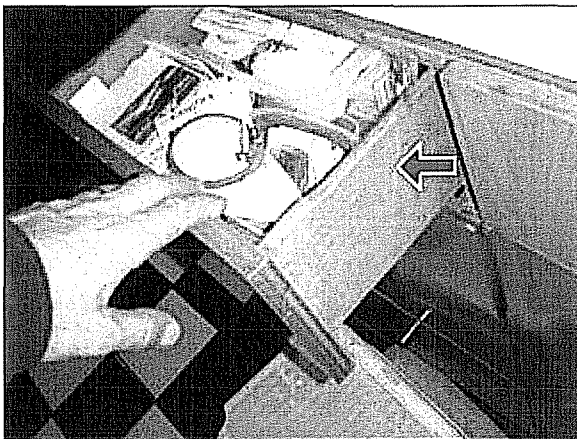
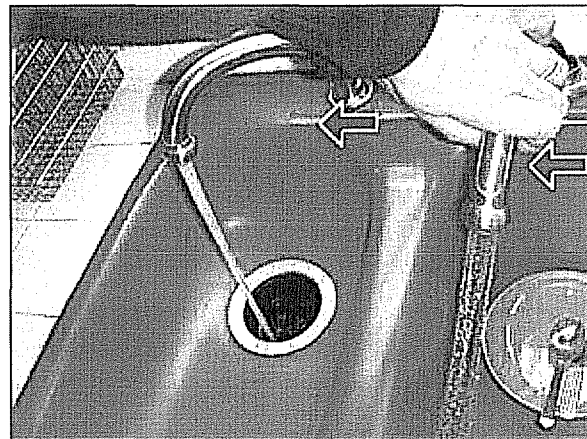
**Comments:** Needs Further Evaluation / Repair

- Cabinet drawers with open guide type ( without stop - drawer can slide out of cabinet). Recommend to upgrade for safety.
- Moderate to heavy general wear and age defects were noted - upgrade / renovations recommended.
- Defective sprayer noted.
- Water damaged board noted under the sink cabinet - have it checked by a qualified termite inspector.
- **Kitchen in need of remodel/ upgrade. Have it checked by a qualified contractor.**

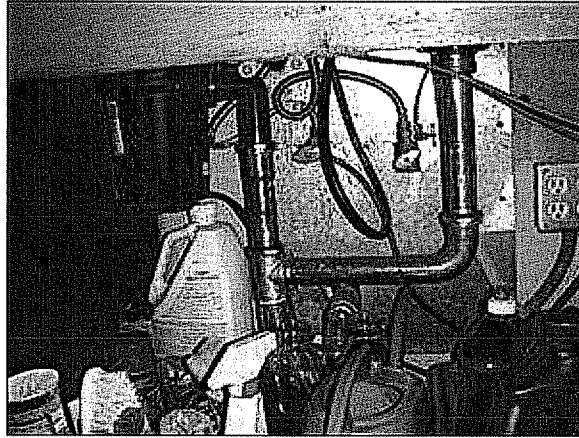
10.1 Picture 1

**Comments:** Monitor Condition

- Noisy disposer noted.

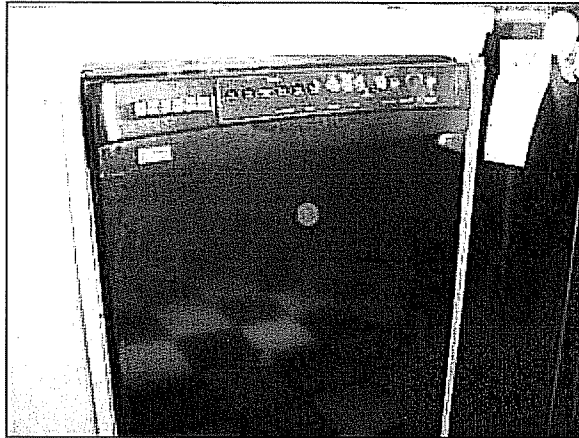
10.2 Picture 1

**Comments:** Needs Further Evaluation / Repair

- Dishwasher not tested at this inspection.

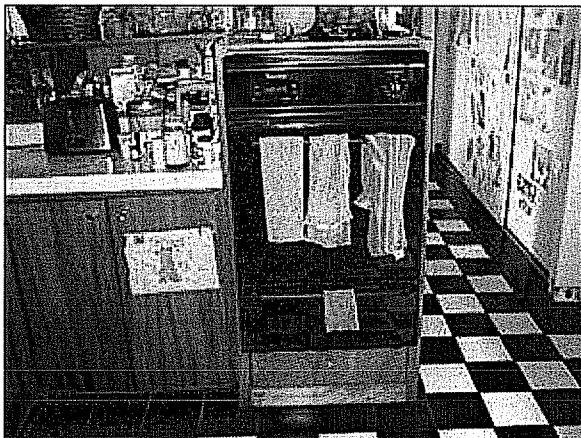
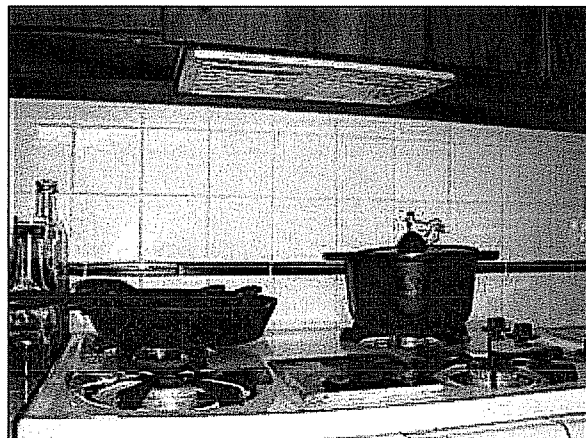
**Comments:** Monitor Condition

- Old oven noted

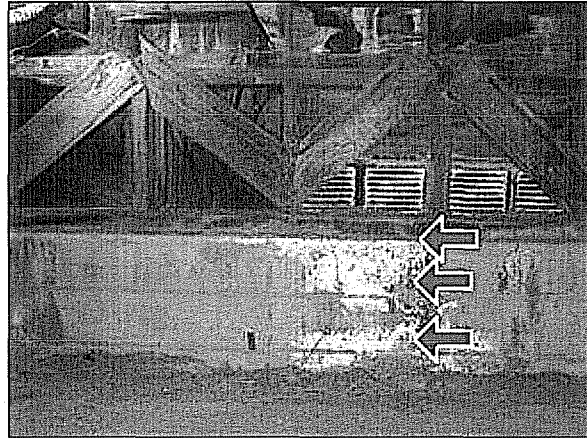
12.0 Picture 2

- Efflorescence was noted present on the foundation wall - recommend to keep moisture around the inspected property to a minimum.(Picture 1)(Picture 2)
- Cracks considered common in size and type were noted at the time of inspection.

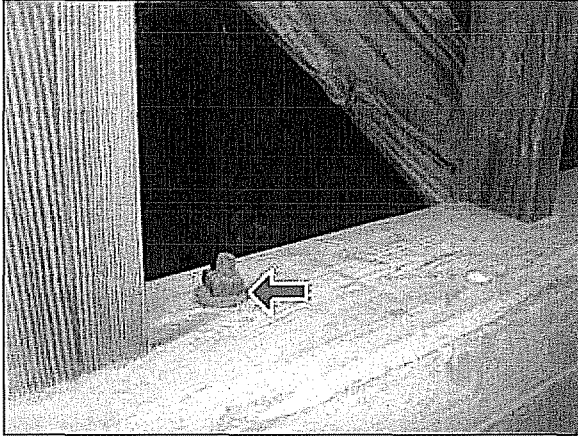
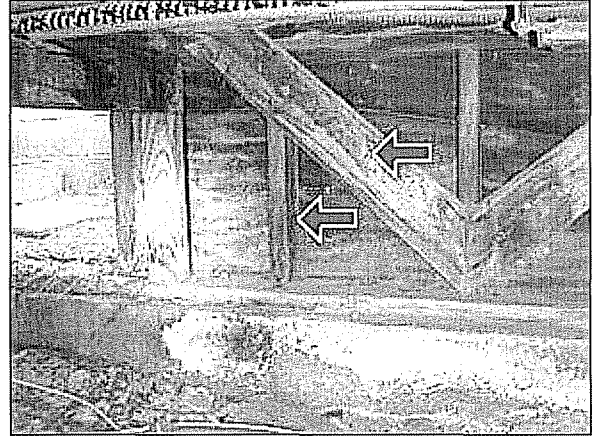
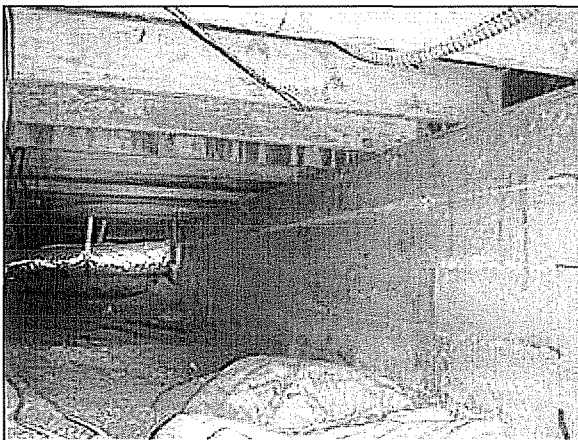
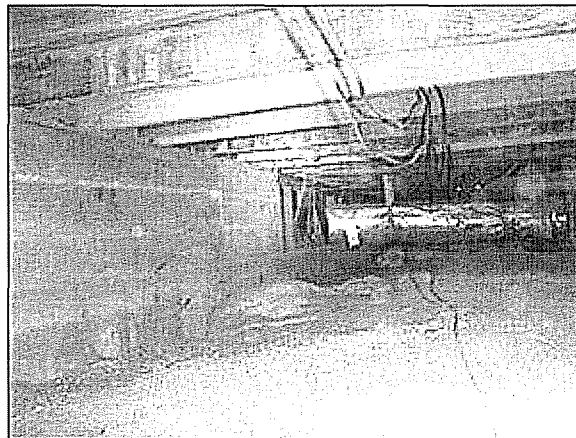
- Anchor bolts from time of construction were noted at the foundation wall.(FYI). Bolt size, spacing not with today's standards.
- Non reinforced cripple walls noted(common for the age/type of the construction) - recommend further evaluation for seismic retrofit by qualified Structural Engineer.
- Some cracks noted at foundation walls. (Picture 4). Recommend to monitor. have it checked by a qualified structural engineer.
