Neighborhood Council: Hermon

Council File Number: 14-0163-S17

Summary: The Hermon Community is a peaceful and tranquil place to live. However, there are issues that any neighborhood will have to contend with. In 2016 it was the homeless population that overpopulated the Arroyo. In 2017 petty crimes involving car break ins were rampant. Those issues, for the most part, have dissipated. In 2018, our top priority is sidewalk repair. In August 2018, the Hermon Neighborhood Council hosted an event with Councilmember Huizar with approximately 75 residents. The residents overwhelmingly voiced their concern with buckling and broken sidewalks that are a tremendous public safety hazard. Our community is made up of lots of families and elderly. Becuase of the failing sidewalks, families with kids that push their kids in baby carriages have a hard time maneuvering through broken sidewalks. The elderly find it difficult to meander their wheelchairs around broken sidewalks an at times have no choice but to meander into streets. The Hermon Neighborhood Council has put together an in-depth analysis focusing on sidewalk conditions in Hermon. This is our top priority and we ask the City Council an

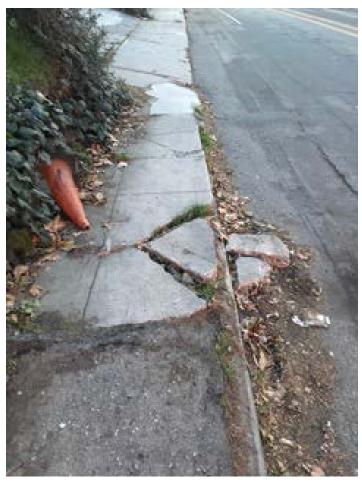
LOCATION: Via Marisol area West of Avenue 60

DESCRIPTION:
Problems in area is known
Complete street and sidewalk repair has been budgeted by the city of Los Angeles for 2019

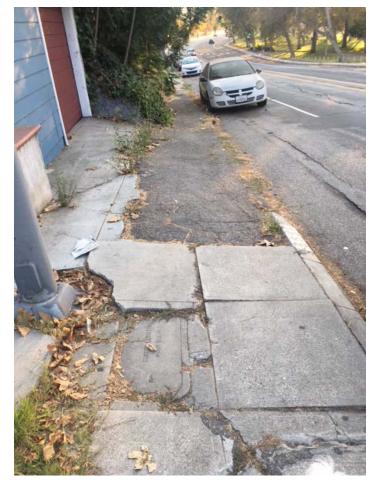
LOCATION: Wheeling Way

DESCRIPTION: Sidewalk crossing above stepstreet broken and sinking.

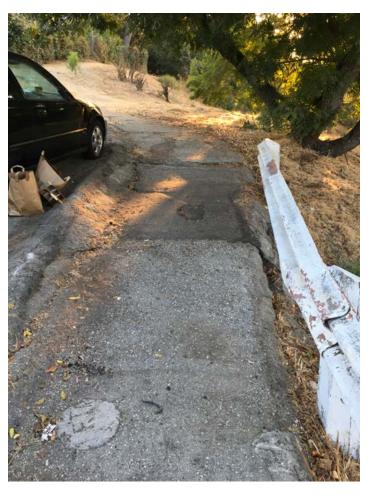
LOCATION: Wheeling Way step street down to Via Marisol

DESCRIPTION: Steps and edging broken, shifting and in disrepair

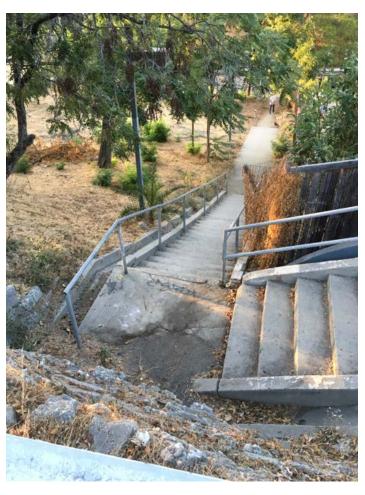
LOCATION: Bushnell Way at Wheeling Way

DESCRIPTION: Sidewalk missing and severly dropped area from ground movement.

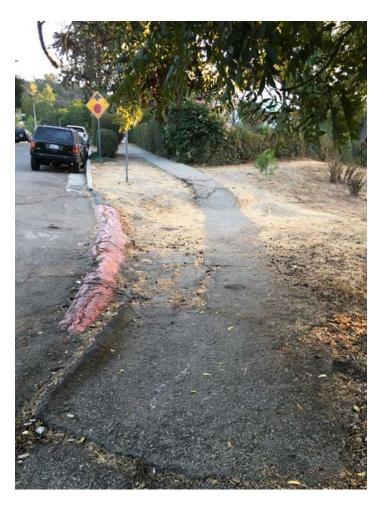
LOCATION: Kendall at Monterey Between 432 Kendall and Monterey Road

DESCRIPTION:
A few lifted areas
around trees. Prevoiusly patched with
asphalt

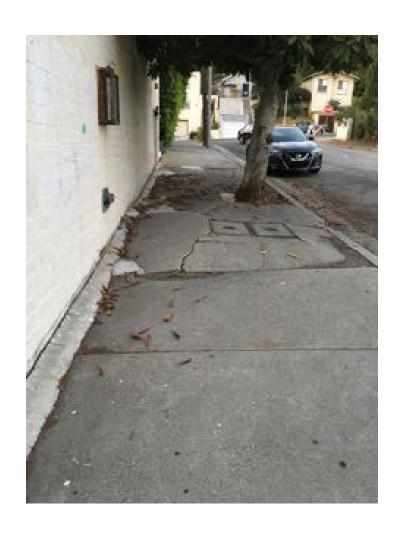
LOCATION: 5444 Monterey Road (Just South of Kendall)

DESCRIPTION: Drop in sidewalk around water meter. cracking at corners

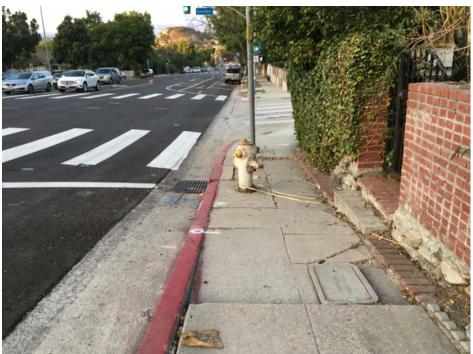
LOCATION: 5500-5506 Monterey Road (Just North of Kendall)

DESCRIPTION: Lift in sidewalk. previous repair is broken and worn.

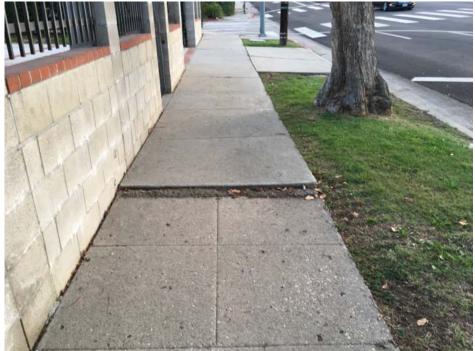
LOCATION: 502-510 Colman Ave (at Monterey Road)

DESCRIPTION: Lift in sidewalk. previous repair is broken and worn.
