Street Damage Restoration Fee Study

City of Los Angeles

Bureau of Street Services

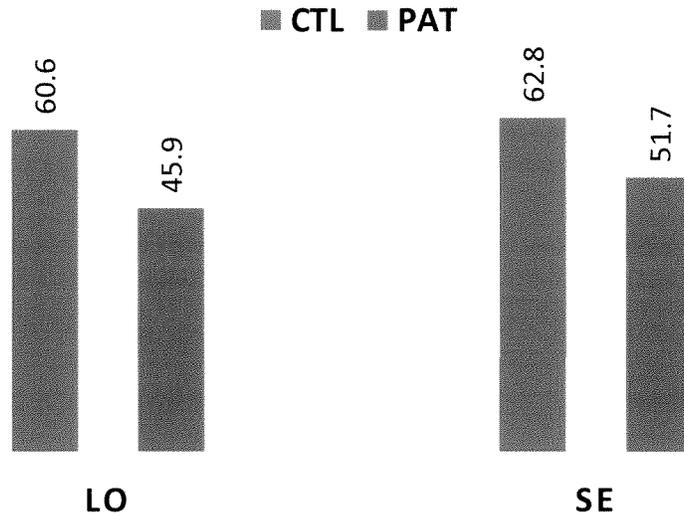
Figure 3.2 – PCI of Control (CTL) vs Patched (PAT) Inspection Units for Local (LO) and Select (SE) Streets.

The PCI was determined for each of the selected sites; once for the pavement area that included the utility cut patching (PAT) and once for the corresponding control area that has no utility cut patching (CTL). **Figure 3.2** is a comparison of the area weighted average PCI of the CTL vs. PAT test sites. For the Local streets (LO), the PCI of the CTL is about 15 points higher than the PAT sites. For the Select streets (SE), the PCI of the CTL is about 11 points higher than the PAT sites.

1. The PCI of the Control (Non-patched) is about 15 points higher than the Patched areas in Local sites. Similarly, the PCI of the Control (Non-patched) is about 11 points higher than the Patched areas in Select sites. **Figure 3.2.**

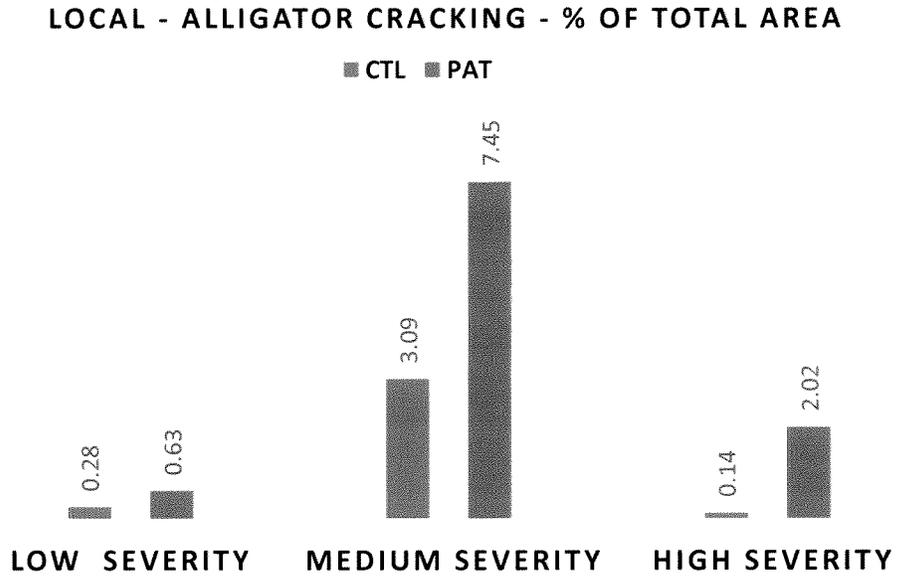
Figure 3.7 – Comparison of CTL and PAT Alligator Cracking Severity Levels

More insight in the effect of utility cut patching on pavement structural condition can be seen in **Figures 3.7, and 3.8**. The figures show a comparison of Alligator cracking between CTL and PAT sites by severity levels. As can be seen, the significant difference is not at the Low severity, but rather at the Medium and High severities. This is another manifestation of the weakened pavement structure due to utility cut patching.

2. There is a higher percent of load related distresses (Alligator cracking and Rutting) in Patched areas vs. Control (**Figures 3.5 and 3.6.**). Most of the distress percentages are at the medium and high severity levels of the distresses (**Figures 3.7 and 3.8.**)

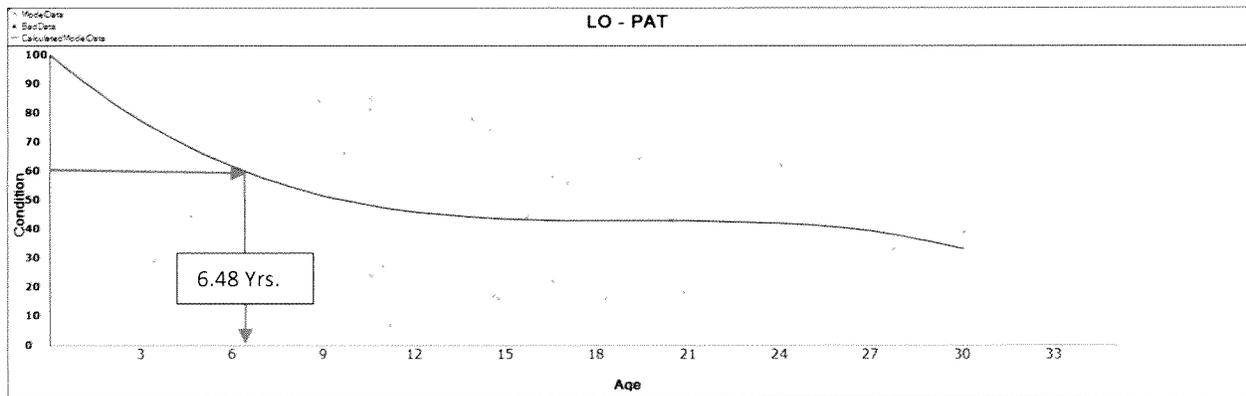
Figure 3.12 – PCI Deterioration Family Model for Local Patched Inspection Units

The PAVER pavement management system was used to develop the best fit PCI deterioration model for each of the families using the 95% envelope for identification of outliers. The models are presented in **Figures 3.11, 3.12, 3.13, and 3.14** respectively. Using a Critical PCI of 60, the functional age of each of the families was calculated and the results summarized in **Figure 3.15**. As seen in the figure, there is a significant loss in the pavement functional life exceeding 60% for both the Local and the Select streets. This is not surprising based on the results of the distress analysis presented earlier.

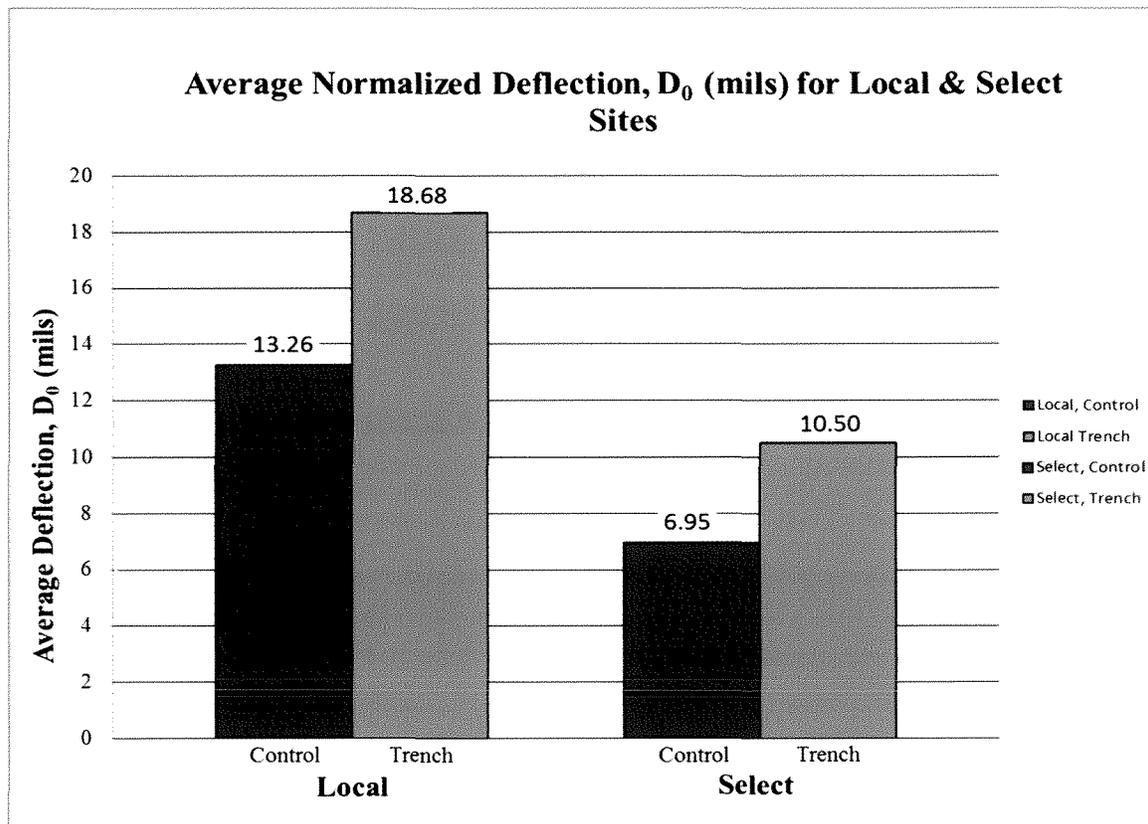
Figure 4.4 – Comparison of Control and Trench (PAT) Average Deflections

Accumulated deflection, D_0 (Normalized to 9 Kips and 68° F) of Local Sites and respective Controls clearly show higher accumulated deflection on trenches than controls. The values are 560 mils and 398 mils, correspondingly. The same observation is seen in Select Trenches vs. Controls where the values are 504 mils and 334 mils, respectively (**See Figure 4.3**). The average normalized deflection (D_0) of Local Trenches was 41% higher than their corresponding Control. The average normalized deflection (D_0) of Select Trenches was also 51% higher than their corresponding Control (**See Figure 4.4**). This shows that the pavement surrounding each trench has been weakened more than the rest of the pavement section, thereby

4. The average deflection around the patches is significantly higher than the Control. **Figure 4.4.**
5. The weakened width around the patch (measured perpendicular to patch joint) varies from 2.5ft to 10ft. with an average of 5.2 ft. The deflection ratio around the edge of the patch compared to away from the patch ranges from 1.25 to 2.74 with an average of 1.59. **Figure 4.17.**

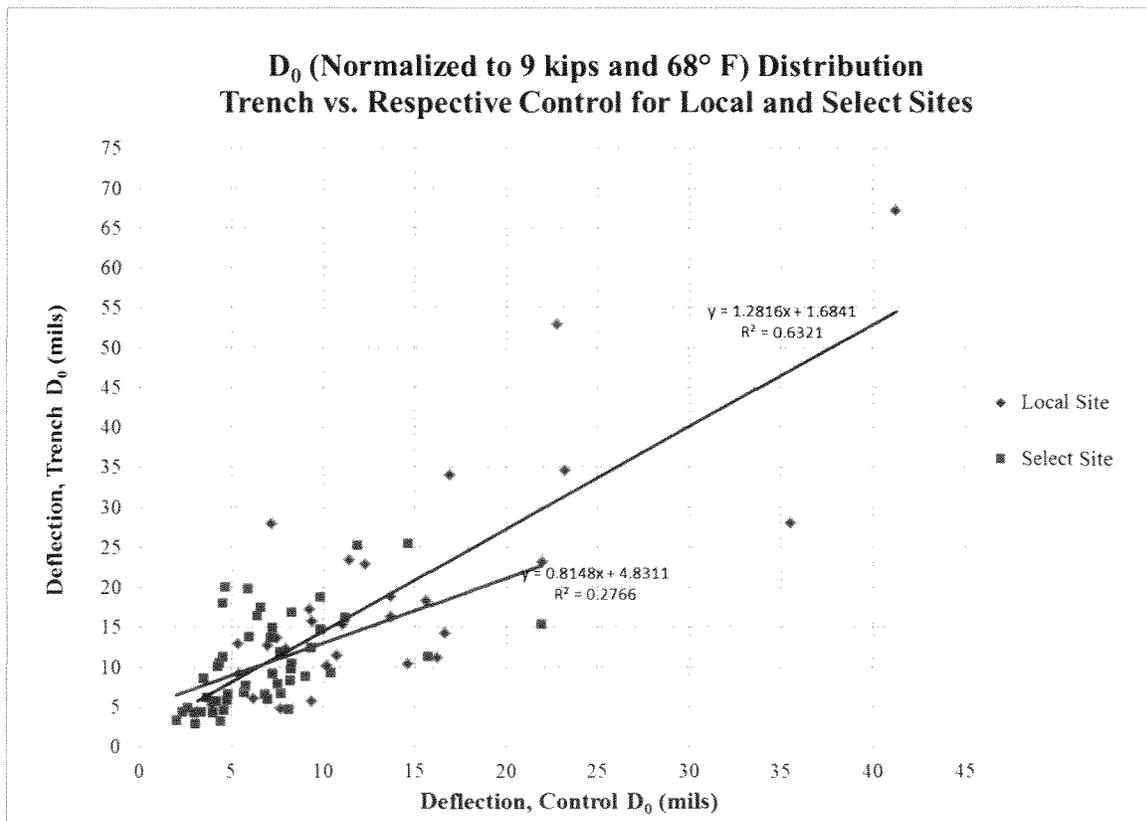
A regression analysis was performed to determine the relationship between the average normalized deflections (D_0) of Local and Select trenches and their respective controls by means of a scatter plot (See **Figure 4.5**), then a straight line (the best fit of the regression line) that describes such relationship in the best possible manner was calculated and drawn with the Excel program.

The trend of the regression line clearly shows that the normalized deflections in the trench area are higher than the control area or that the trench area has been debilitated by the utility trench.

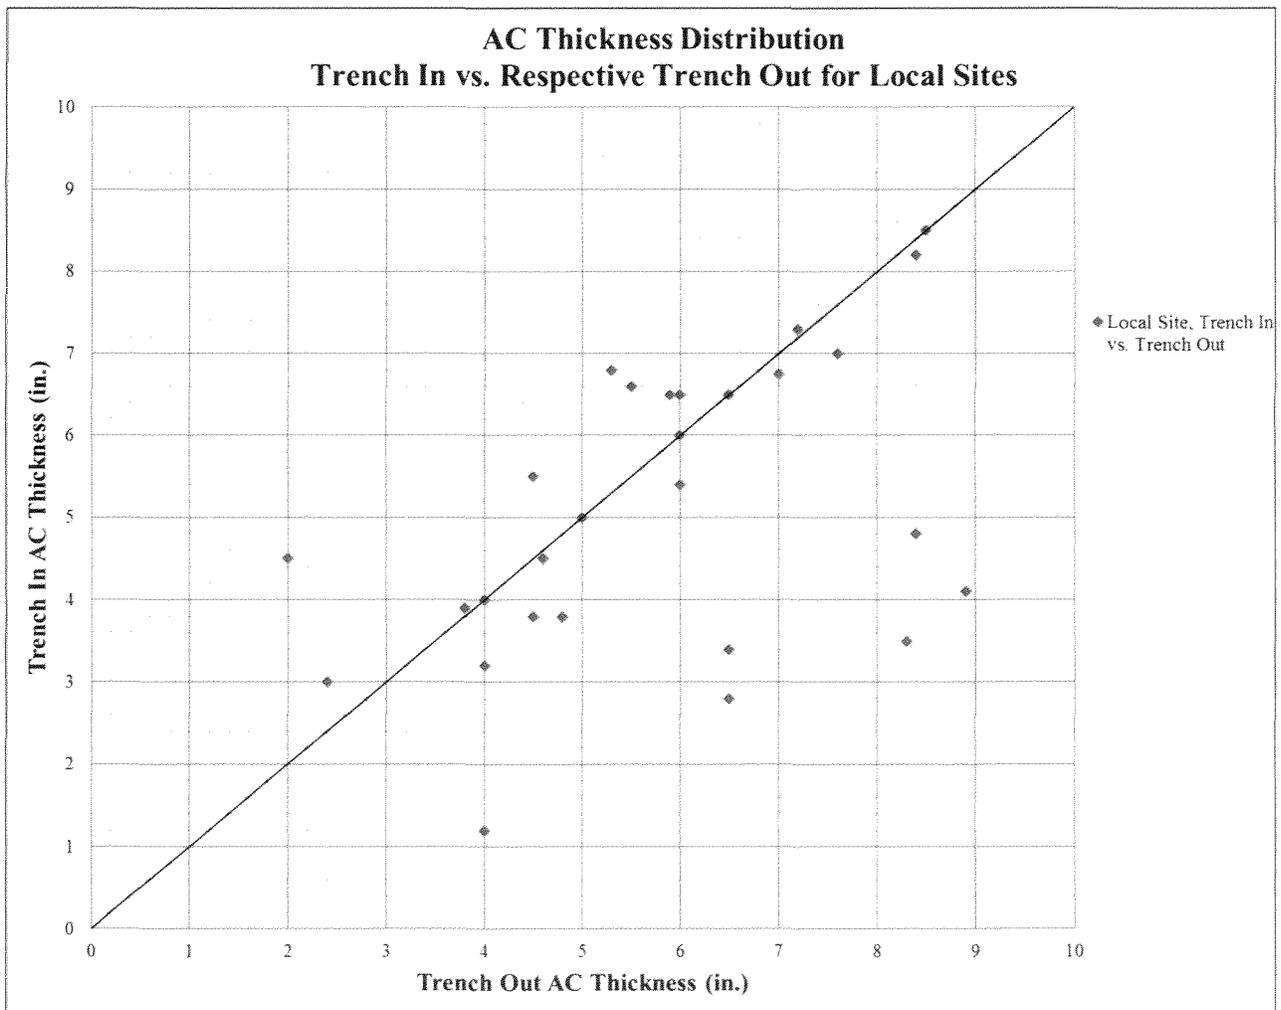
Figure 4.7 – AC Thickness Comparison between Trench – in and Trench -out for Local Sites

than Local streets. This is further illustrated in **Figures 4.7 and 4.8** showing a scatter plot between the Trench-out and Trench-in AC thickness for Local and Select sites. The figures show that most of the Select trenches and several of the Local trenches were not properly restored to match the original pavement AC thickness. **Figure 4.9** is a photo of the coring process.

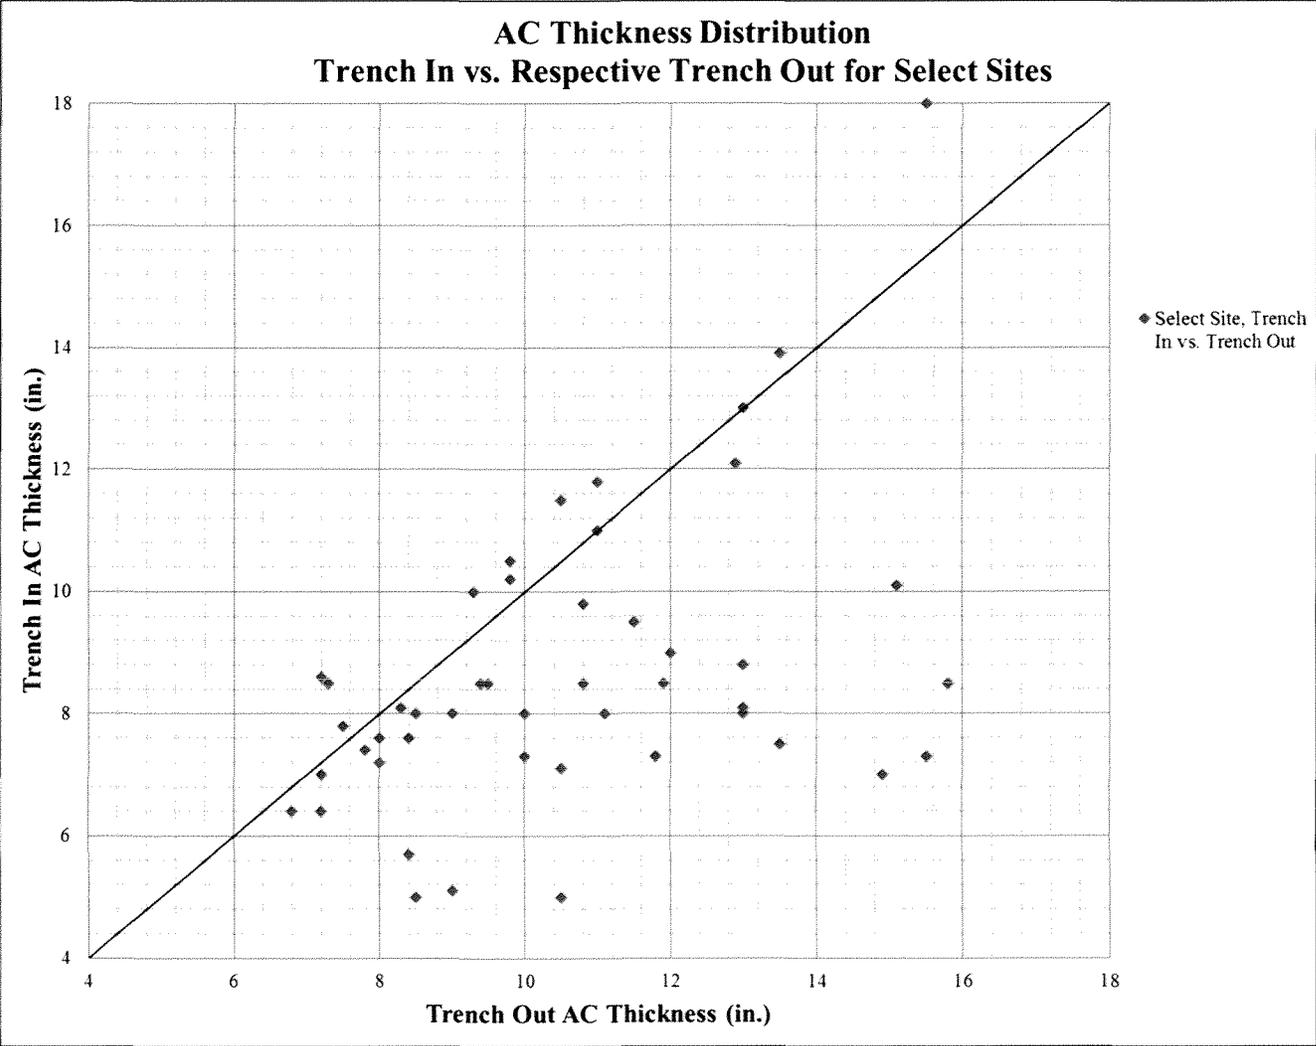
Figure 4.8 - AC Thickness Comparison between Trench – in and Trench -out for Select Sites

Furthermore, the study indicated that utility trenches were not properly restored to match the original pavement condition. It is also evident that the damage and the repairs on higher traffic streets (**Select**) due to utility trenches are higher and therefore, costlier than low traffic streets (**Local**).

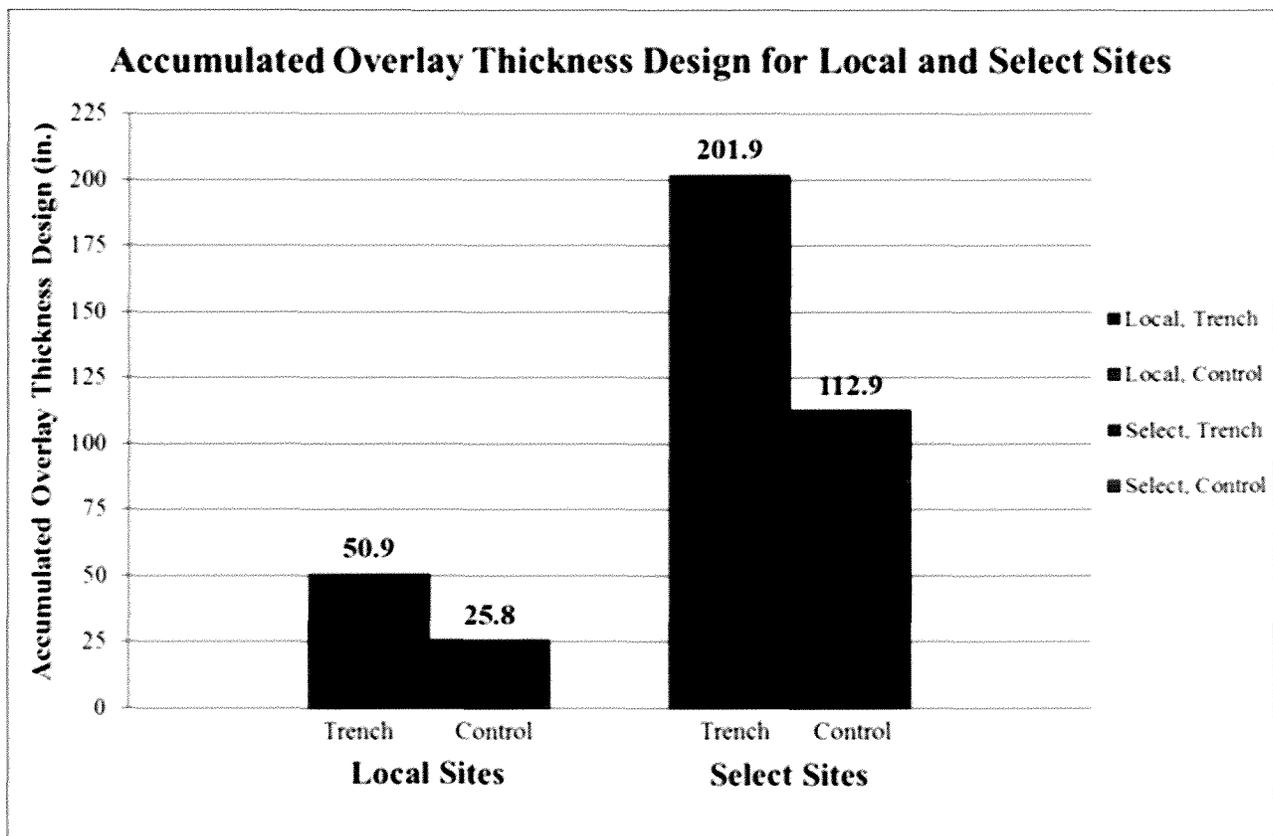
Figure 4.12 – Comparison of Accumulated Required Overlay Thicknesses

The accumulated overlay thickness design, in inches, for Local and Select trenches and their respective control areas are presented in **Figure 4.12**. In both street classifications, the accumulated required thickness design is significantly higher in the Trench area than the Control area (98% higher for Local & 79% higher for Select).

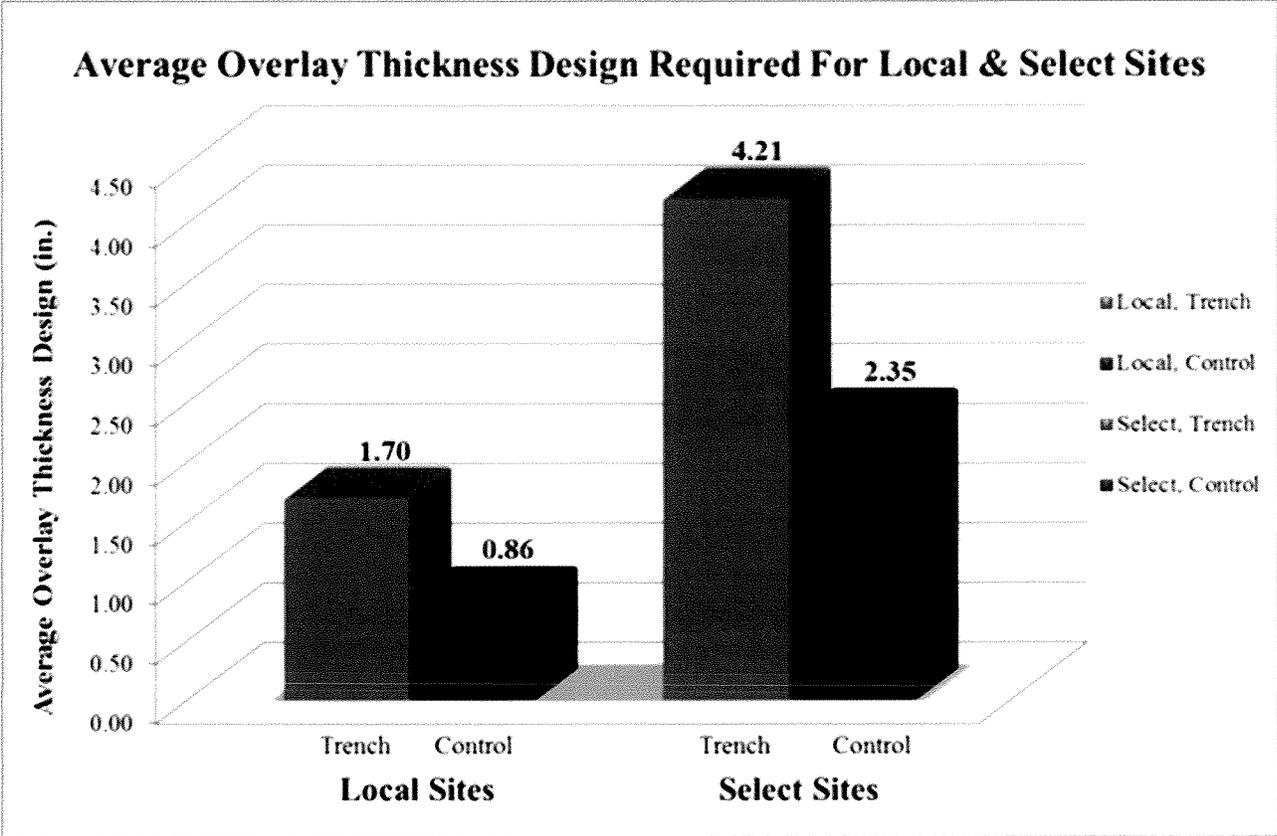
Figure 4.13 – Comparison of Average Required Overlay Thicknesses

In addition, the average overlay thickness design has also been calculated to illustrate how the weakness inflicted in the pavement by the utility trench must be restored with “additional thickness structure” to meet traffic demands when compared with the control average overlay thickness design required to meet such demands (see **Figure 4.13**). Using this figure, it was concluded that the Local trench areas require an average of **0.84** inches more structure than its respective control and an average of **1.86** inches more structure is required for the Select trench area than its respective control. This means that the trench’s surrounding pavement has been negatively affected by the excavation of the trench, and the effects are very significant and costly to remediate the damage caused by the trench to bring the structure back to its original capacity.

6. The loss in structural life was estimated at 55% for Local sites and 53% for Select sites. **Figure 4.15.**
7. The average overlay design thickness for Patch is about twice as much as that needed for the Control. **Figure 4.13.**

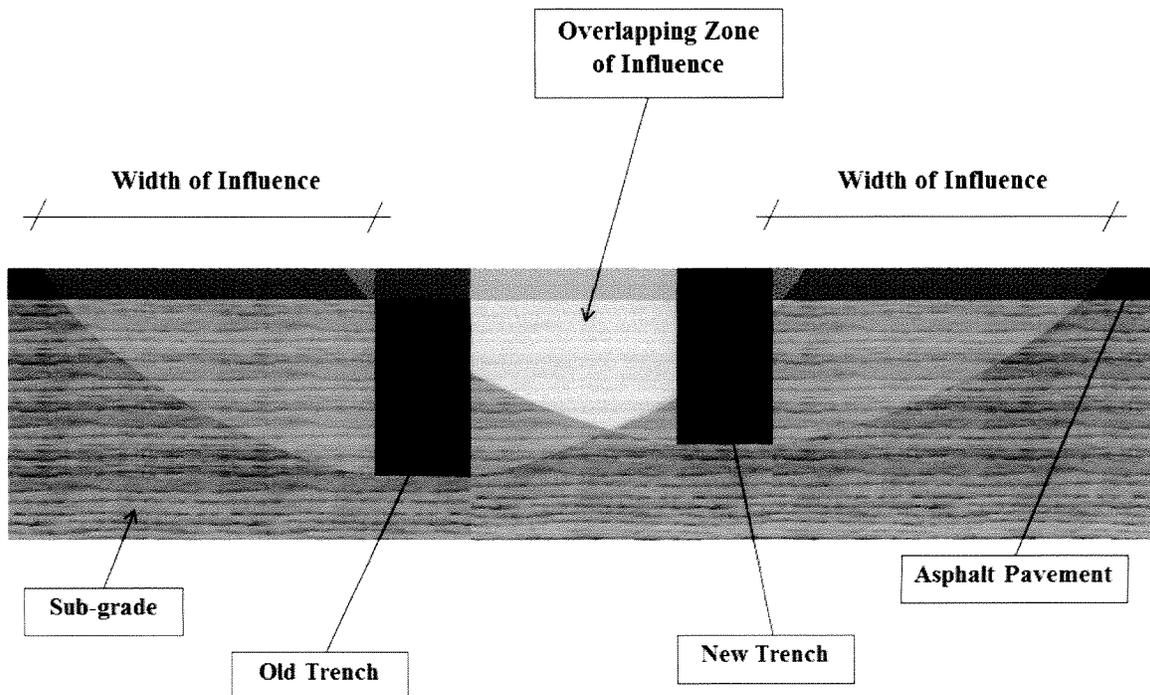
Figure 4.18 - Sketch of Overlapping Width of Influence under pavement.

The results clearly show that utility cut patching weakens the surrounding pavement structure and thus the shorter functional life as well as the need for a thicker overlay thickness at the time of rehabilitation. The weakening of the pavement structure can also be compounded when the influence of two utility cut patches intersects as illustrated conceptually in **Figure 4.18**.
