RE: **LA TUNA FIRE RESPONSE AND RECOVERY SUMMARY REPORT**

BOE La Tuna Fire Burn Area Mitigation – Assessment and Recommendations W.O.
E1908261

SUBJECT: **La Tuna Fire Burn Area Mitigation – Assessment and Recommendations**
W.O. E1908261 **BOE-GED File No. 17-200**

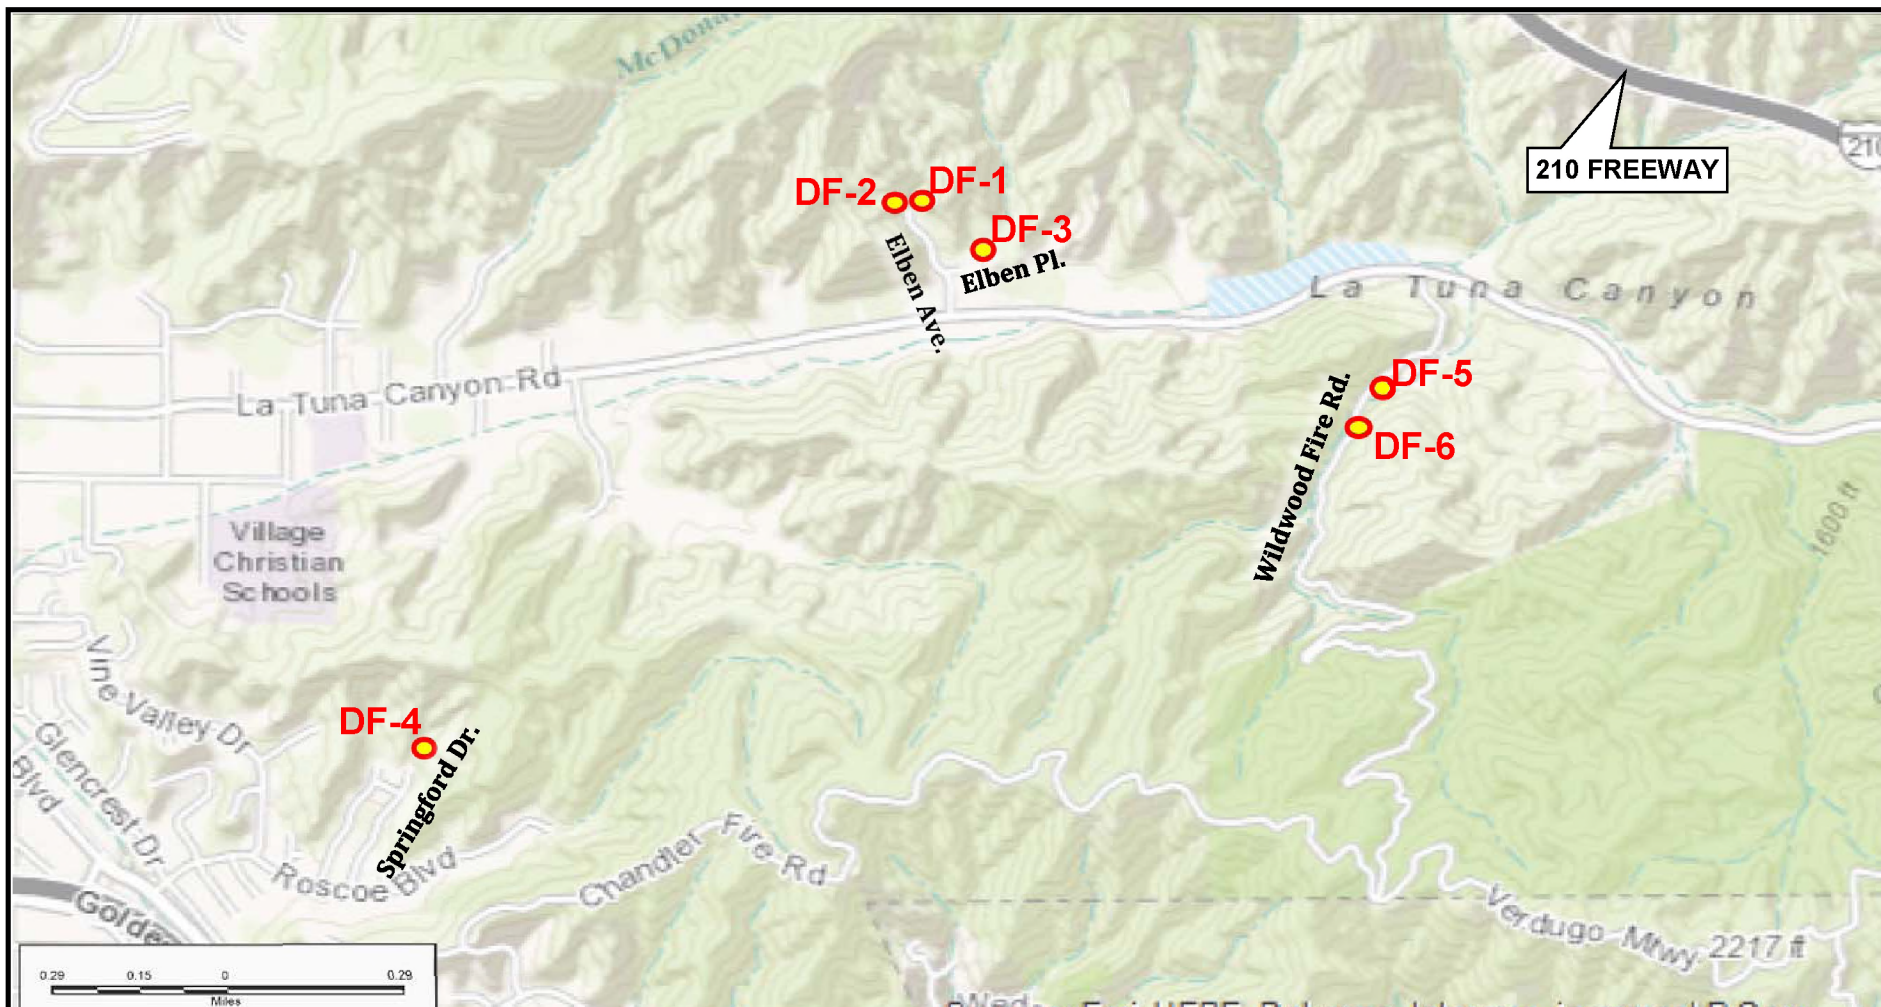
FIGURE No. 1

As illustrated in Figure 1, debris fences are situated near the northern terminus of Elben Avenue, near the eastern terminus of Elben Place, along Wildwood Fire Road, or near the northeast terminus of Springford Drive in the Verdugo Mountains of Los Angeles (Figure 1). For purposes of discussion, the debris fences have been identified as DF-1 through DF-6 herein. According to Navigate LA, DF-3 through DF-6 were constructed on private property, and DF-1 and DF-2 were constructed across both private property and the public right-of-way (Figures 2 through 5). Permission to access DF-5 and DF-6 was requested by GEO but not allowed by the private property owner. The condition of DF-5 and DF-6, following the wildfire, was verbally reported to GEO by the property owner, and those statements are included herein.

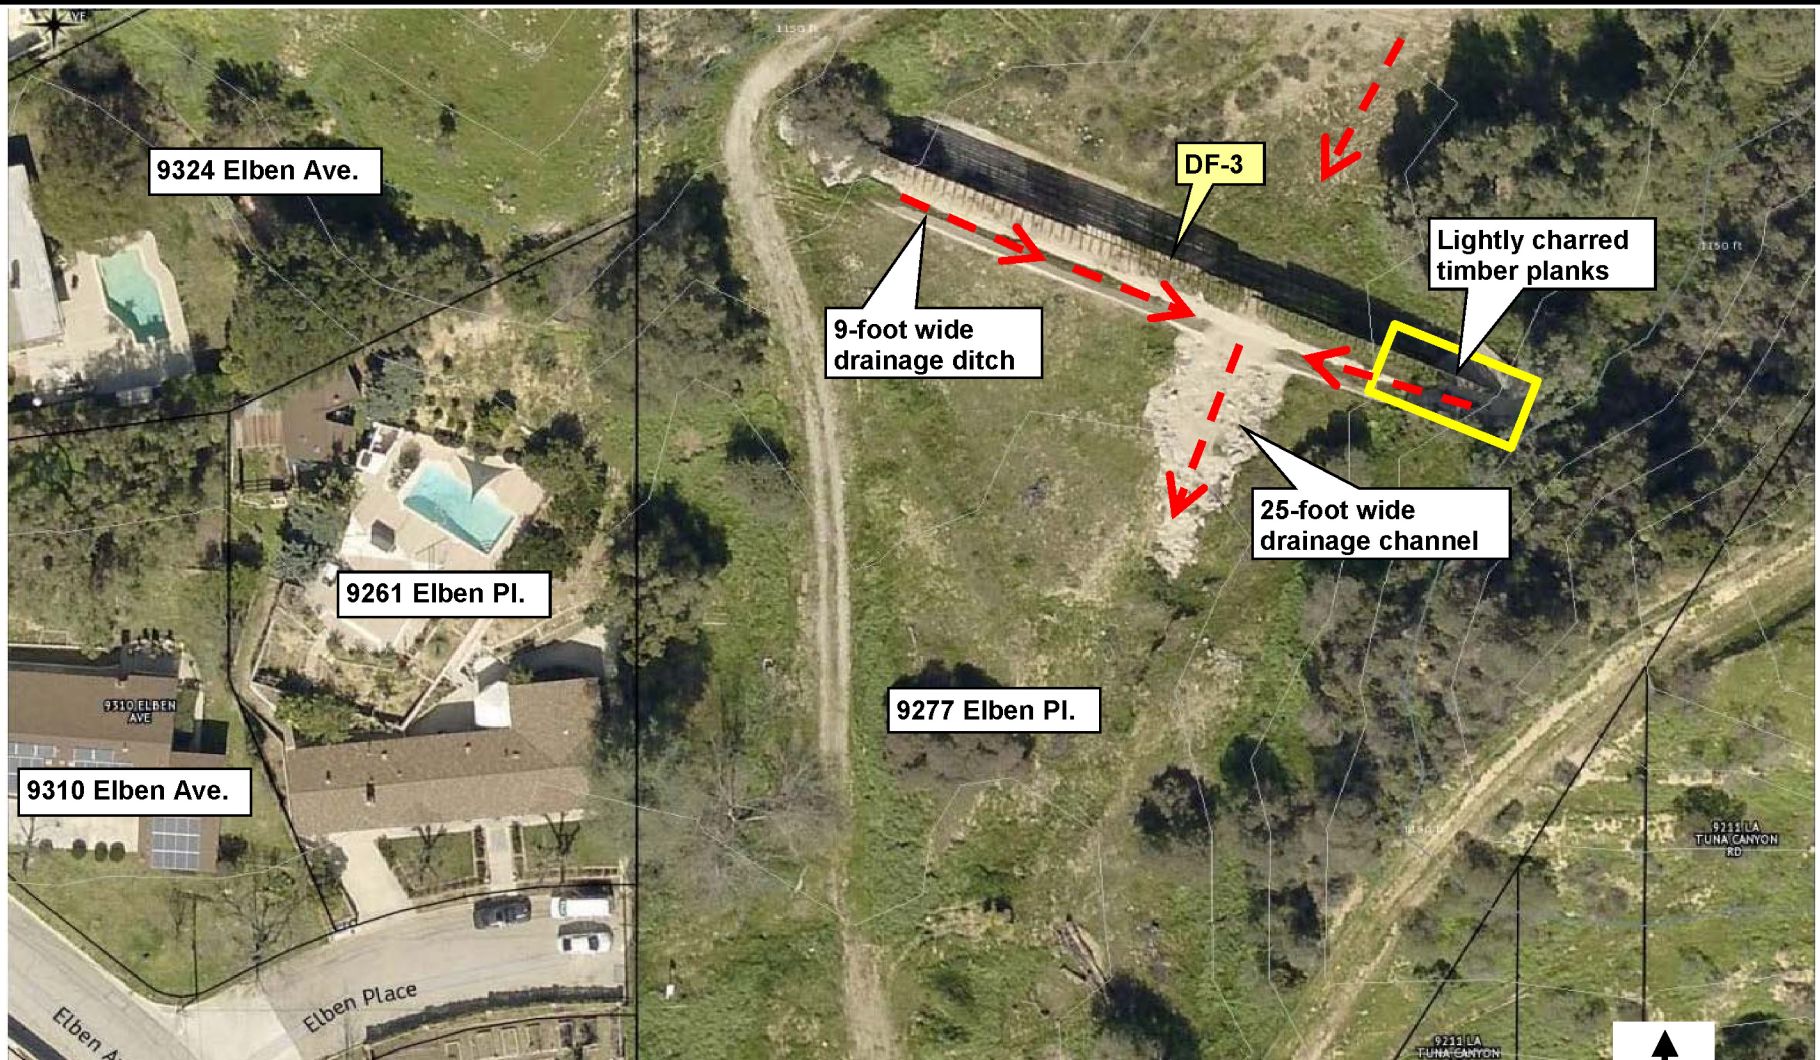
FIGURE No. 3

Runoff that flows through the debris fences is directed to a variety of downstream improvements. Downstream of DF-1, DF-2 and DF-4 are Portland cement concrete (PCC) access roads that are lined by PCC curbs, and facilitate both vehicular access and direct runoff toward the storm drain system (Figure 4 and Photo 3). Directly downstream of DF-3 is a 9-foot wide PCC drainage ditch that trends parallel to the fence. The drainage ditch flows toward a 25-foot wide drainage channel that directs runoff away from the fence in a southwesterly direction (Figure 3 and Photo 5).
