**Appendix C**  
**Piezocone Penetration Testing Data**

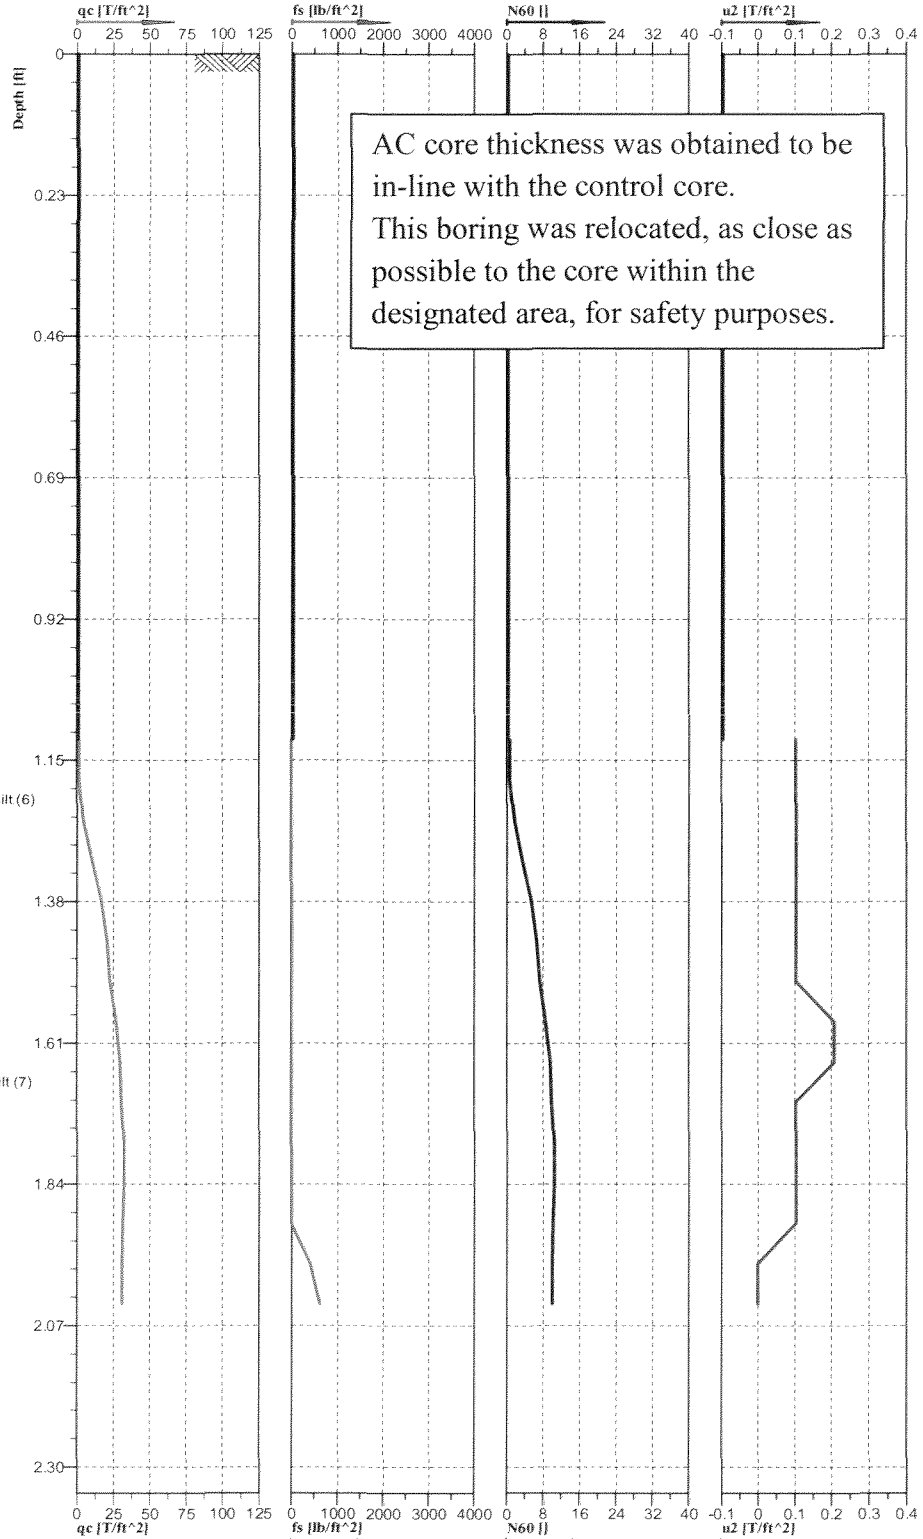
Lab No.: 17-741-137

Classification by  
Robertson 1986

Cone No: 4130  
Tip area [cm<sup>2</sup>]: 10  
Sleeve area [cm<sup>2</sup>]: 150

Location: 18011 Sherman Way	Position: X: 0.00 ft, Y: 0.00 ft	Ground level: 0.00	Test no: 1
Project ID: Select Site # 10	Client: Street Services	Date: 11/8/2016	Scale: 1 : 3
Project: SDRF		Page: 1/1	Fig: 1
TRENCH OUT		File: S10 Trench Out.cpd
