# **The Hollywood Fault — Prudent Steps Forward in 2015**

by Robert H. Sydnor

The purpose of this report is to assess the location and activity of fault strands associated with the Hollywood Fault within the Hollywood 7½-minute quadrangle. Those faults determined to be sufficiently active (Holocene) and well-defined are zoned by the State Geologist as directed by the Alquist-Priolo Earthquake Fault Zoning (AP) Act of 1972 (Bryant and Hart, 2007). This report does not attempt to reevaluate any strands of the Newport-Inglewood Fault zone.

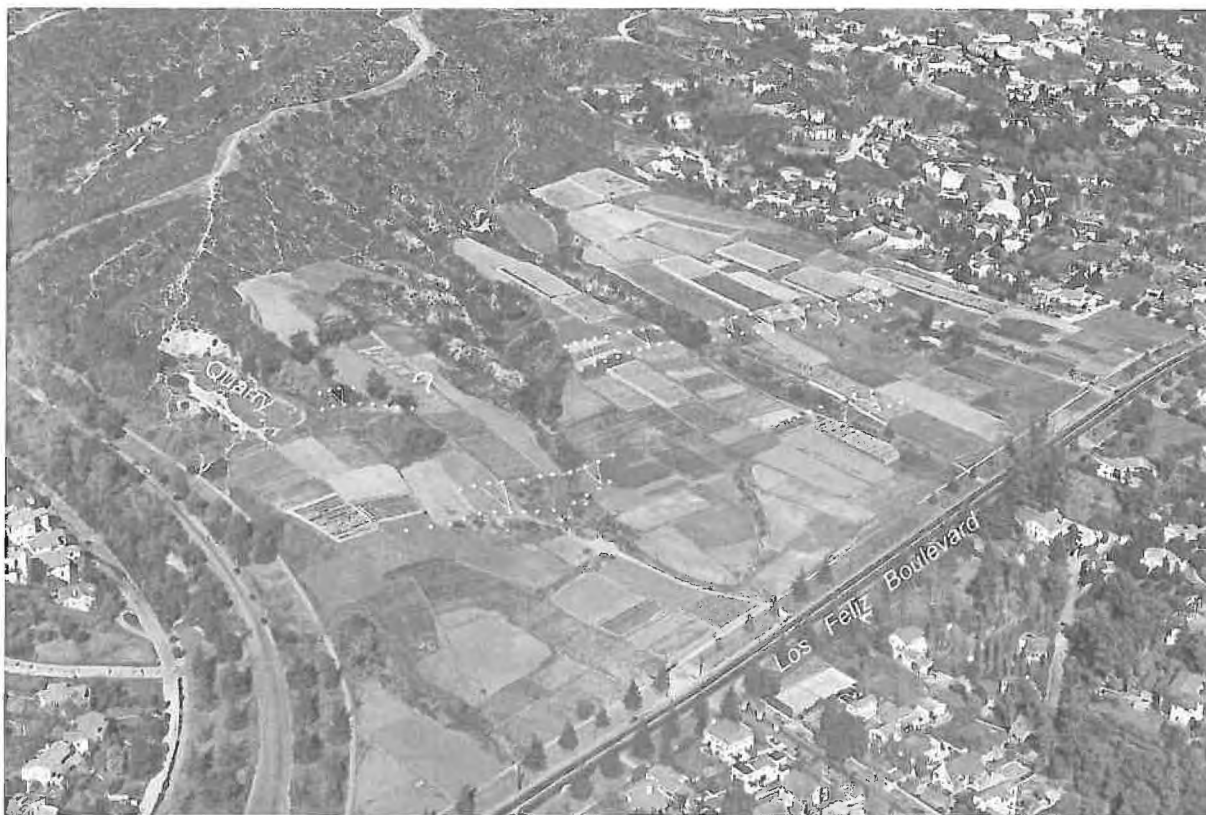
**Figure 15** - Oblique aerial view of the Mead Estate from 1928, showing principal and minor scarps (Yellow dotted lines) extending across the property. Site is located at the west end of Los Feliz Boulevard (Plate 2, site 5). (Photo by Fairchild Aerial Surveys, 2/25/1938, from UCLA Geography Department).

A northern strand is defined at its western end by an offset fan surface (Plate 2, site A5) that is observable in vintage aerial photography as shown on Figure 15. There is at least one principal fault indicated by the steepest drop in the surface (S4a) and possible secondary faults between the principal strand and Los Feliz Boulevard indicated by additional local breaks in the slope gradient. Further east, this fault, as a single strand, is intermittently expressed by steepened slopes along trend (S4b, S4c); the fault is locally overlain by younger fans, such as that emanating from Vermont Canyon. At its eastern end it passes through a local topographic saddle (S4d) and then appears to join the Los Feliz Boulevard fault strand.

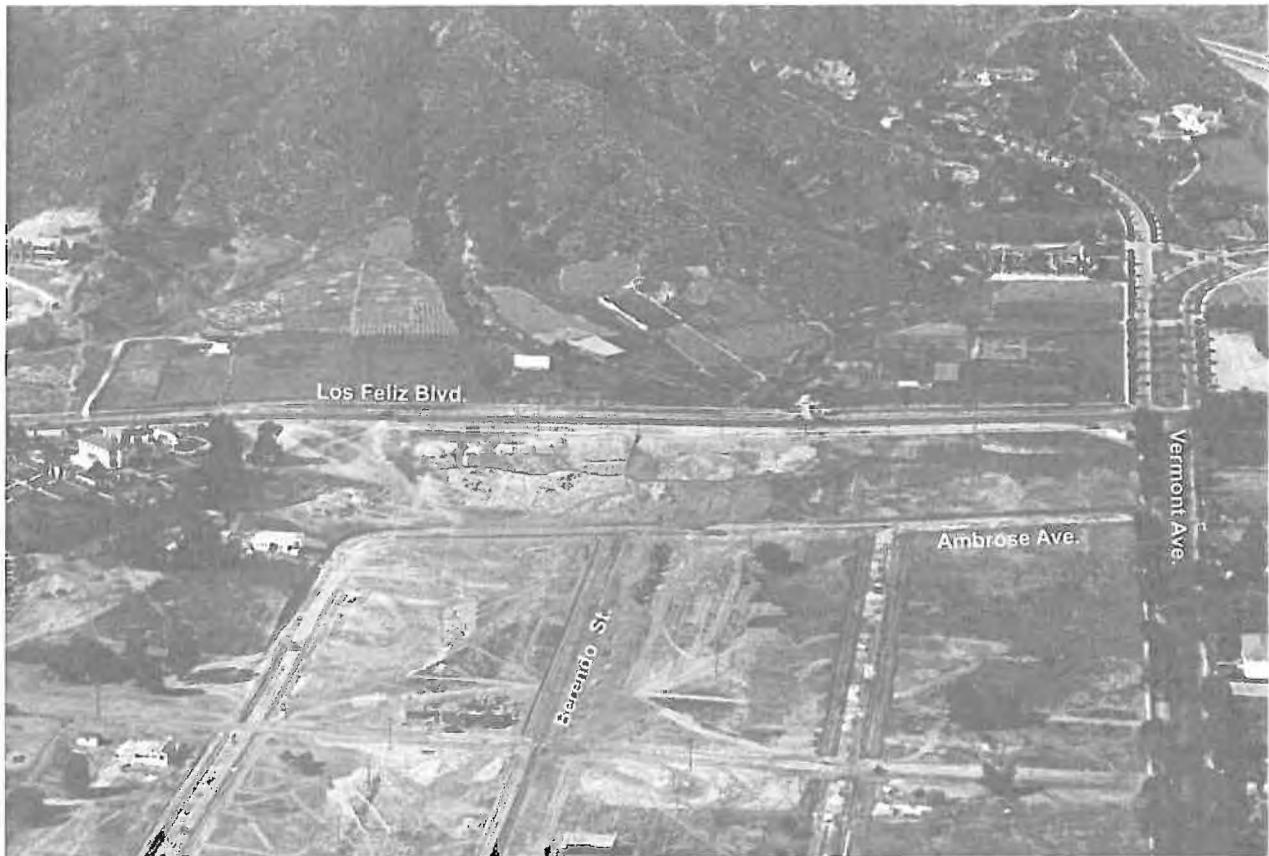
**Figure 16** - Oblique aerial photo near the intersection of Vermont Ave. and Los Feliz Blvd. showing fresh grading south of Los Feliz Blvd. Lineaments (highlighted with red) are possible fault traces. (Photo by Spence Aerial Photos, circa 1921; from UCLA Spence collection).
