**CALIFORNIA GEOLOGICAL SURVEY
FAULT EVALUATION REPORT FER 253**

**THE HOLLYWOOD FAULT
in the Hollywood 7.5' Quadrangle
Los Angeles County, California**

by
Janis L. Hernandez
Engineering Geologist
and
Jerome A. Treiman
Senior Engineering Geologist
February 14, 2014

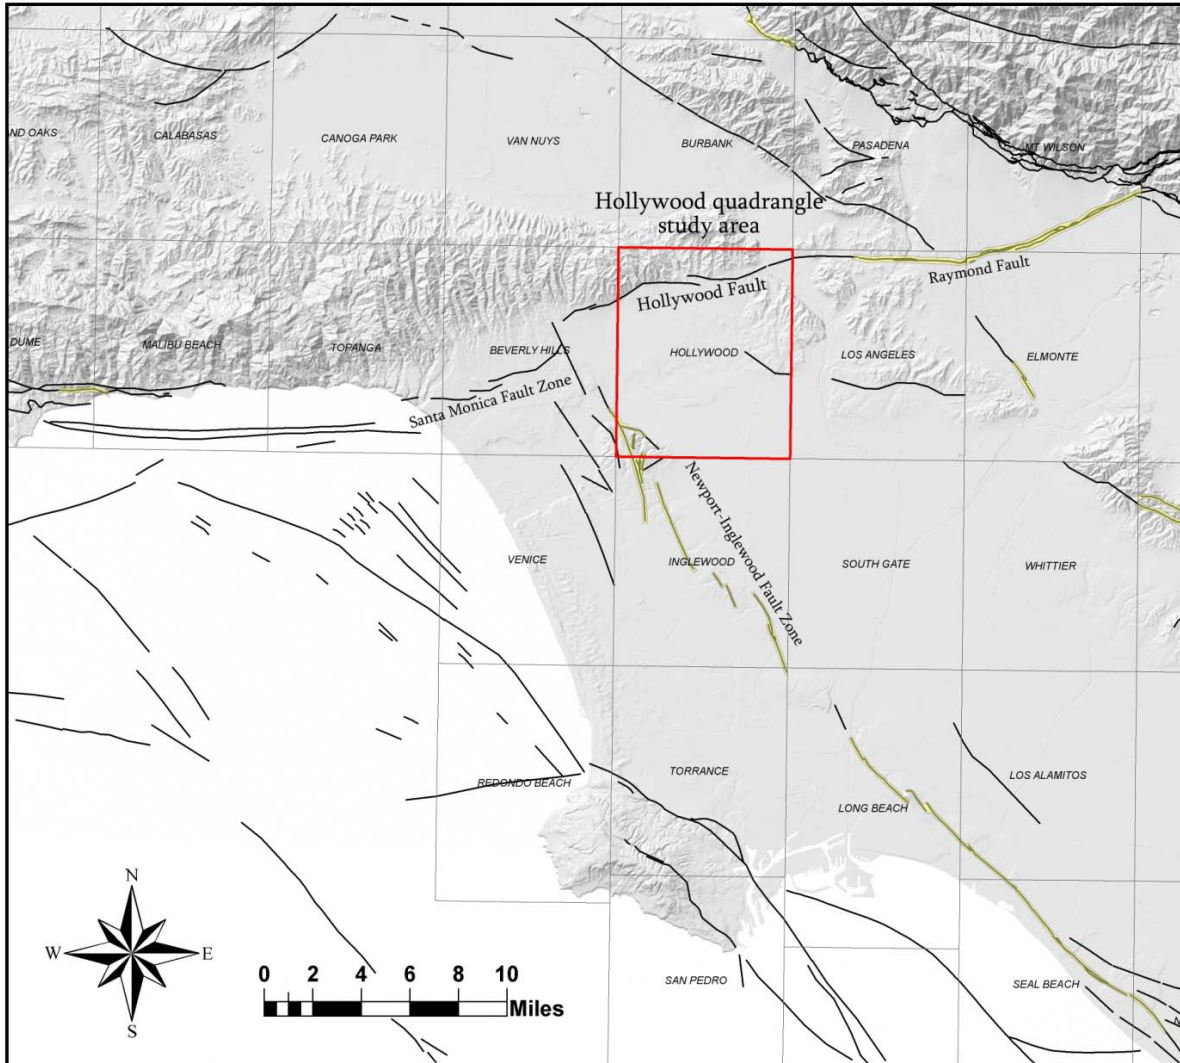
Figure 1- Study area of the Hollywood quadrangle and names of selected faults in the vicinity. Faults within existing Alquist-Priolo Earthquake Fault Zones are within yellow-shaded boundaries; other faults are indicated in black. Fault strands of the Newport-Inglewood Fault Zone are not a part of this evaluation. Source: USGS Quaternary Fault and Fold Database of the United States. (<http://earthquake.usgs.gov/hazards/qfaults/>)

The Hollywood Fault is within the central portion of the Santa Monica-Hollywood-Raymond Fault system, which is collectively part of a greater than 200-km long west-trending system of oblique, reverse and left-lateral faults that separate the Transverse Ranges geomorphic province of California on the north, from the Peninsular Ranges province on the south (Dolan *et al.*, 1997). The Hollywood Fault extends east-northeast for about 17 km through densely populated areas, including the cities of Beverly Hills, West Hollywood, and the community of Hollywood within the City of Los Angeles, trending eastward to the Los Angeles River Valley (Figure 1).

Recent detailed geologic and geotechnical studies for residential and commercial development in the cities of West Hollywood and Los Angeles have reported Holocene faulting at a number of sites along the Hollywood Fault. Infrastructure projects (sewer and subway) and groundwater studies, in addition to gravity data, also provide support that the Hollywood Fault is active and continues eastward toward the Raymond Fault. The majority of the Raymond Fault has been zoned as active, to within about 4 km east of the Los Angeles River at the eastern edge of the Santa Monica Mountains (see Figure 1).

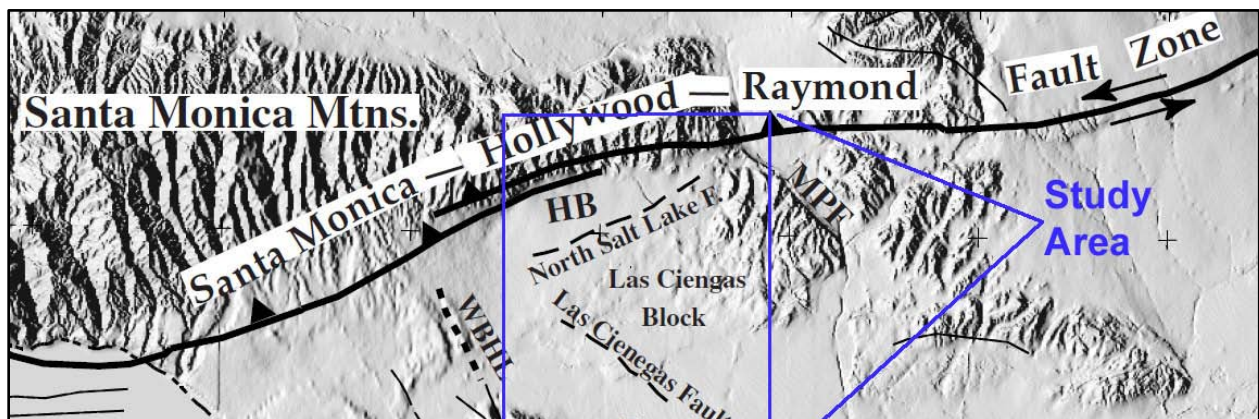
Figure 1a - location of Hollywood Basin (HB) with respect to the Hollywood Fault and the North Salt Lake Fault. (clipped/modified from Hildenbrand *et al.* (2001))

Mapping by Hill *et al.* (1979) similarly reported the Hollywood Fault trace located at the base of the Santa Monica Mountains, however, they also mapped a southern trace, which they referred to as the Santa Monica Fault. This southern trace delineates the south margin of the Hollywood basin, defined by a zone of differential subsidence (shown on Plate 1). The identification of this zone is supported by their analysis of oil well data, groundwater data, and review of precise leveling surveys. A similar assessment of the structural boundary of the Hollywood Basin was made by Hildenbrand *et al.* (2001) based on gravity data, although they identified the southern bounding structure as the North Salt Lake Fault (Figure 1a).

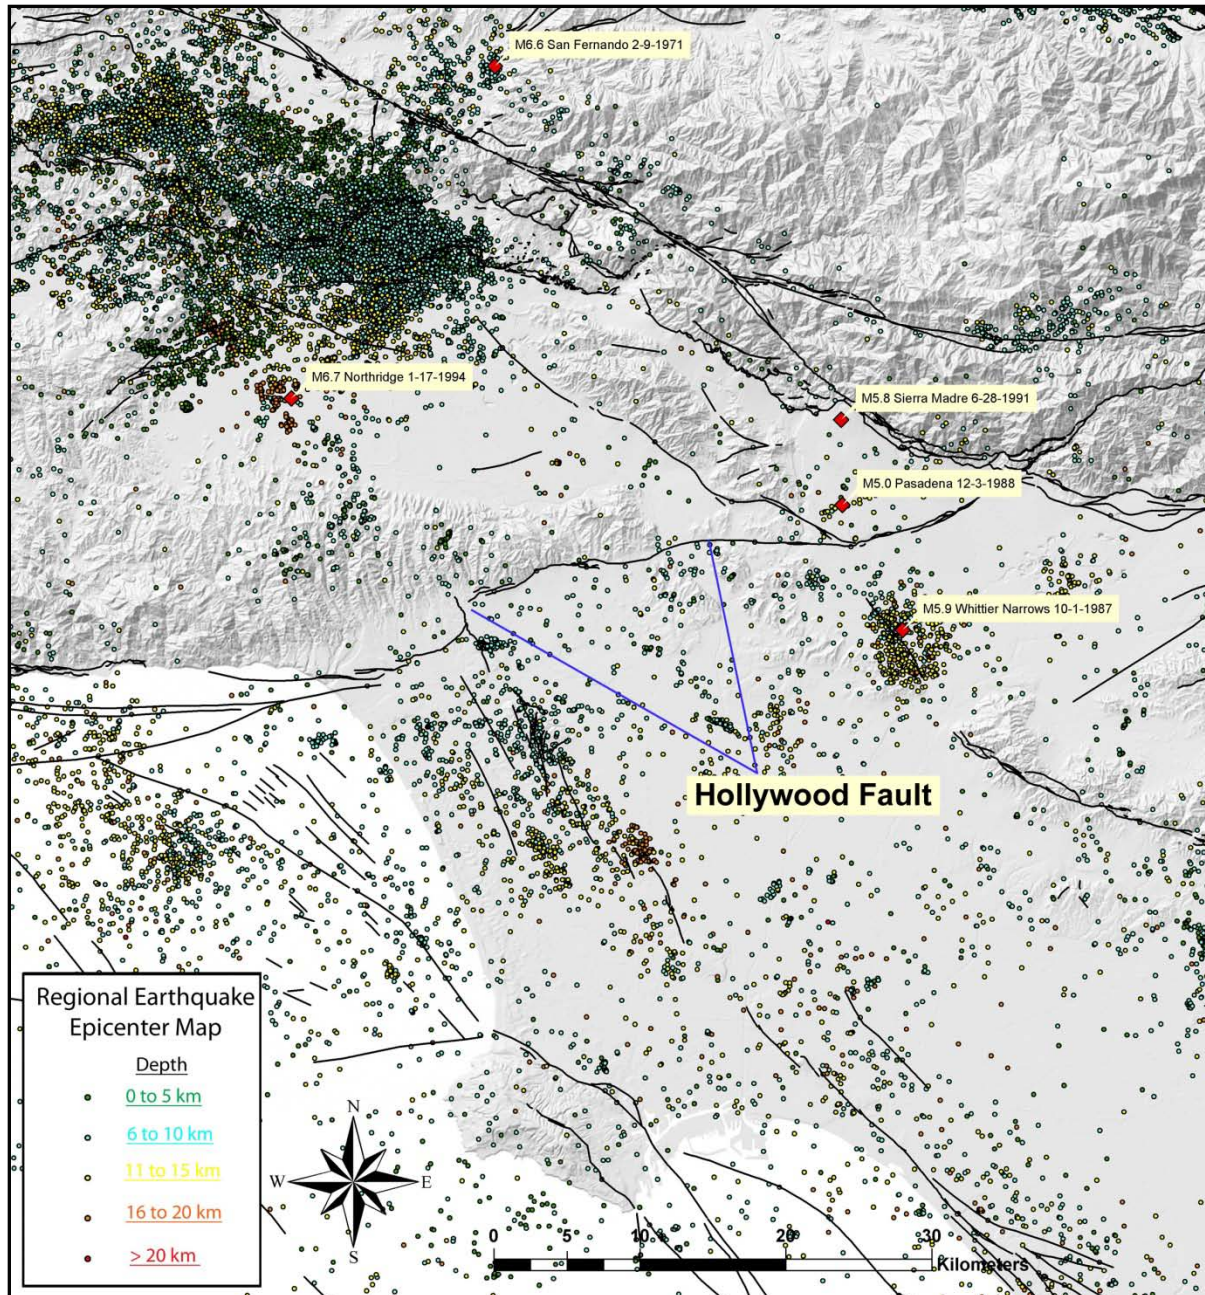
Figure 2 - Regional seismicity from 1981 to June 2011 (Hauksson *et al.*, 2012), including significant faults within the greater Los Angeles basin area. Faults (in black) are from the U.S. Geological Survey and California Geological Survey, 2006, Quaternary fault and fold database. (<http://earthquake.usgs.gov/hazards/qfaults/>)

Regional seismicity records from Hauksson *et al.*, (2012), indicate there have not been any significant earthquake events within the past 30 years that might be confidently associated with the Hollywood Fault (Figure 2). In the Los Angeles region, several historical earthquakes have generated strong shaking in the vicinity of the Hollywood Fault, including: the 1971 M6.6 San Fernando, 1987 M5.9 Whittier Narrows, 1988 M5.0 Pasadena, 1991 M5.8 Sierra Madre, and the 1994 M6.7 Northridge event. The 1988 Pasadena earthquake occurred on the Raymond Fault. Seismic records from the 1988 event provided additional confirmation of left-lateral displacement along the Raymond Fault (Jones *et al.*, 1990).

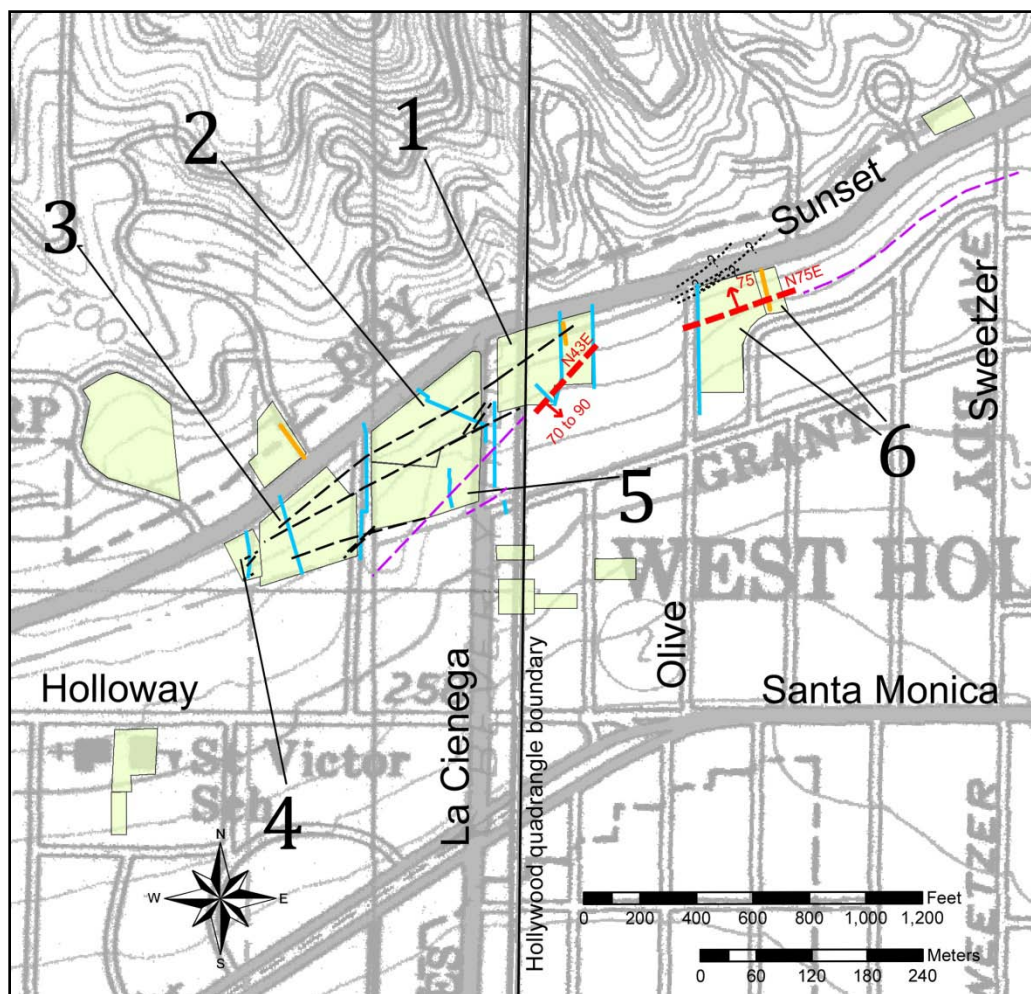
Figure 3- Study site boundaries (light green boxes) where fault studies have provided evidence of faulting (localities 1 through 6, discussed in text; these and other localities are also shown on Plate 1). Un-numbered sites found no evidence of faulting. Faults with evidence of Holocene displacement indicated in red; purple faults are potentially active; black faults are pre-Holocene. Short gold lines are trenches, and blue lines are boring transects. Note: not all exploratory boring transects are shown at this scale.

The City of West Hollywood Fault Precaution Zone Map, and Geologic and Seismic Hazard Technical Background Report, prepared by KFM Geoscience, Inc. (2010) is a crucial part of the City of West Hollywood General Plan. Included in the KFM report is a summary of Fault Rupture Hazard Studies from 29 sites that are on file with the City, collected from 1997 to 2013. Of these reports, 8 sites yielded data that active faulting exists within those sites or otherwise helped constrain the fault location near the western boundary of the Hollywood Quadrangle. Of these 8 sites, several studies were performed adjacent or in close proximity to one another; these are shown on Figure 3.

An investigation by Harza (1998, Figure 3, locality 1) was one of the earliest studies in this area that found two zones of faulting: a northern and a southern fault zone. Paleoseismic studies from borings and trenching at the site indicate these north-dipping faults of the northern fault zone do not offset an argillic soil horizon estimated to be over 120,000 years old based on degree of soil profile development. This northern fault zone includes several strands, which they report strike from N50°E to N70°E, dipping from 50° to 60° NW. Striae and slickensides measured in bucket auger borings provided evidence for north-side-down normal sense of displacement for these northern strands.

The trace of the Hollywood Fault has historically been mapped very close to the mountain front in this area (Hoots, 1930; Dibblee, 1991; Dolan *et al.*, 1997). Recent geotechnical studies within the city of West Hollywood have located the principal active trace of the fault at several sites (see Plate 1; figure 3). These studies have also shown that, although the fault is concealed by young sediment in many areas, the Holocene deposits are quite thick and have been displaced by recent faulting (Harza, 1998; ECI, 2001a; LAW/Crandall, 2001; WLA, 2004)). Some scarps, north of the principal fault trace, have been shown to be related to an ancient shoreline and these are not associated with any evidence of active faulting. Several subtle slope breaks further out from the mountain front are ambiguous in origin and not directly attributable to faulting.

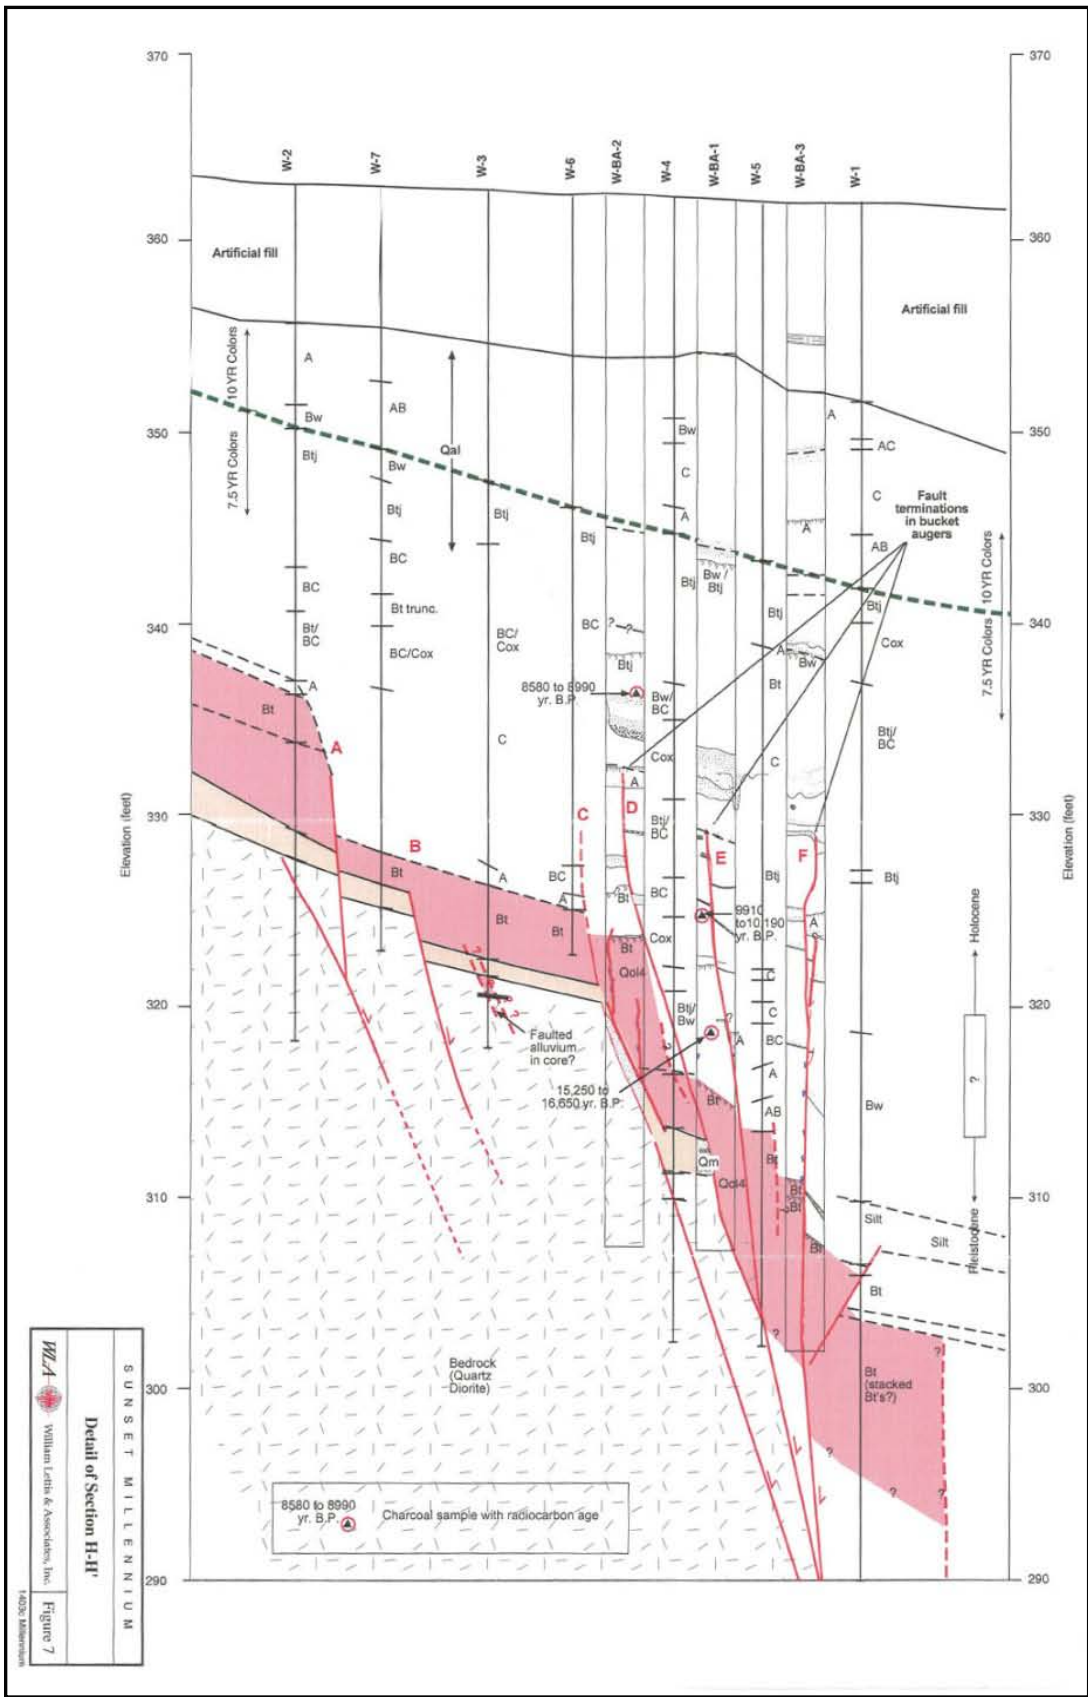
Figure 4 - Upward terminations of fault strands D, E, and F within Fault "1", Locality 1; modified from WLA, 2004.

The southern fault zone (herein discussed as Fault 1) was reported as a northeast striking, southeast dipping fault that vertically offset Quaternary deposits at least 150 feet and acts as a groundwater barrier. Harza (1998) recommended a building setback zone for Fault 1 as a precautionary method until further studies could be made. Recent work, including observations from down-hole logged bucket auger borings and ¹⁴C dating of the soils by WLA (2004) have determined this southern fault zone (Fault 1) is active. Figure 4 illustrates the upward terminations of three strands (D, E, and F) of Fault 1. Fault 1 is oriented N50° to 55°E, dipping 53° to 56° SE as reported from bucket auger down-hole observations. Charcoal samples from faulted soil horizons revealed dates about 9,910 to 10,190 ybp, and 15,250 to 16,650 ybp. WLA (2004) also reported an unfaulted soil horizon above fault strand D to be 8,590 to 8,990 ybp, suggesting a minimum age of faulting at fault strand D. They suggested that, because the fault tips of strands D, E, and F all occur at about the same stratigraphic position, these three closely spaced splays ruptured in the most recent earthquake. Based on the detrital charcoal samples, they concluded the most recent surface-rupturing earthquake on strands D, E, and F of Fault 1 occurred between ~8,500 and 10,000 years ago.

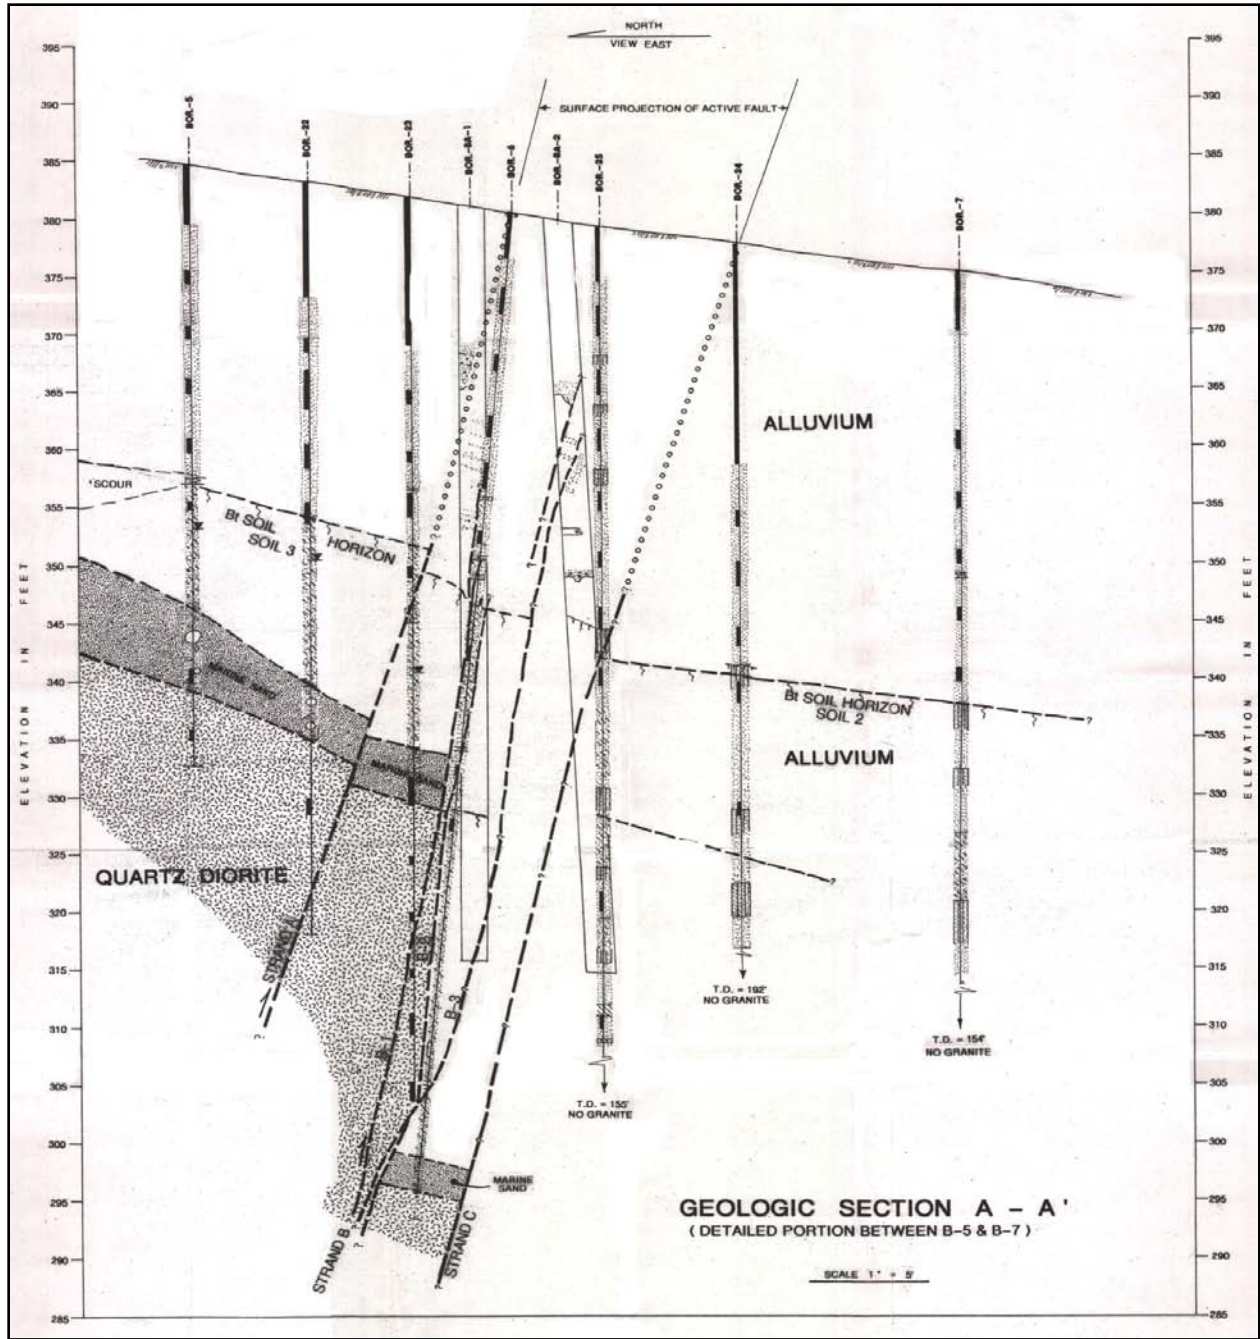
Figure 5 - Cross section showing south-side down offset on the southern fault zone at the southeast corner of Sunset Blvd. and Olive Drive, West Hollywood (site 6). Thickness of marine sand decreases to the south. Modified from Law/Crandall, 2001.

Studies located on the southeast corner of Sunset Boulevard and Olive Avenue at Locality 6 (Applied Earth Sciences, 1997; Johnson, 1999; Law/Crandall, 2001) found that a northern and southern set of faults crossed the site. The northern fault zone, as in studies to the west, was reported as not active based on unfaulted Pleistocene soils at the site. Additionally, these studies encountered the marine abrasion platform and associated cobble and boulder size clasts of well-rounded quartz diorite and other exotic clasts, with well-sorted, clean, fine- to medium-grained sand. They interpreted the northern fault zone as a minor, secondary fault zone that accommodated local extension in a left step of the Hollywood Fault zone. The active southern fault zone is steeply north-dipping, and extends into alluvial units of Holocene age up to within 15 feet of the ground surface (Figure 5). Law/Crandall (2001) determined this strand is active based on radiocarbon dating of detrital charcoal samples, indicating the faulted soils were approximately 9,000 to 10,000 years old. Both Law/Crandall (2001) and Applied Earth Sciences (1997) recommended structural setbacks from the fault. This southern strand vertically offsets bedrock by at least 150 feet of south-side down separation, and also forms a steep groundwater step. Unfaulted Pleistocene sediments were documented south of the southern fault zone.

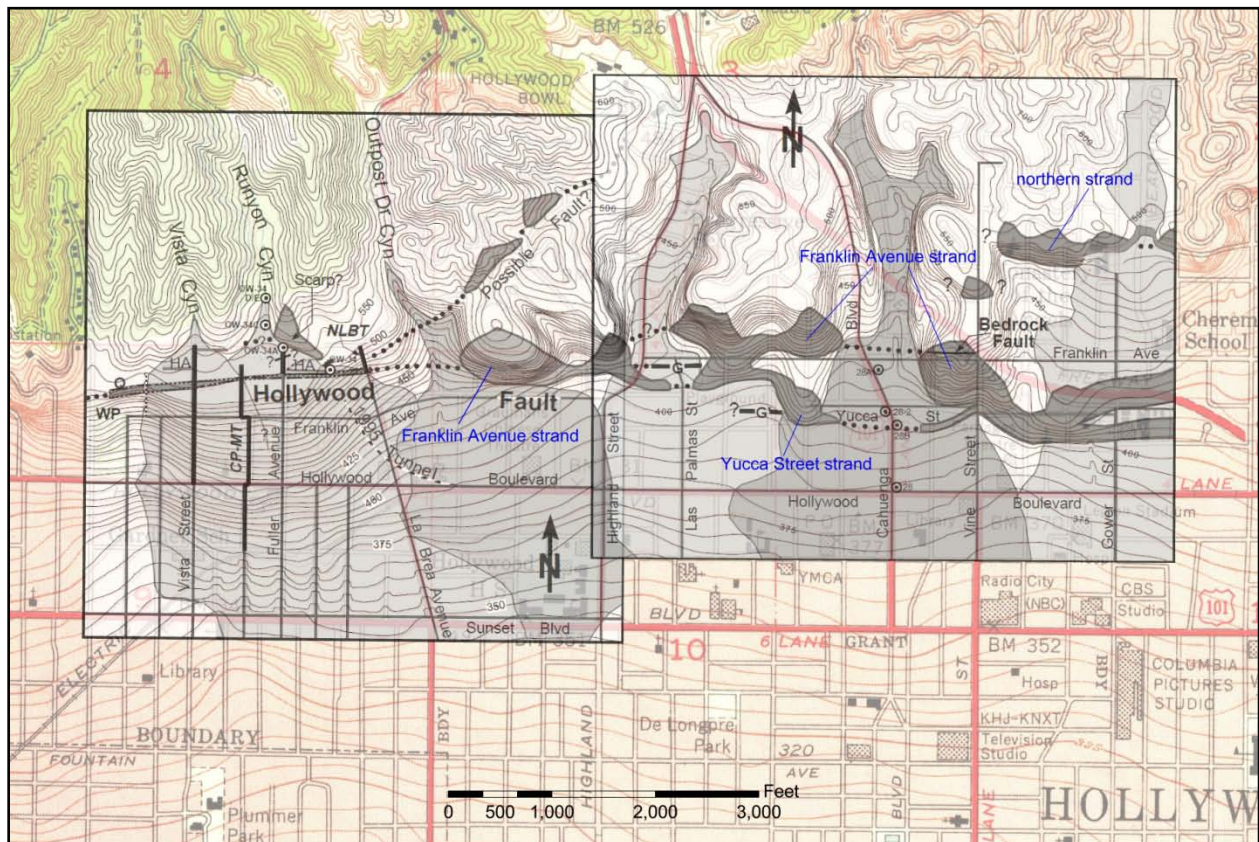
Figure 6 – Detailed mapping and investigations by Dolan *et al.* (1997, their figures 4 and 6), shown overlying a 1953 topographic map base of the Hollywood area. “G” indicates groundwater barrier. Dark shaded areas indicate fault scarps. This historic topographic map is composited from 1923-1925 plane table surveys, with a 5-foot contour interval up to the 500 foot elevation contour and is similar to the topographic data set used by Dolan *et al.* (1997).

Much of the synthesis and reported details in the downtown Hollywood area go back to Dolan *et al.* (1997). Work by Dolan *et al.* (1997) included geomorphic analysis of tectonic landforms along the fault trace using historic topographic maps (1920s vintage) and field reconnaissance. They also presented and analyzed data from several geotechnical studies. They interpreted at least three major fault splays: the Franklin Avenue strand, the Yucca Street strand, and a northern strand as shown in Figure 6 (see also Plate 1). Details of individual parts of their study are discussed below.

There is another line of subdued and discontinuous scarps, mapped by Dolan *et al.* (1997; also see Figure 6), that splays west-northwest from the main fault trace. This possible fault appears to die out with no expression across Brush Canyon or at the Hollywood Reservoir

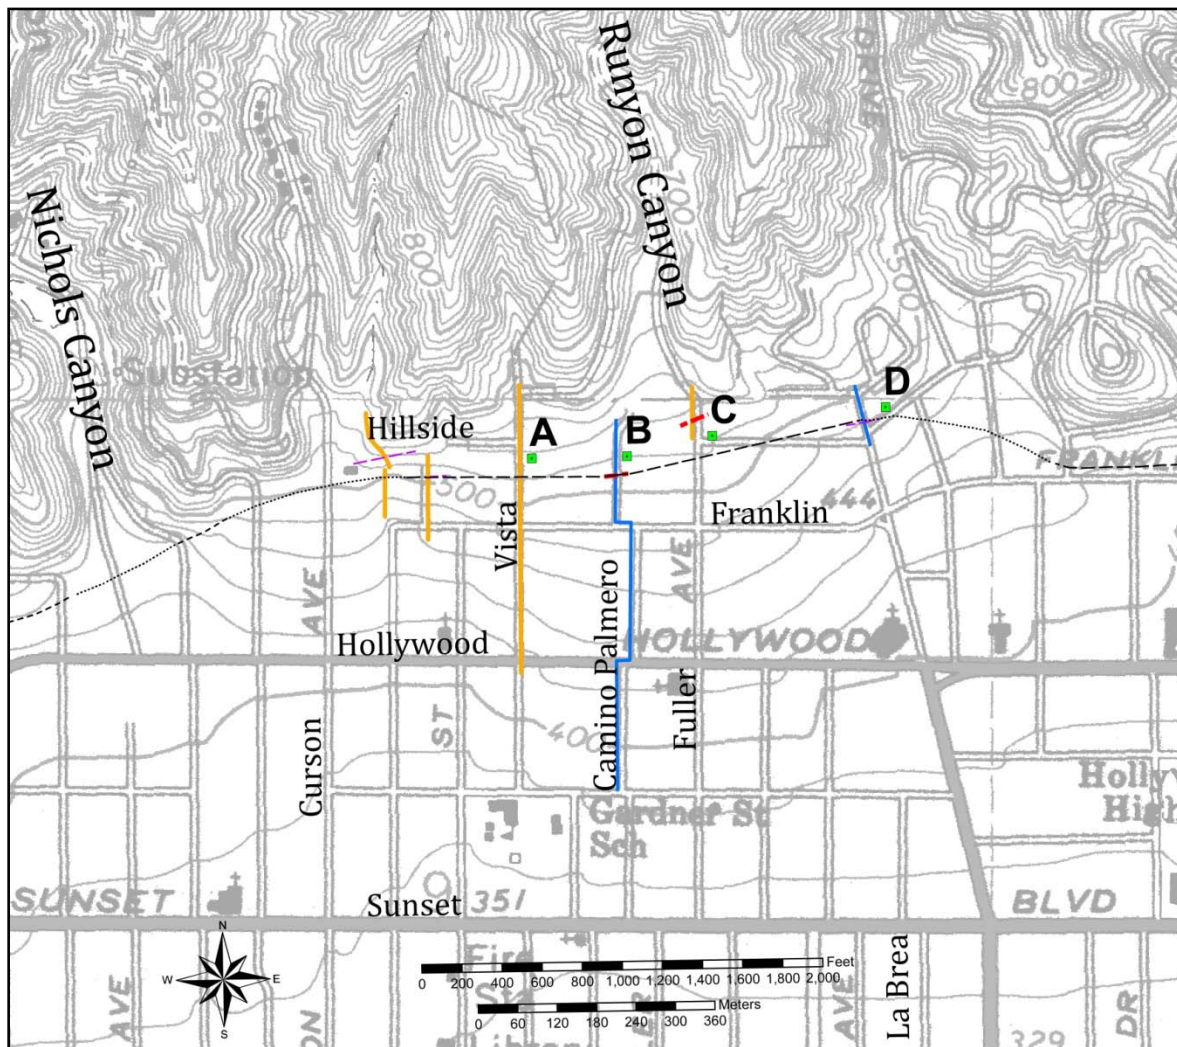
Figure 7 - North Hollywood area, locality 10, showing location of shallow trench data (gold lines) and borehole transects (blue lines) completed for the Metro Red Line study (Earth Technology Corporation (1993), sewer relief trenches and storm drain tunnel. Green squares indicate study localities: A - Vista Street storm drain trench; B - Camino Palmero-Martel Avenue Metro RedLine transect; C - Fuller Avenue storm drain trench; D - La Brea Avenue Metro RedLine transect. Dashed red line segments along transects indicate the active fault trace or projection based on supporting data from adjacent sites. Purple dashed lines represent fault strands of indeterminate age. Black lines are faults recommended herein for zoning.

Along the Vista Street storm drain transect (Figure 7, site A), the Hollywood Fault was not encountered in the ~1400 foot long trench, however (Dolan *et al.*, 1997) reported the depth of this trench was likely insufficient to observe the fault trace. The La Cienega and San Fernando Valley Sewer Relief Tunnel project (1953, as reported in Earth Technology Company, 1993) along Sierra Bonita west of site A, encountered faulted granite with gouge and breccia in test borings.

Along the Camino Palmero-Martel Avenue Metro RedLine transect (Figure 7, site B), evidence for faulting included groundwater barriers and quartz diorite bedrock faulted over alluvium, with average dips of ~77° to the north. Dolan *et al.* (1997) and Earth Technology Corporation (1993) reported up to four fault strands with apparent north side-up displacement of the granitic bedrock at depth (Figure 8), however the southern-most strand appears to be the youngest based on offset younger soils. Groundwater elevation changes were reported on the order of 40 or 50 feet across the fault as shown in Figure 8 (inset). This site was further explored (Dolan *et al.*, 2000) with successive bucket auger borings that revealed additional evidence that one, and possibly two surface ruptures had occurred within the past 20,000 years, the most recent event occurring about 7,000 to 9,500 years ago. Additionally, based on the downhole observations made within the boreholes for this study, Dolan *et al.* (2000) reported that all of the fault strands encountered were near vertical with a dip about 85° northward, and that the most recent surface rupture resulted in north-side down separation. This sense of near-surface separation contrasts with the reverse sense at depth, supporting the contention of Dolan *et al.* (1997) that there is a strong component of strike-slip displacement (presumed left-lateral).

Storm drain trench excavations by Los Angeles County Department of Public Works along Fuller Avenue (Figure 7, site C), revealed a secondary strand of the Hollywood Fault, oriented N59°E, 74°NW with north-side-up vertical separation (reported by Dolan *et al.*, 1997). This fault displaced the base of a possibly Holocene clayey sand.

At the La Brea Avenue Transect (Figure 7, site D) evidence for faulting includes quartz diorite apparently thrust over Quaternary alluvium, similar to the Camino Palmero site (Dolan *et al.*, 1997; Earth Technology Corporation, 1993). Shallow groundwater was encountered north of the fault at depths between about 10 feet to 43 feet, whereas south of the fault groundwater was not encountered within the upper 200 feet of borings. They reported the fault dip steepens with depth, ranging from 25° to 60° to the north.

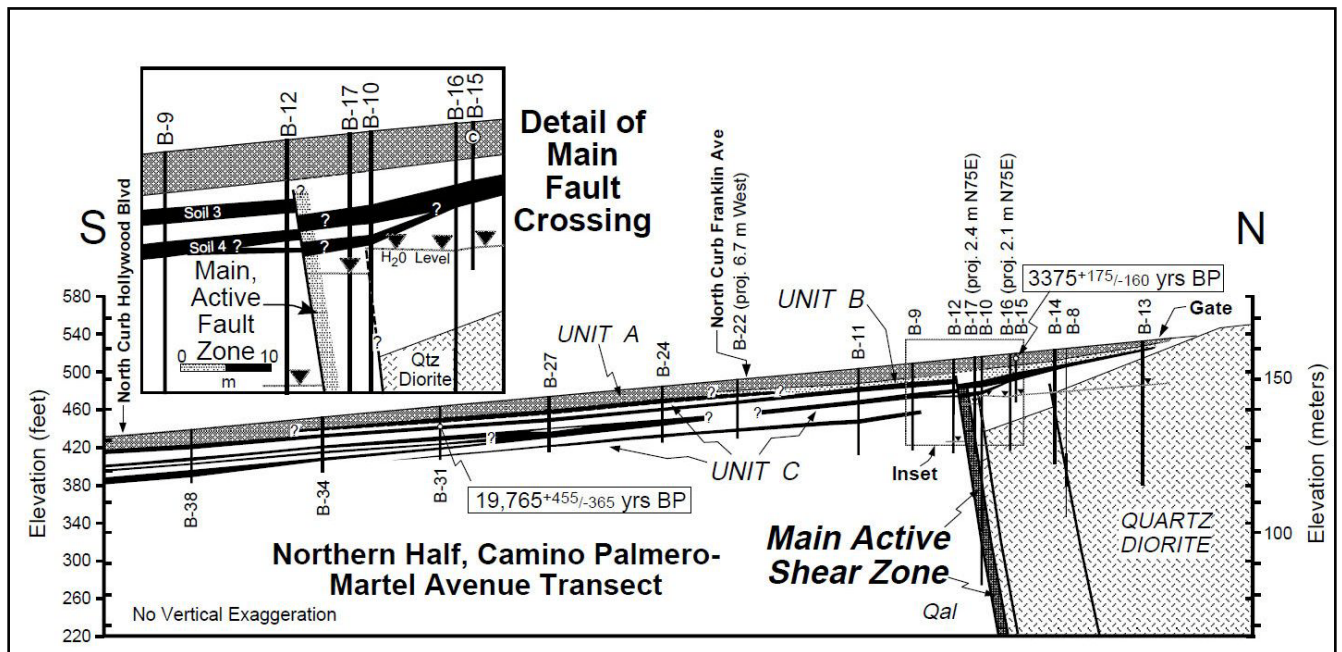
Figure 8 - Cross section of continuously cored boreholes along the northern half of Camino Palmero transect. Note down to the north soil profiles, particularly between B-10 and B-12, across the active fault strand. Depth to groundwater was encountered at about 55 feet on the north, and about 89 feet bgs to the south. Figure modified from Dolan *et al.* (1997).

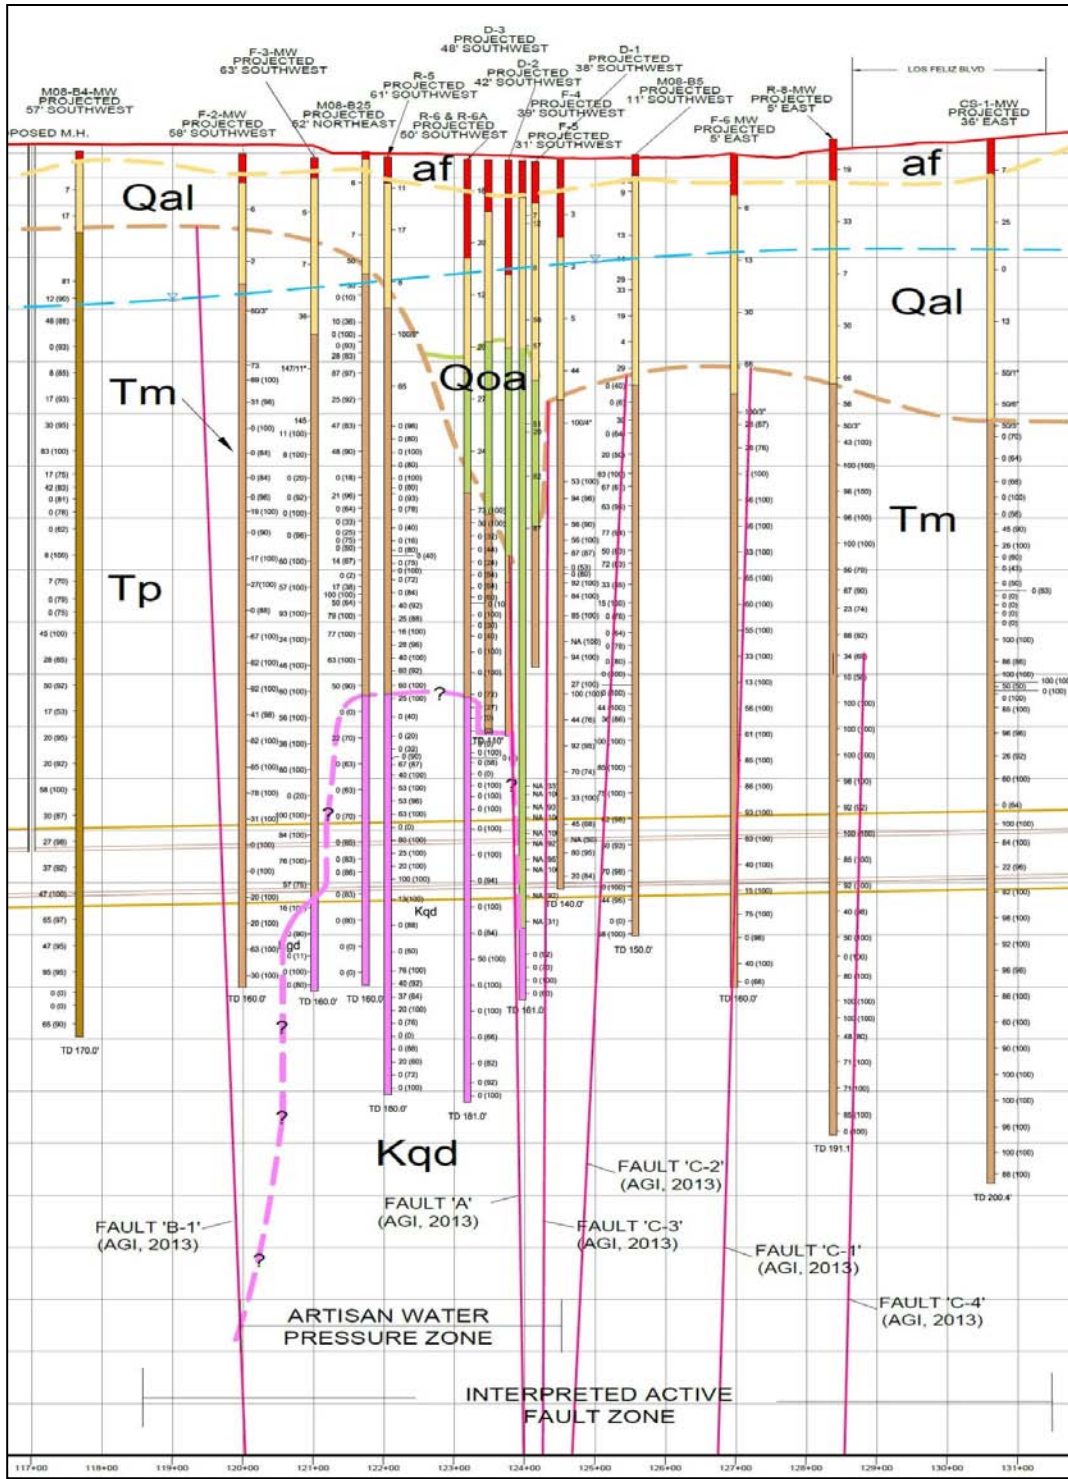
Figure 9 – Cross section with Fault 'A' interpreted as the main trace within the active fault zone. Note differential thickness of recent alluvium, and depth of older alluvium between Fault 'A', and Fault 'C-3'. Kqd = Cretaceous quartz diorite; Tp = Puente Formation; Tm = Modelo Formation; Qoa = Quaternary older alluvium; Qal = Quaternary alluvium; af = artificial fill. Cross section modified from City of Los Angeles Geotechnical Engineering Group (2013). Grids are 10' in height and 100' in width.

identified at least 6 fault traces which dip steeply (north and south) and are interpreted to include the north-dipping main trace of the Hollywood Fault Zone. Advanced Geoscience, Inc. (2013) reports that the main fault and several secondary faults appear to be trending to the east, based on two sets of seismic data. Evidence for faulting found in borings along the transect line includes: thickening of young alluvium across several borings within the fault zone, a thickening and offset of older alluvium deep within closely-spaced borings, and deeper offsets within sedimentary bedrock (Puente Formation) and quartz diorite. Artesian groundwater conditions are also reported within a narrow zone as noted in a cross-section prepared by the City of Los Angeles, included here as Figure 9.

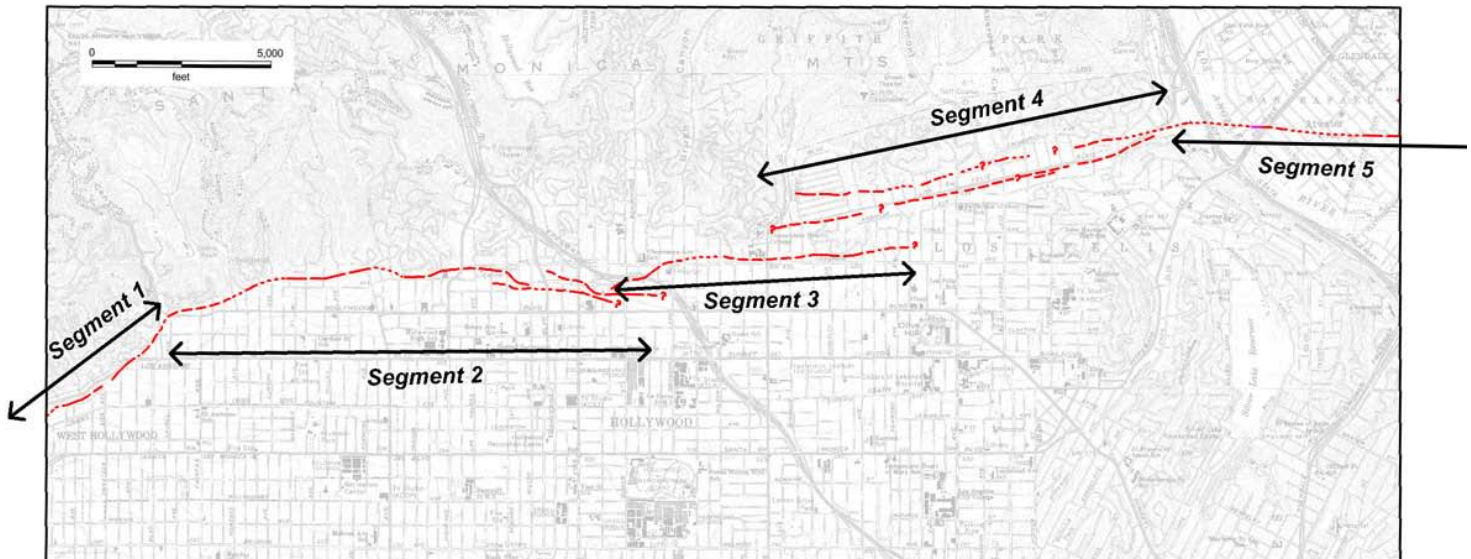
Figure 10 - index to fault segments discussed in the text. Red lines are faults identified for zoning.

To aid discussion we have divided the fault zone, as it crosses the Hollywood Quadrangle, into five segments (Figure 10). The westernmost segment (segment 1), from within the city of West Hollywood, trends northeast along the southern edge of the Santa Monica Mountains, primarily as a single trace. Segments 2 and 3 trend more east-west and are expressed in several near-parallel left-stepping fault strands. Segment 4 trends east-northeast, paralleling Los Feliz Blvd., and consists of at least two sub-parallel fault strands. Eastward from the Los Angeles River we describe Segment 5 which appears to consist of a single surface trace until the eastern boundary of the map.

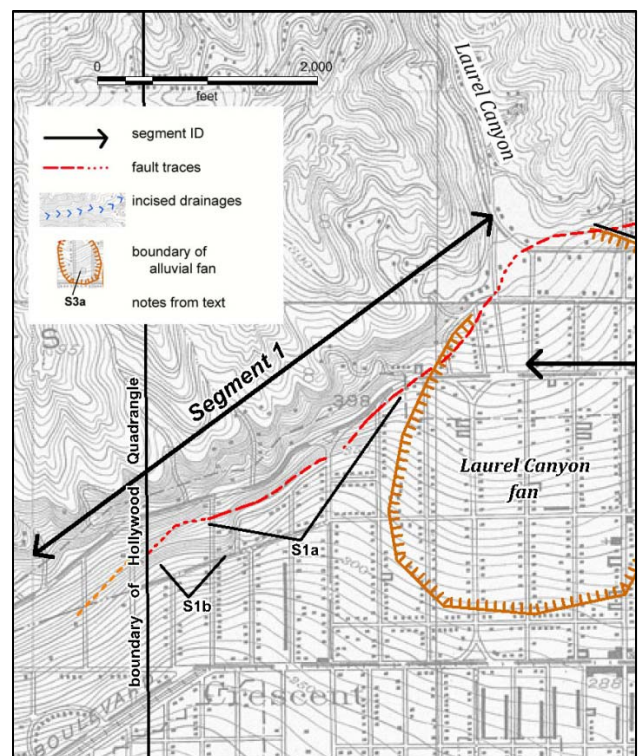
Figure 11 - Geomorphic features along Segment 1. Base map from 1926 Hollywood and Burbank 6' quadrangles.

We prepared an interpretive map from these topographic bases, delineating locally incised drainages and a complex set of nested alluvial fans being shed from the Santa Monica Mountains (Figures 11, 12, 13, 14 & 17). In particular we have made note of abrupt transitions from erosion (the channels) to deposition (the fans) and, where these are aligned with other corroborative or suggestive features, have interpreted fault movement to explain this change in sedimentary regime.

Segment 1 extends from the west margin of the map northeasterly to the vicinity of Laurel Canyon (Figure 11). The fault is expressed here by a well-developed scarp along the base of the hills (S1a). Some less-prominent scarps, north of the identified fault, may be related to a paleo-shoreline identified in the area (WLA, 1998c). Several small scarps near the base of the mountain front on Plate 2 (Site A1) are thought to be related to this paleo-shoreline feature. Several subtle slope breaks in the ground surface to the southeast may indicate additional splays, but these are less certain and may just mark the distal extent of fan deposition. A prominent scarp-like feature (S1b) at the edge of the map is crossed, on projection to the west, by fault studies which found no evidence of active faulting along that trend. The young Holocene-age alluvial fan emanating from Laurel Canyon has entirely obscured surface evidence of the fault in that location.

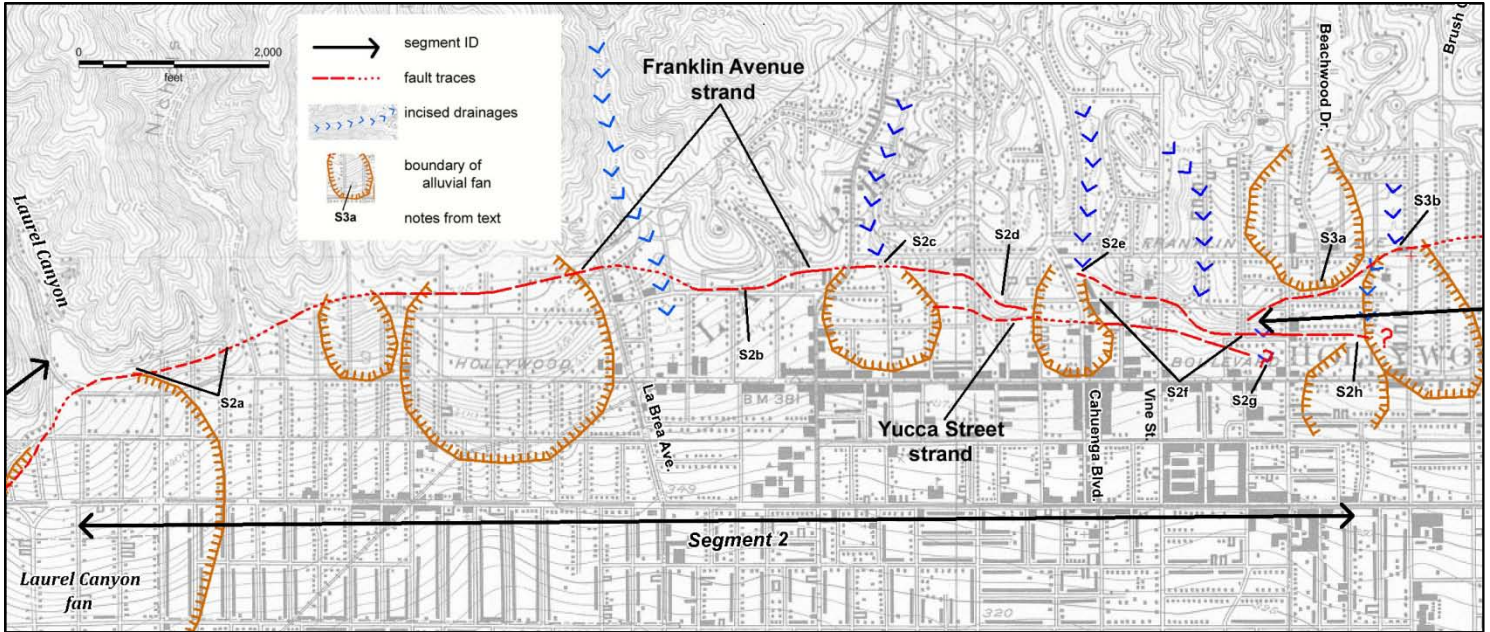
Figure 12 - Geomorphic features along Segment 2. Base map from 1926 Hollywood and Burbank 6' quadrangles.

Segment 2 trends east-west from Laurel Canyon to Beachwood Drive (Figure 12). The western portion is distinguished by a slightly sinuous mountain front with small fans emanating from small to medium-sized canyons. The mouths of these canyons are in rough alignment as far east as La Brea Avenue, suggesting some linear structural control, but the fault may be buried and overlapped by fan deposition so that the fault trace would be somewhat south of the current slope break. Oversteepened and eroded slopes at the south end of several intervening ridges are interpreted to be related to faulting. More subtle breaks in slope gradient to the south are possibly related to the distal edges of the small alluvial fans and cannot be ascribed with any certainty to faulting (Plate 2, site A2). The south end of the first ridge to the east of Laurel Canyon (S2a) appears oversteepened and is likely a fault scarp. Dolan *et al.* (1997) also noted the scarp in this area. A break in slope also veers away from this scarp and across a local fan coming off of the slopes, suggesting young displacement. Subtle tonal lineaments (Plate 2) suggest the fault location to the east across the Nichols Canyon drainage.

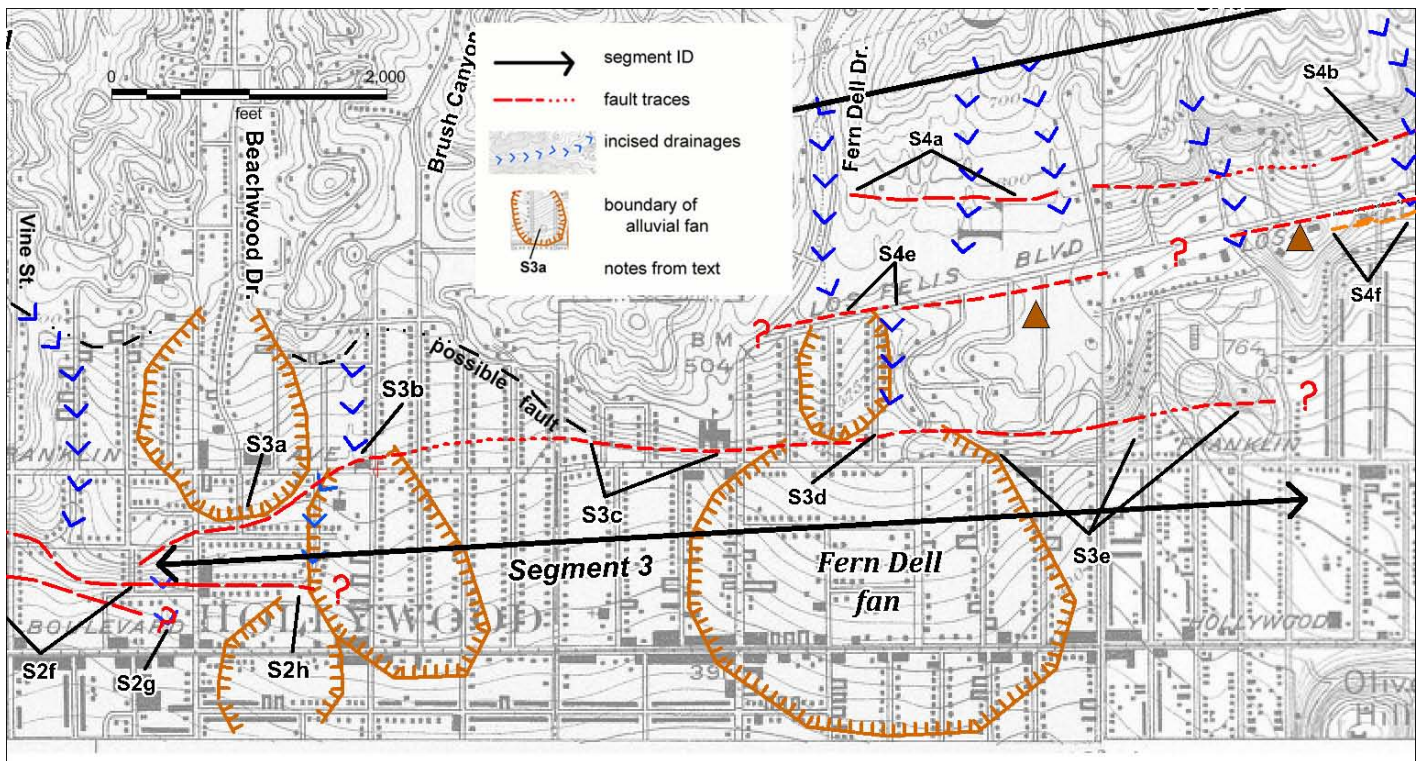
Figure 13 - Geomorphic features along Segment 3. (brown triangles indicate saddles discussed in Segment 4)
Base map from 1926 Burbank and 1928 Glendale 6' quadrangles.

Segment 3 overlaps Segment 2 at its west end and Segment 4 at its east end (Figure 13). It appears to function as a transition in the stepover between those two segments. The western end is suggested by a slight steepening of the fan gradient below Beachwood Drive and Franklin Avenue (S3a), and an incision to deposition transition just to the east (S3b). The main alluvial fan of Brush Canyon conceals the trace for a short distance and then the approximate fault location is indicated by the abrupt slopes just north of Franklin Avenue (S3c, S3e). This prominent scarp is also marked by the initiation of fan deposition from the Fern Dell drainage (S3d) as well as a break in the fan gradients. Geomorphic expression of this fault segment dies out about 0.5 km west of Vermont Avenue.
