**CALIFORNIA GEOLOGICAL SURVEY
FAULT EVALUATION REPORT FER 253**

**THE HOLLYWOOD FAULT
in the Hollywood 7.5' Quadrangle
Los Angeles County, California**

by
Janis L. Hernandez
Engineering Geologist
and
Jerome A. Treiman
Senior Engineering Geologist
February 14, 2014

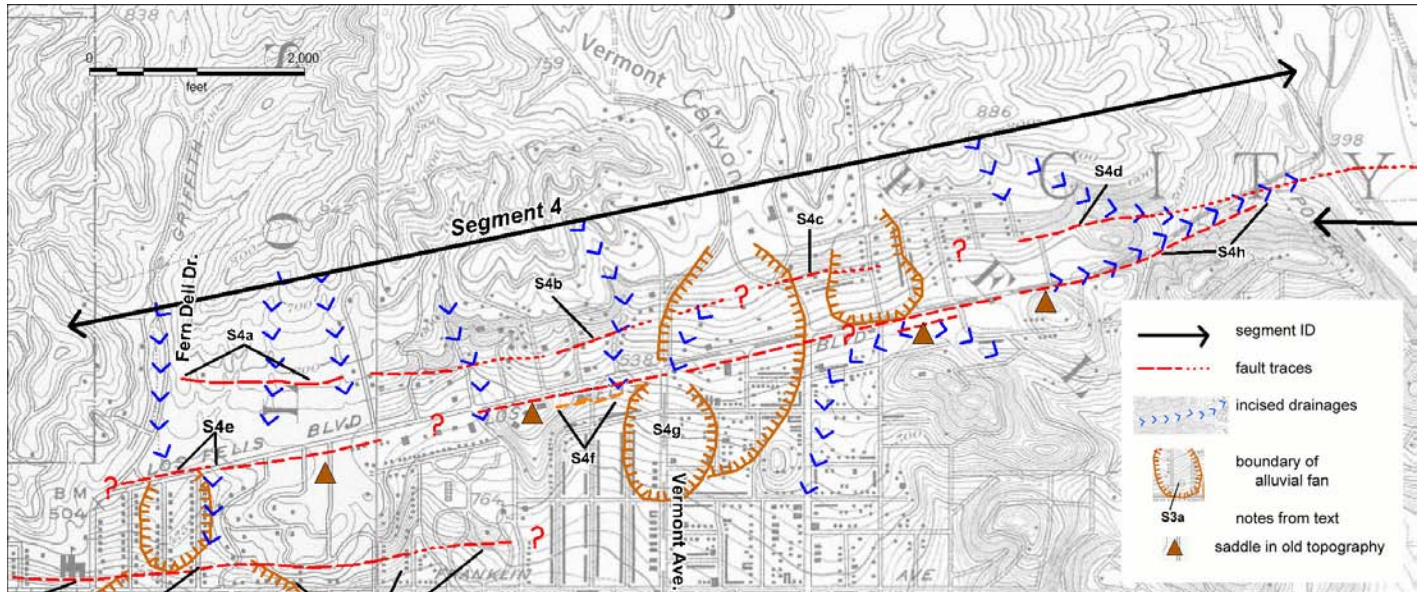
Figure 14 - Geomorphic features along Segment 4. Brown triangles locate prominent saddles along the Los Feliz Boulevard fault strand. Base map from 1926 Burbank and 1928 Glendale 6' quadrangles.

We prepared an interpretive map from these topographic bases, delineating locally incised drainages and a complex set of nested alluvial fans being shed from the Santa Monica Mountains (Figures 11, 12, 13, 14 & 17). In particular we have made note of abrupt transitions from erosion (the channels) to deposition (the fans) and, where these are aligned with other corroborative or suggestive features, have interpreted fault movement to explain this change in sedimentary regime.

Segment 4 overlaps Segment 3 at its western end and there are geomorphic indications of at least two parallel faults in this segment (Figure 14). This segment is grossly indicated by an east-northeast trending trough that has been breached by erosion. Los Feliz Boulevard follows this trough.

What we consider the principal active fault strand has few sharply defined indicators but is taken as the axis of the geomorphic trough that is followed by Los Feliz Boulevard. The general nature of this trough is indicated by several remnants of its eroded south margin with prominent saddles (Figure 14, brown triangles) along the fault trace, and is further confirmed by several profiles constructed from the LiDAR DEM.

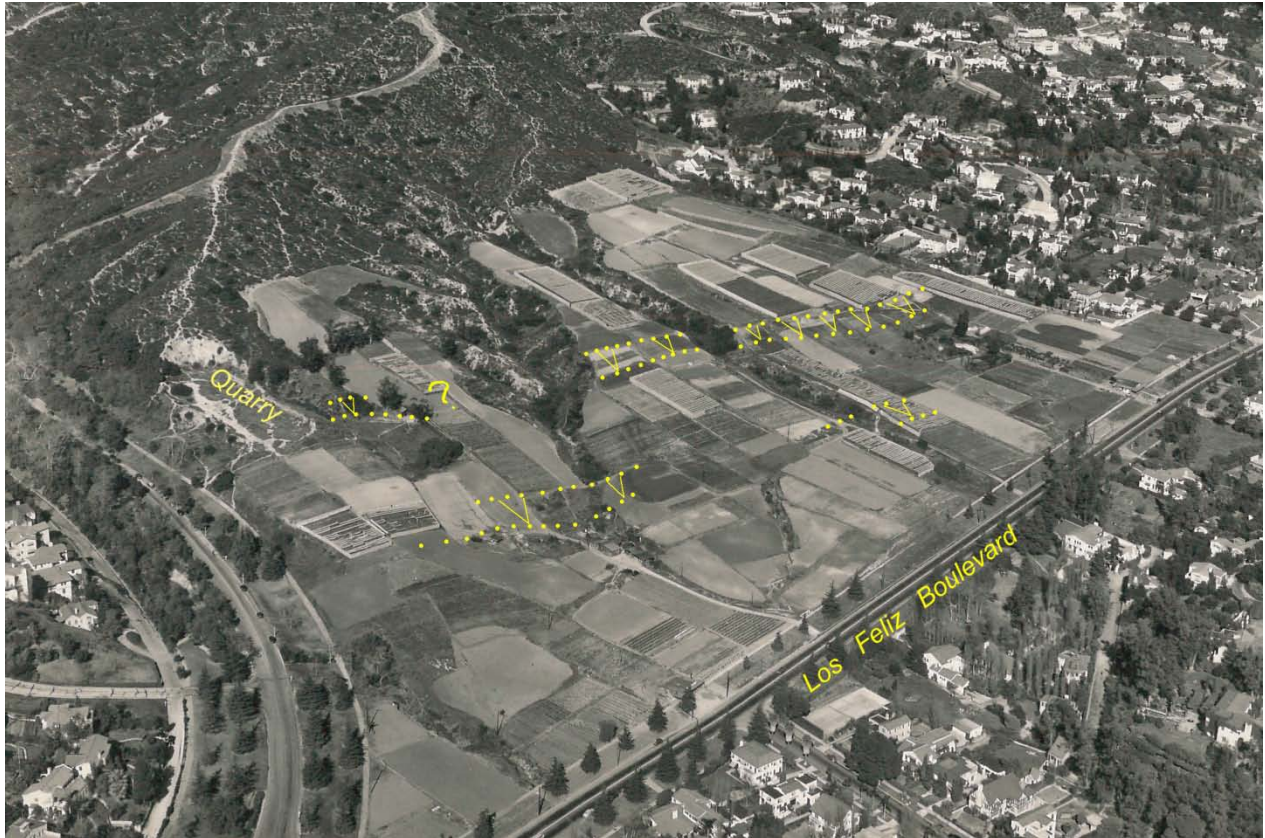
Figure 15 - Oblique aerial view of the Mead Estate from 1928, showing principal and minor scarps (Yellow dotted lines) extending across the property. Site is located at the west end of Los Feliz Boulevard (Plate 2, site 5). (Photo by Fairchild Aerial Surveys, 2/25/1938, from UCLA Geography Department).

A northern strand is defined at its western end by an offset fan surface (Plate 2, site A5) that is observable in vintage aerial photography as shown on Figure 15. There is at least one principal fault indicated by the steepest drop in the surface (S4a) and possible secondary faults between the principal strand and Los Feliz Boulevard indicated by additional local breaks in the slope gradient. Further east, this fault, as a single strand, is intermittently expressed by steepened slopes along trend (S4b, S4c); the fault is locally overlain by younger fans, such as that emanating from Vermont Canyon. At its eastern end it passes through a local topographic saddle (S4d) and then appears to join the Los Feliz Boulevard fault strand.

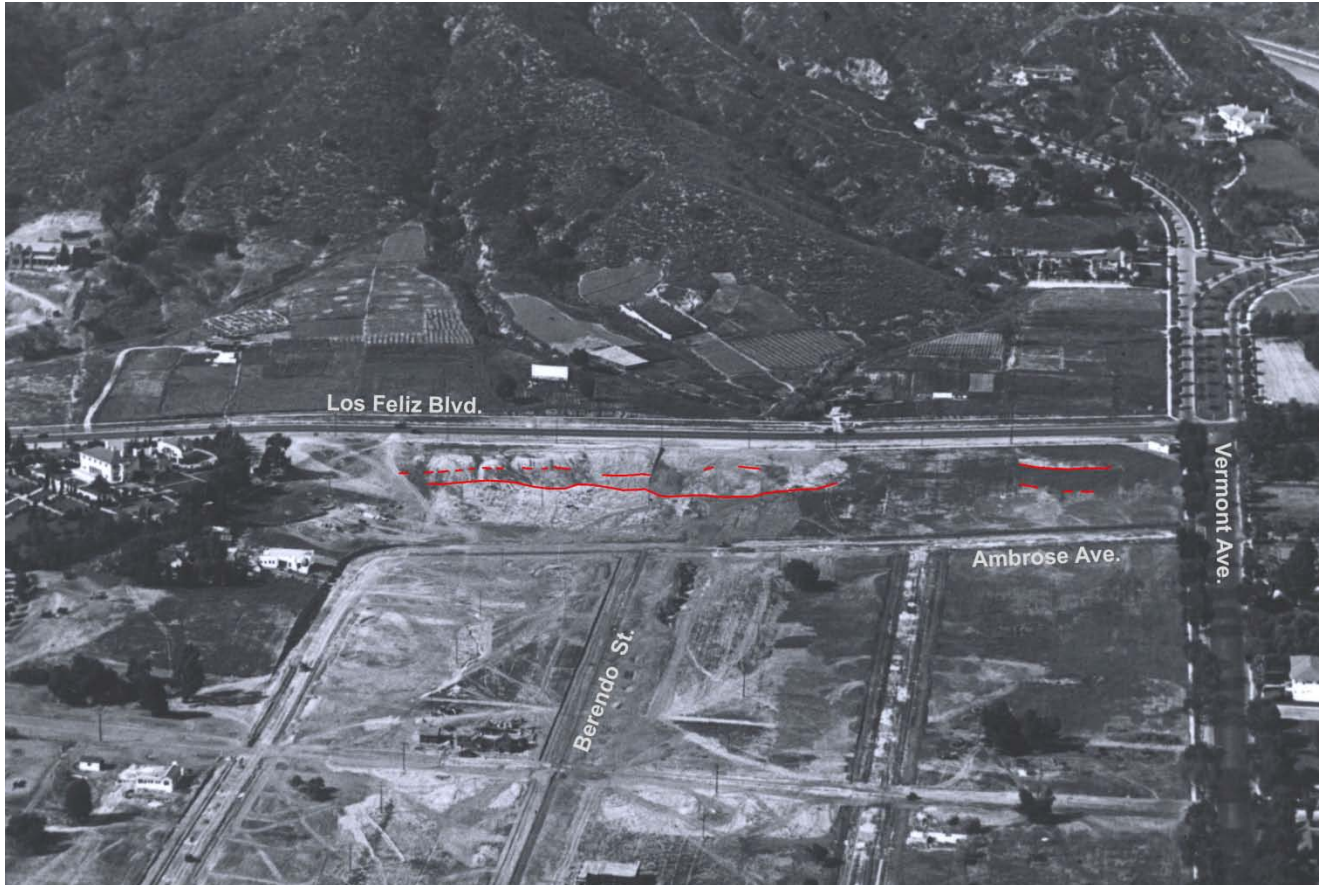
Figure 16 - Oblique aerial photo near the intersection of Vermont Ave. and Los Feliz Blvd. showing fresh grading south of Los Feliz Blvd. Lineaments (highlighted with red) are possible fault traces. (Photo by Spence Aerial Photos, circa 1921; from UCLA Spence collection).

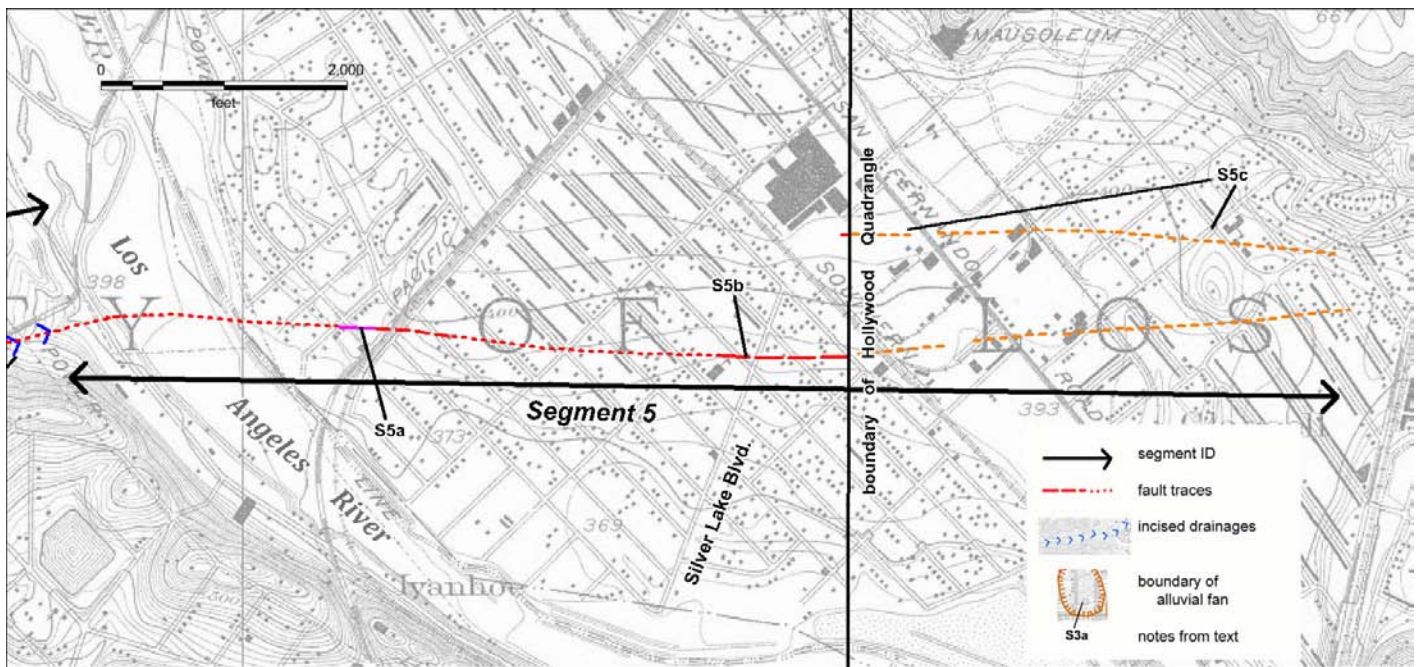
Figure 17 - Geomorphic features along Segment 5. Base map from 1928 Glendale 6' quadrangle.

Segment 5 continues eastward across the abandoned flood plain of the Los Angeles River in the Atwater area (Figure 17). An elongate knoll, just east of the river, has its southern terminus at the inferred fault location (S5a) where there are also some faint tonal lineaments and a possible scarp along the fault. Farther east the Hollywood Fault is expressed as a series of low, discontinuous breaks in the flood plain surface with south side down orientation, as previously observed by Weber (1979; 1980). At the eastern edge of the quadrangle the drop is as much as 2-3 m (Plate 2, site A6). There is a possible pressure ridge where the fault crosses Silver Lake Boulevard (S5b); it is visible in the elevation of several residential lots in spite of the roads having been graded level. Although scarps are noticeable in several of the streets, some of the previously mapped features (scarps and lineaments) have been obscured by development.
