LOS ANGELES HARBOR DEPARTMENT  
ENGINEERING DIVISION  
425 S. Palos Verdes Street  
San Pedro, CA 90733-0151

**SUBJECT: COMPLIANCE WITH LIMITED SIDEWALK REPAIR PLAN (C.F. # 13-0600-S109)**

Attachment 1: City of Los Angeles Harbor Department Sidewalk Survey Map

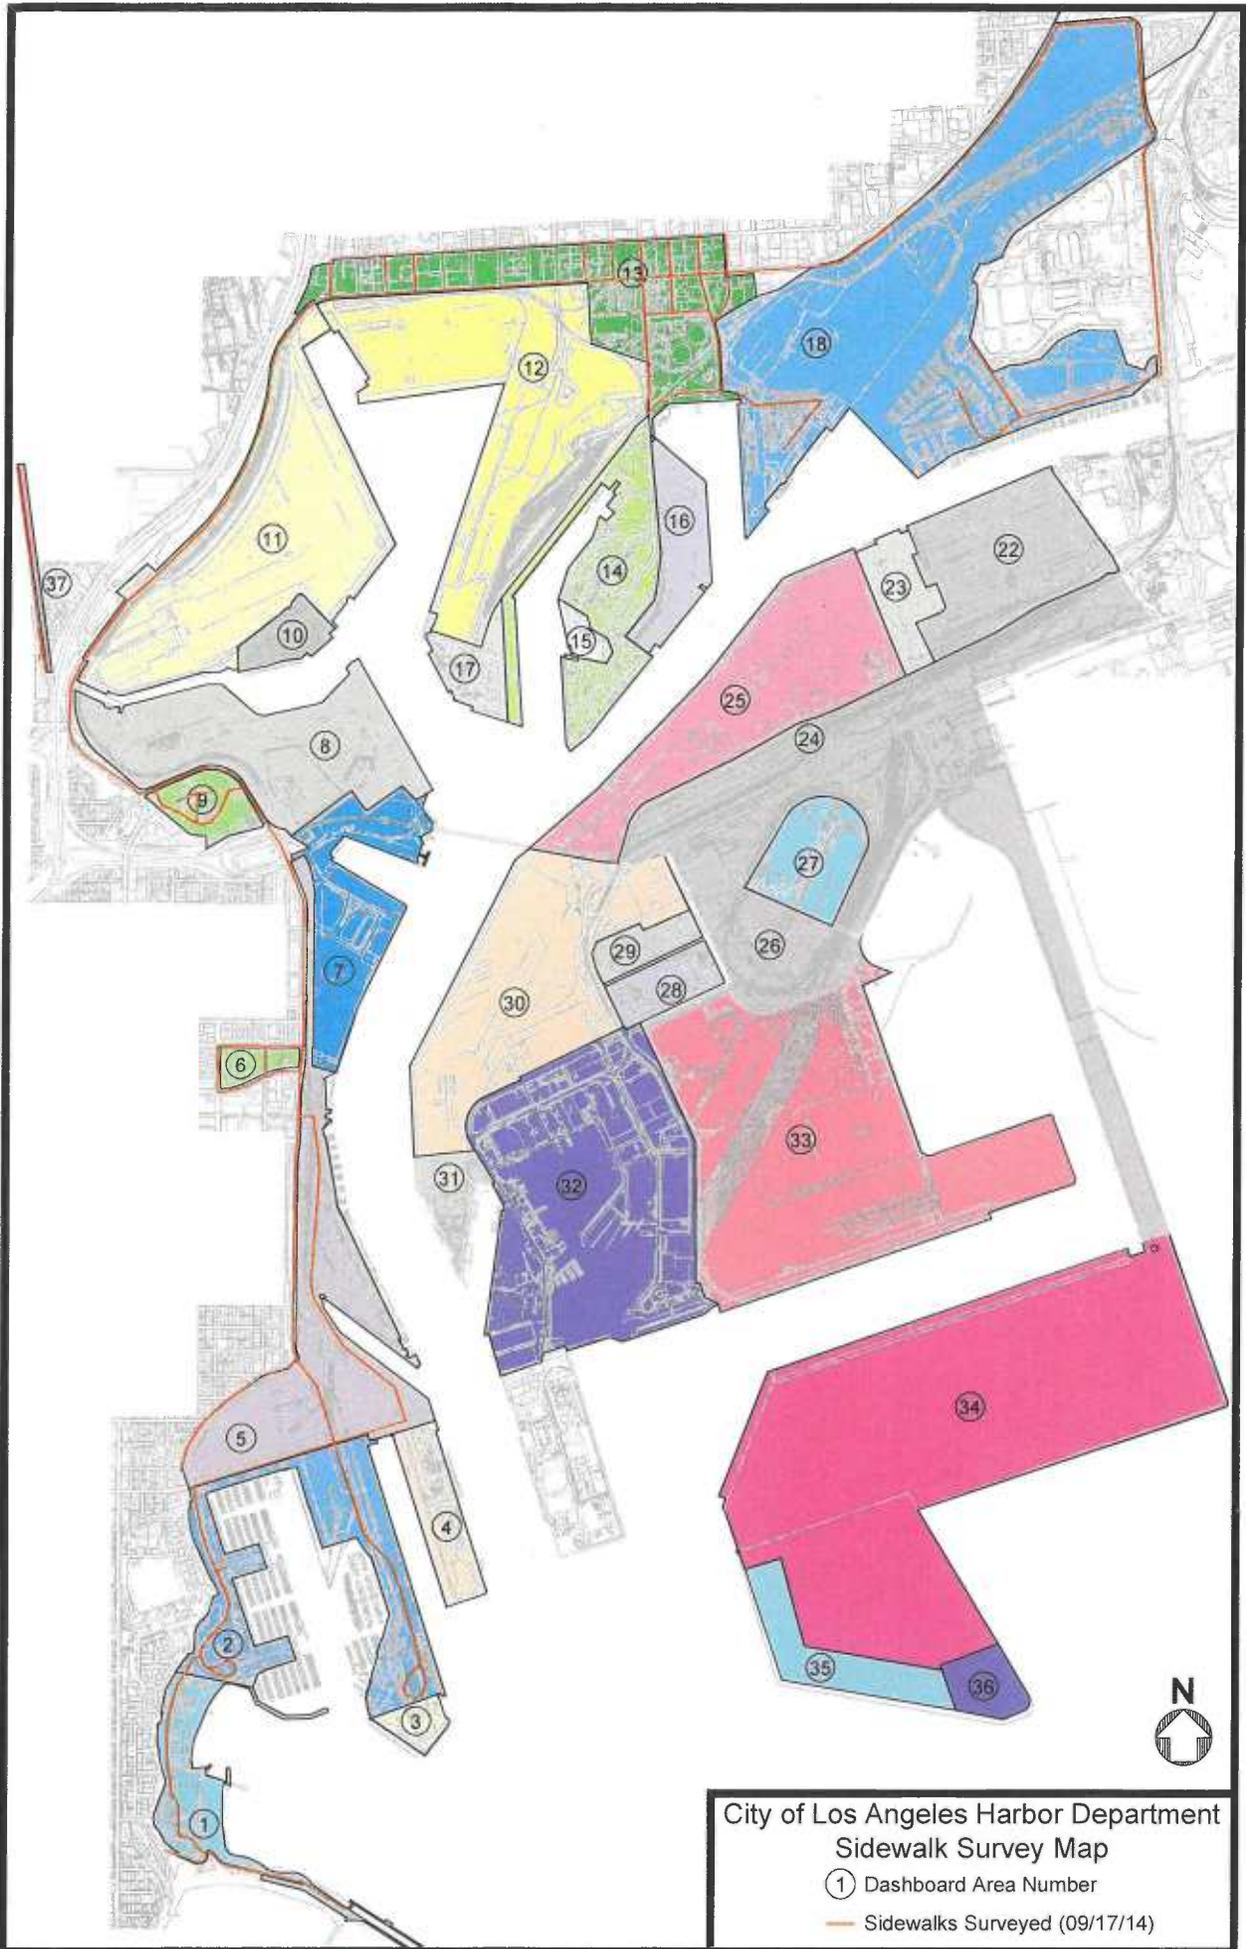
In September of 2014 nine two-person teams surveyed a total of 17.5 miles of streets adjacent to Harbor Department facilities in the communities of San Pedro and Wilmington, as shown on the attached map. Both sides of the streets were surveyed for damage or other obstructions that would affect pedestrian access. Sidewalks adjacent to Harbor Department property on Terminal Island have not yet been surveyed, due to the general lack of pedestrian traffic in the entirely industrial area, but will be surveyed by the end of 2014. Results for the approximately 35 miles of sidewalks surveyed are summarized below:
