Street Damage Restoration Fee Study

Testing Portion

City of Los Angeles

**Test Report of
Los Angeles Street Damage Restoration Fee (SDRF) Update Study**

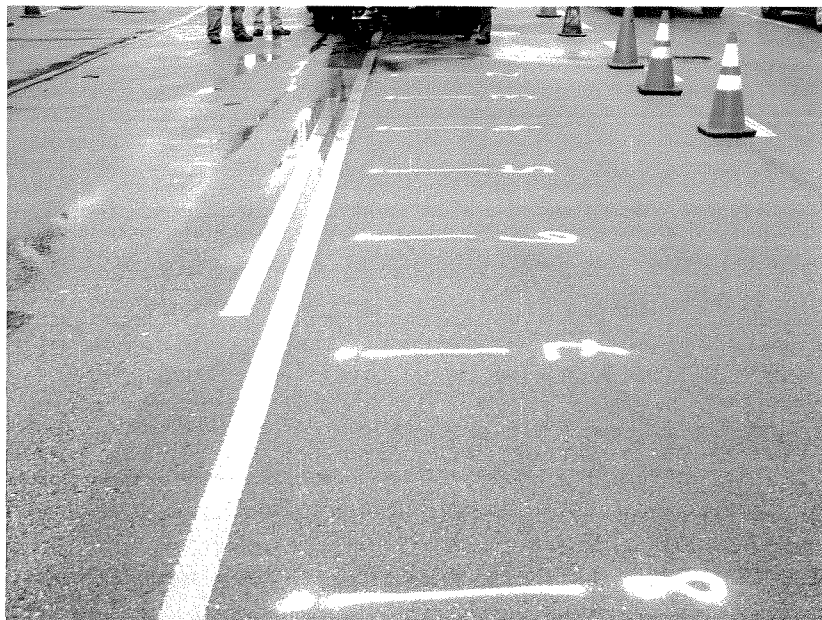
Figure 3: Shows FWD to be measured in a control area with consistent Asphalt thickness structure.

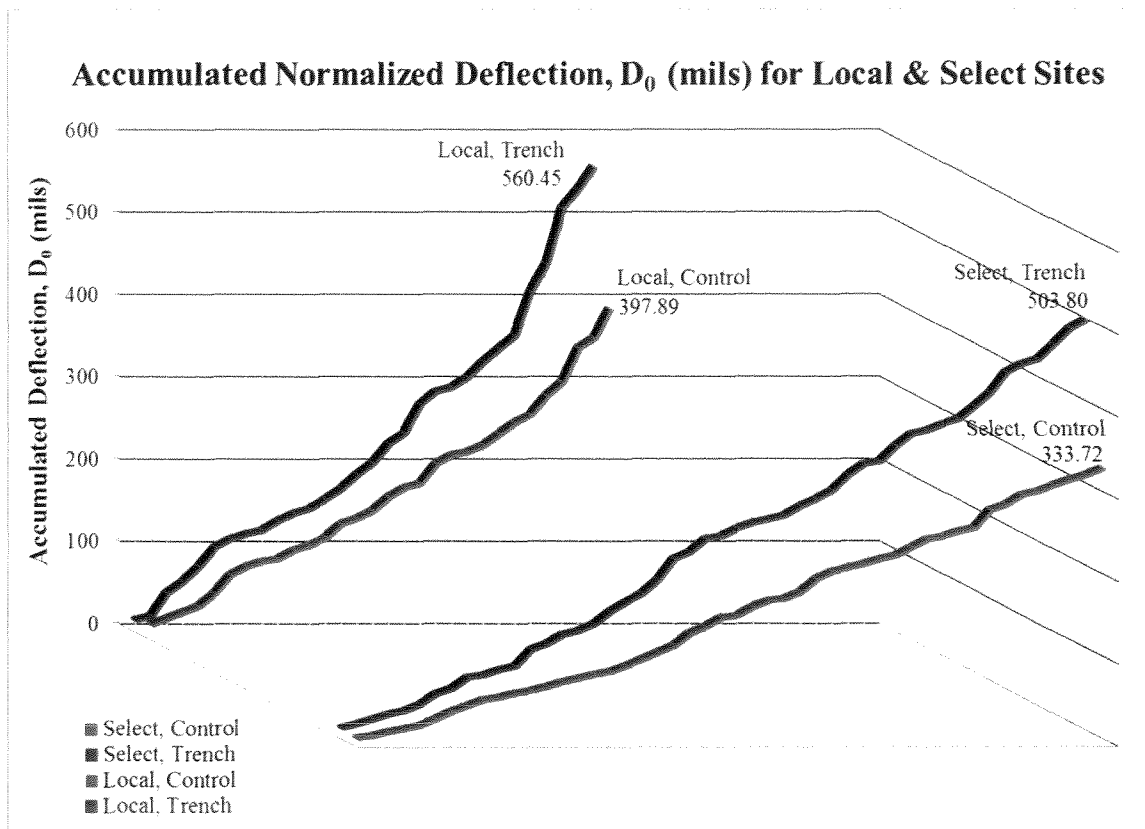
Figure 4

Accumulated deflection, D_0 (Normalized to 9 Kips and 68° F) of Local Trenches and respective Controls clearly shows higher accumulated deflection on trenches than controls. The values are 560 mils and 398 mils, correspondingly. The same observation is seen in Select Trenches vs. Controls where the values are 504 mils and 334 mils, respectively (**See Figure 4**). The average normalized deflection (D_0) of Local Trenches was 41% higher than their corresponding Control. The average normalized deflection (D_0) of Select Trenches was also 51% higher than their corresponding Control (**See Figure 5**). This shows that the pavement surrounding each trench has been weakened more than the rest of the pavement section, thereby accelerating pavement failure under traffic. It was also observed that the damage was higher among select streets than local streets.

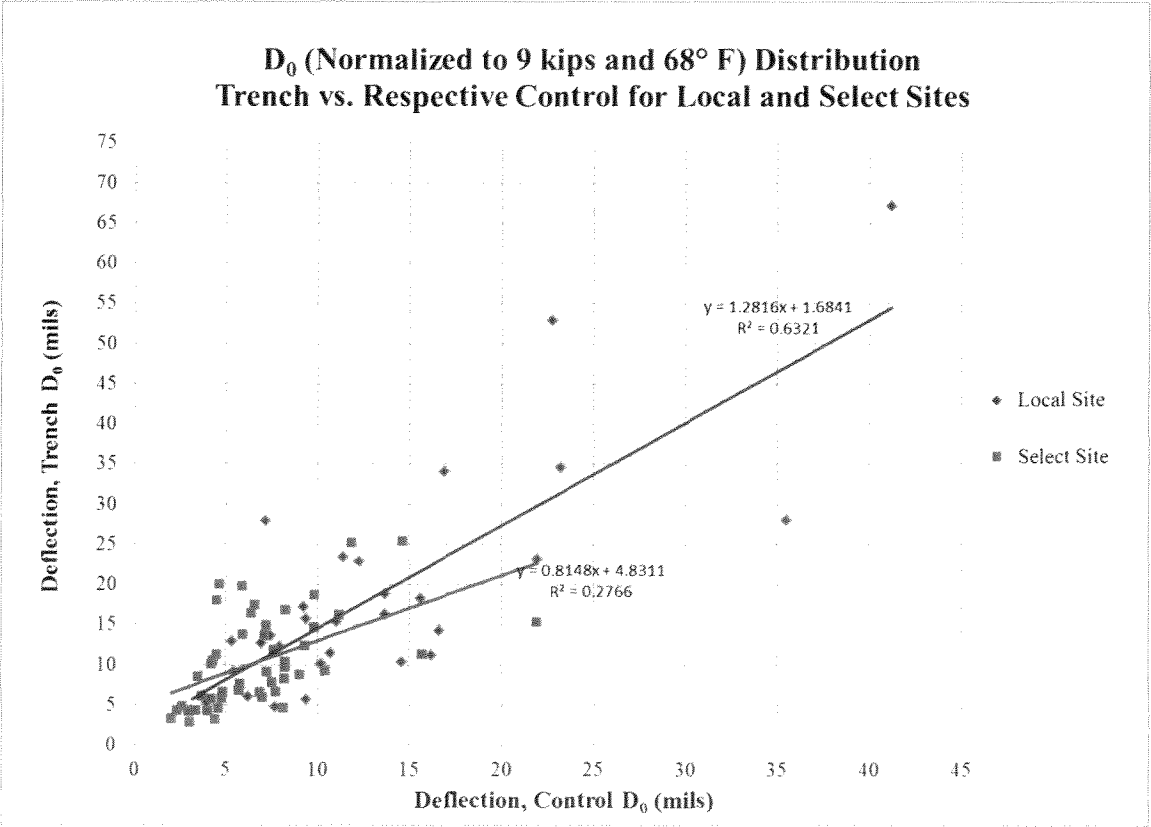
Figure 6

A regression analysis was performed to determine the relationship between the average normalized deflections (D_0) of Local and Select trenches and their respective controls by means of a scatter plot (See Figure 6), then a straight line (the best fit of the regression line) that describes such relationship in the best possible manner was calculated and drawn with the Excel program.

The trend of the regression line clearly shows that the normalized deflections in the trench area are higher than the control area or that the trench area has been debilitated by the utility trench.

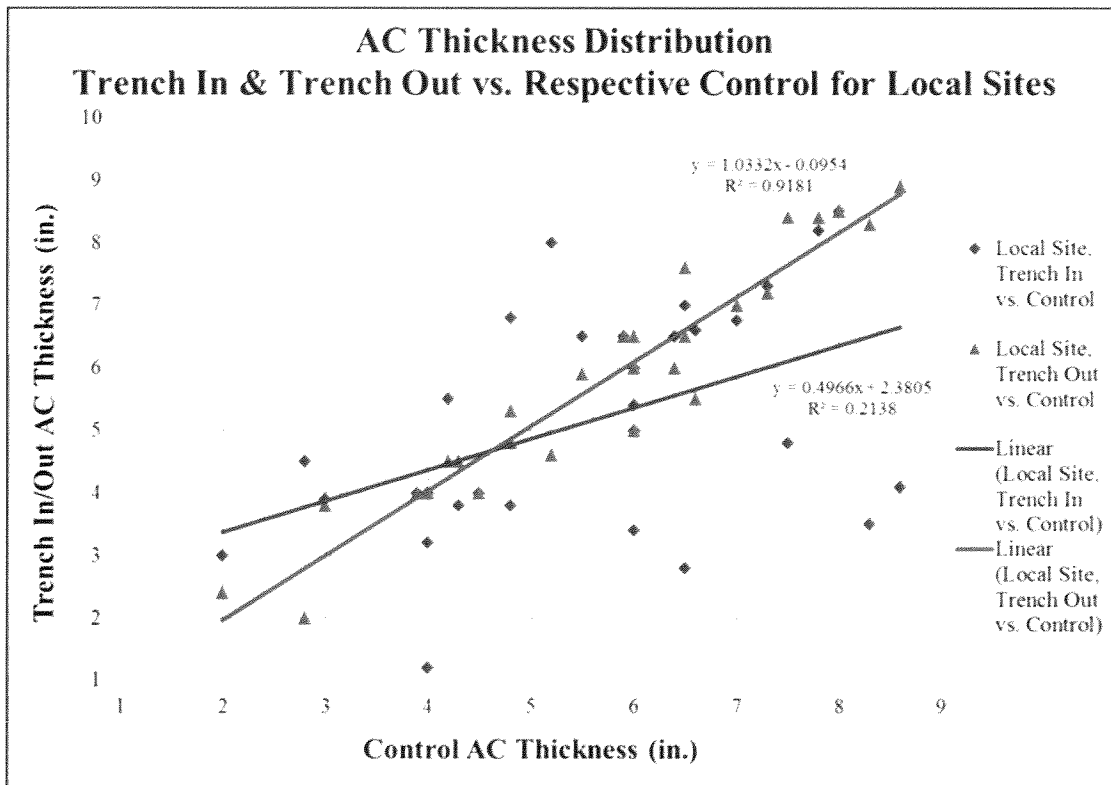
Figure 8

The simple linear regression analysis of pavement thickness distribution among inside of trench (**Trench-In**), out of the trench (**Trench-Out**) and respective control area (**Figures 8 & 9**), displays basically a relationship of 1 to 1 thickness between Trench-Out and Control area for both classifications (**Local and Select**). However the regression analysis between Trench-In and Control in both classifications are not conclusive due to the inconsistency of the trench repair, which indicates that utility trenches were not properly restored to match the original pavement thickness structure.

Coring data shows that inside of trench (**Trench-In**) asphalt concrete thickness is much less than outside of the trench (**Trench-Out**) see **Figures 7, 8 and 9**.

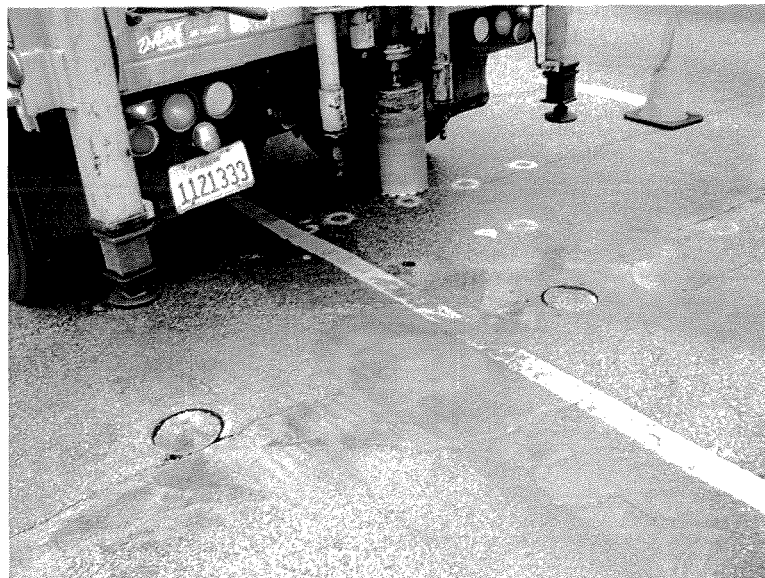
Figure 10: Existing pavement thickness determination Trench-in & Trench-out.

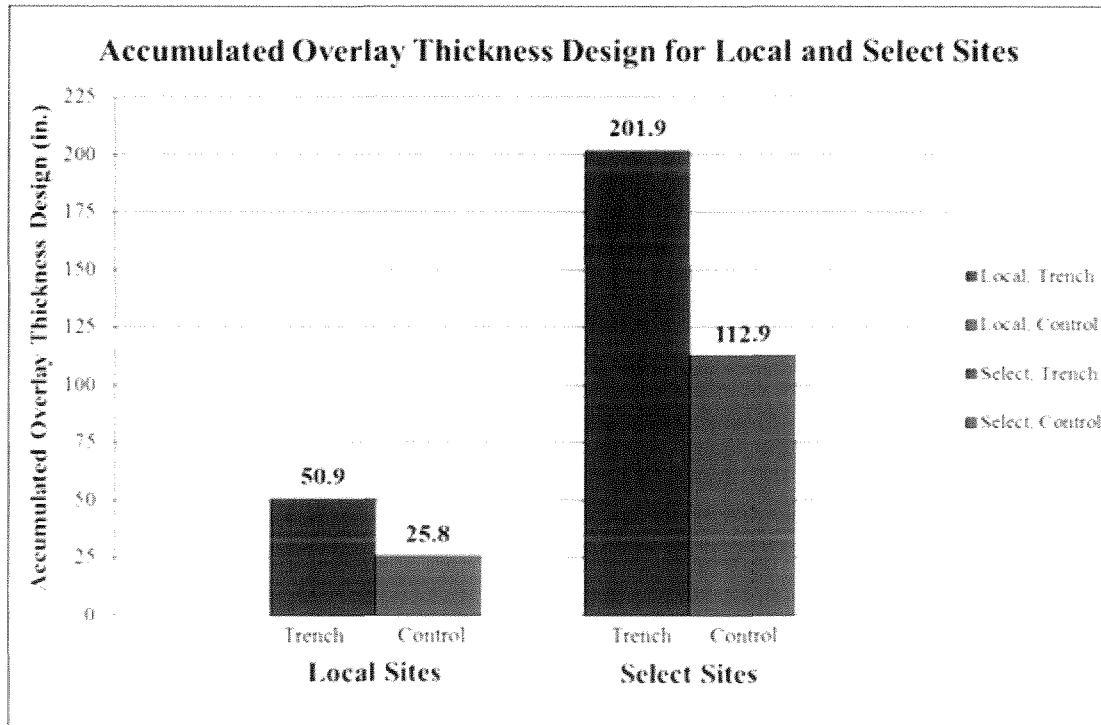
Figure 12

The accumulated overlay thickness design, in inches, for Local and Select trenches and their respective control areas are presented in **Figure 12**. In both street classifications, the accumulated required thickness design is significantly higher in the Trench area than the Control area (98% higher for Local & 79% higher for Select).

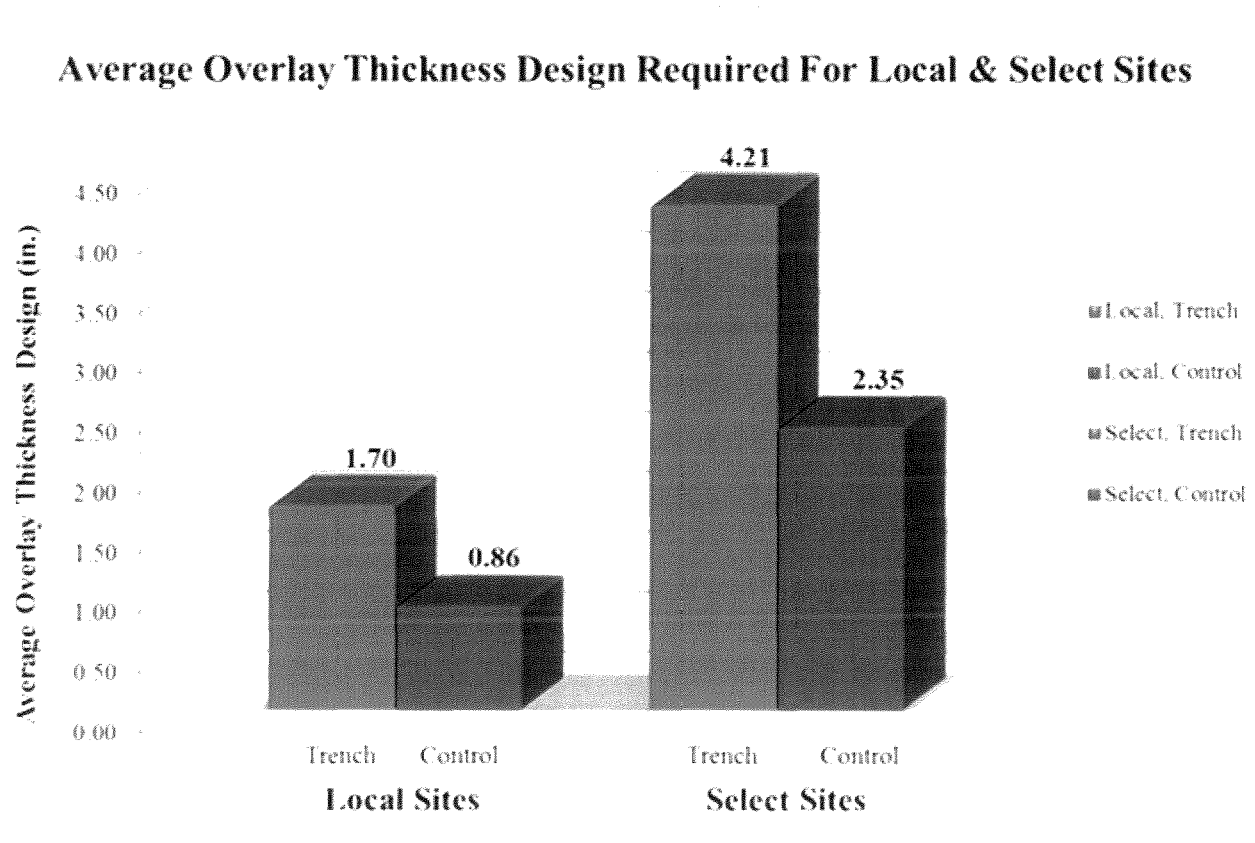
Figure 13

In addition, the average overlay thickness design has also been calculated to illustrate how the weakness inflicted in the pavement by the utility trench has to be restored with “additional thickness structure” to meet traffic demands when compared with the control average overlay thickness design required to meet such demands (see **Figure 13**). Using this figure we conclude that the Local trench areas require an average of **0.84** inches more structure than its respective control and an average of **1.86** inches more structure is required for the Select trench area than its respective control. This means that the trench’s surrounding pavement has been negatively affected by the excavation of the trench, and the effects are very significant and costly in order to remediate the damage caused by the trench in bringing the structure back to its original capacity.

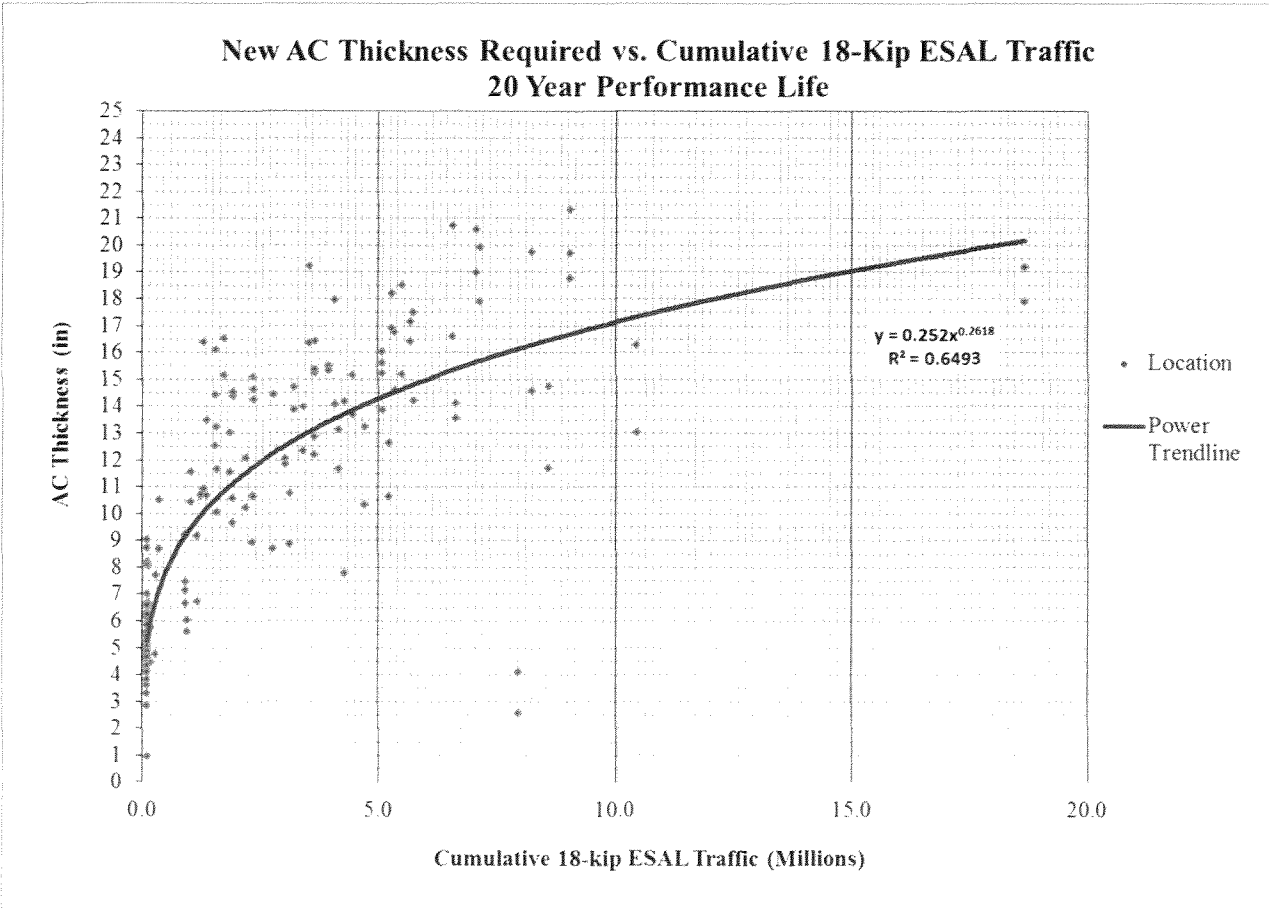
Figure 14

Asphalt Concrete Thickness Designs versus Traffic: Asphalt concrete thickness designs were calculated for all trench and control areas (Local and Select collectively) using the above-mentioned DARWin program and the data acquired in this study were plotted in a graph as AC Thickness in inches (Y) versus Cumulative 18-Kip ESAL Traffic in Millions (X). A power trendline was then calculated and drawn with the Excel program (see **Figure 14**). The best fit-line in this case is a power trendline that demonstrates that the AC thickness designs are directly related to traffic (**more traffic = more thickness**) notwithstanding the reduction of the positive rate of thickness/traffic at high levels of traffic. Therefore the cost to repair the damage in Select or high traffic pavement is a lot higher than the cost in Local or low traffic pavement.
